# Assessing Mars Curiosity Rover Wheel Damage

Arturo Rankin, Nikunj Patel, Evan Graser, Jiun-Kai Freddy Wang, Kimberly Rink  
 Jet Propulsion Laboratory, California Institute of Technology  
 4800 Oak Grove Dr.  
 Pasadena, CA 91109  
 (818) 354-9269  
 arankin@jpl.nasa.gov

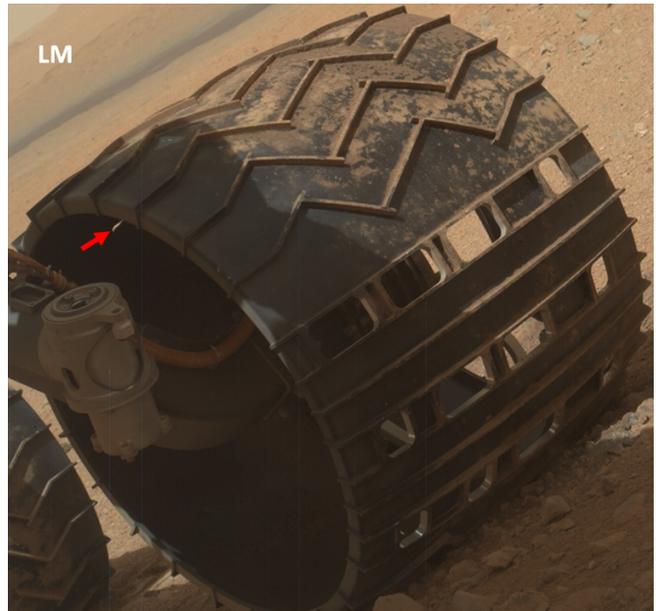
**Figure 6.** Cropped sol 34 MAHLI image of the LM wheel showing the first observed damage to Curiosity wheels. Image Credit: NASA/JPL-Caltech

The first Curiosity wheel damage was discovered during an inspection of the sol 34 MAHLI image of the LM wheel. As shown in Figure 6, light could be seen shining through a crack in the LM wheel skin, as observed from the underside of the wheel. The Tiger team concluded that this crack is likely from wheel/terrain interaction during Curiosity's touchdown on the surface of Mars.

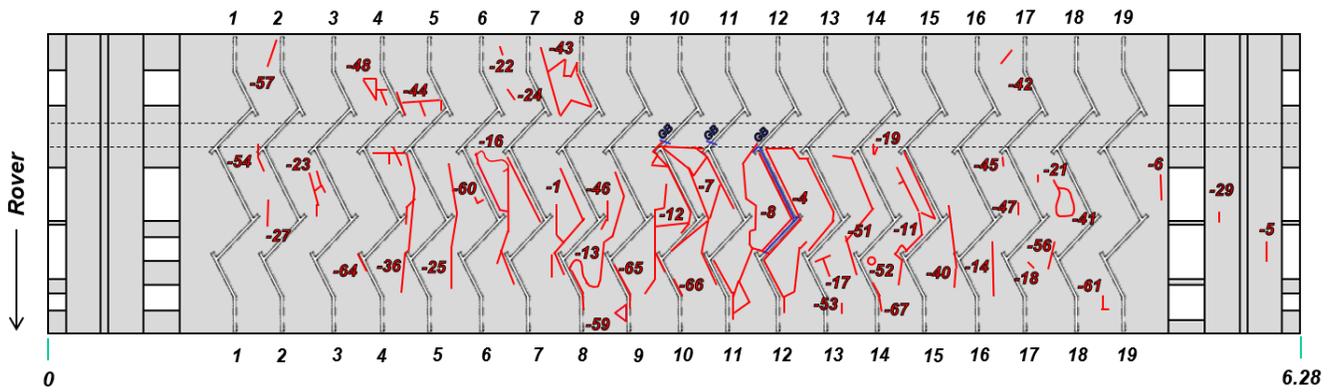
After completing the qualitative assessments, the cracks on the wheels are measured. Each wheel has a crack map that shows the locations and shapes of the features on it. The LM wheel crack map is illustrated in Figure 13. Cracks are numbered in order of their discovery (larger numbers are the most recent). The size of each crack is expressed in terms of a dimensionless ratio by dividing the length of a crack along the width of the skin section, by the width of the skin section. This is done by taking a pixel measurement of the skin section that a crack is on, and a pixel measurement of the crack length parallel to the previous measurement. As illustrated in Figure 14, an image manipulation tool such as GNU Image Manipulation Program (GIMP) is used to take pixel measurements.

Figure 13. Sol 3195 LM wheel crack map. Image Credit: NASA/JPL-Caltech

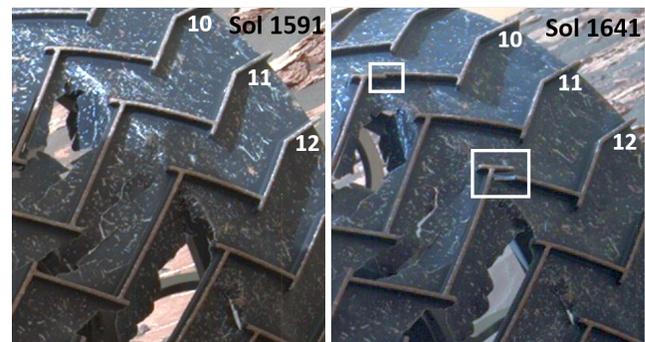
TRCTL was approved for nominal use in flight on sol 1678, following the discovery of the first two LM grouser breaks in sol 1641 wheel images. Since then, the wheel grouser break rate has been significantly slower than predicted by the Tiger team. However, while there have been decreases in damage rates, it is challenging to distinguish if they are due to TRCTL or driving over easier terrain. The first and only grouser break

**Figure 16.** A break occurred on grousers 10 and 12 of the LM wheel sometime between sol 1591 and 1641.

Figure 16 shows the state of LM wheel grousers 10, 11, and 12 on sol 1591, before any grouser breaks had been discovered, and on sol 1641, when the grouser 10 and 12 breaks were discovered. In the sol 1641 image, there is obvious separation where the grouser 12 break occurred, but the grouser 10 break is subtle, not detected by a clear

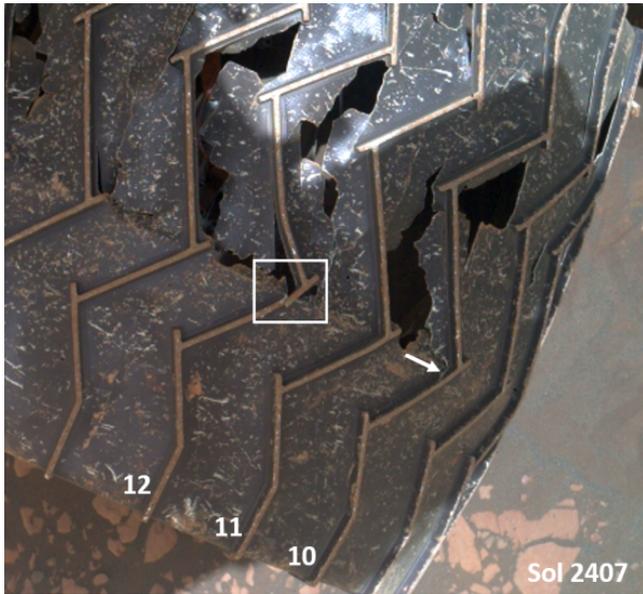
**Figure 17.** Status of the grouser 10 and 12 breaks on the LM wheel on sol 2407.

Figure 17 shows the state of LM wheel grouser breaks 10 and 12 on sol 2407. At the grouser 12 break, there is much less lateral separation than previously seen on sol 1641 and a visible lateral bend in grouser 12. At the grouser 10 break, there is no visible separation or misalignment, but the crack from the base to the top of the grouser is visible from a side view of the grouser.

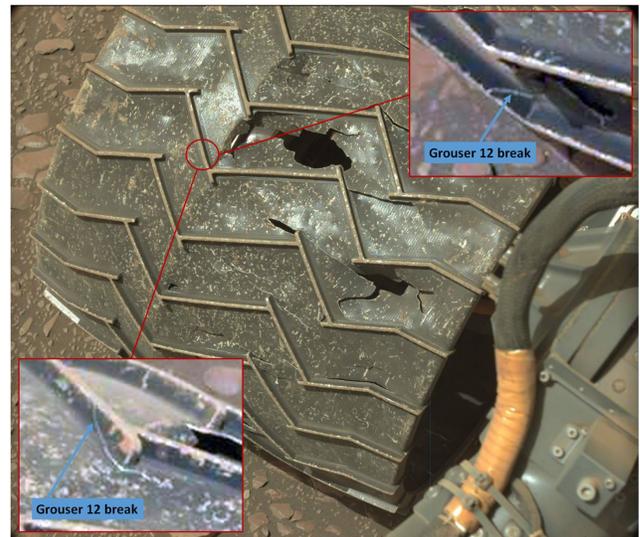
**Figure 19.** A view of the grouser 12 break on the RM wheel on sol 2407. The grouser break is not observable from a top-down view, but can be clearly seen from views of both sides of grouser 12.

view. The biggest damage feature on the LM wheel is named Moria (named after the Dwarven city from J.R.R. Tolkien's works, and voted for by the MSL team). As illustrated in Figure 19, the only grouser break on the RM wheel (on grouser number 12) is not visible from a top-down view of the grouser, but is visible from views of each side of the grouser.

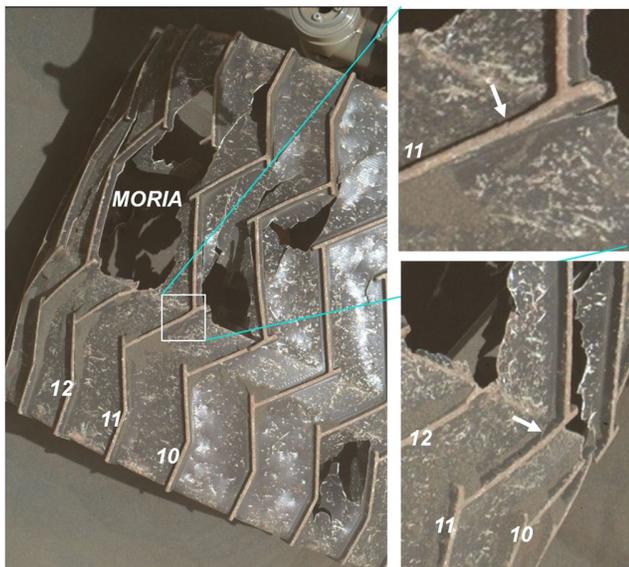
**Figure 18.** A view of the grouser 10, 11, and 12 breaks on the LM wheel on sol 3079. The grouser 11 break is observable from a top-down and side view.

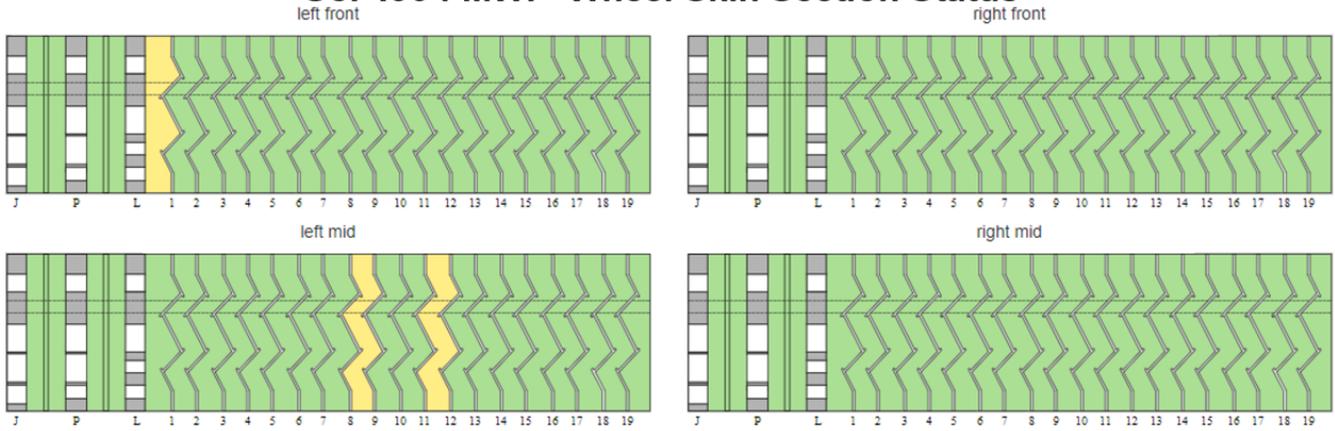
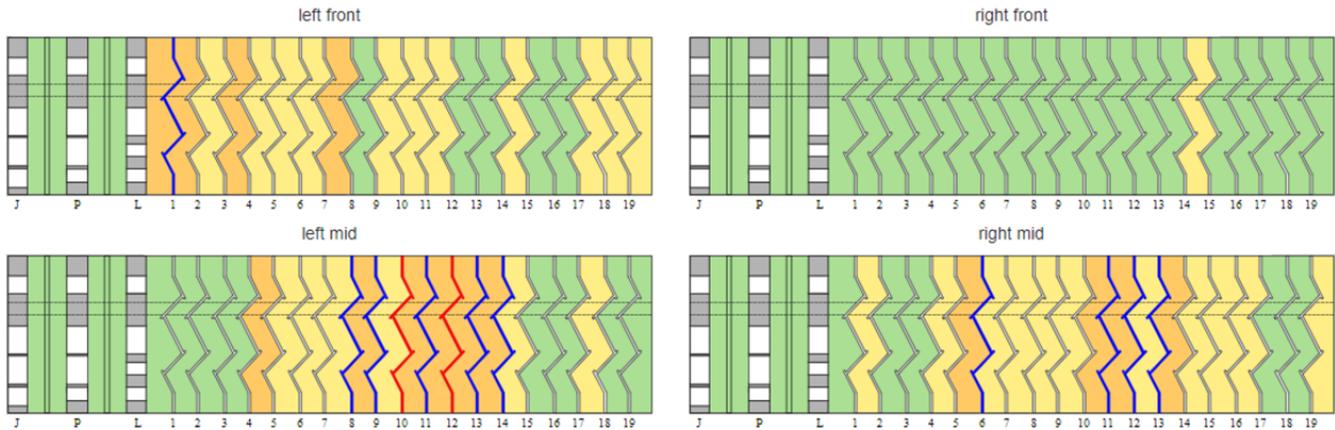
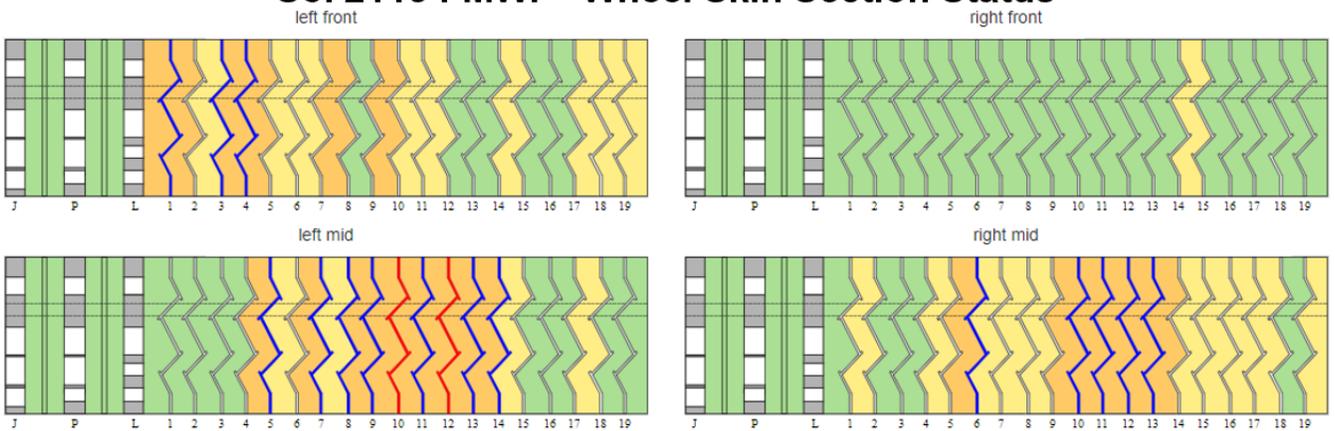
**Figure 20.** Damage per wheel skin sections for sols 490, 1682 and 2115

Figures 20 and 21 show wheel status per skin section and cumulative damage per wheel section, respectively, for the front and middle wheels on sols 490, 1682, and 2115. There was a significant increase in wheel damage from sol 490 to 1682 and a relatively small increase from sol 1682 to 2115. The red lines in Figure 20 are the broken grousers and blue lines are the at-risk grouser due to high damage in the skin section around them. The yellow skin sections in Figure 20 are ones with some damage and orange skin sections are ones with significant damage. The green sections in Figure 20 are the wheel sections with minimal damage.

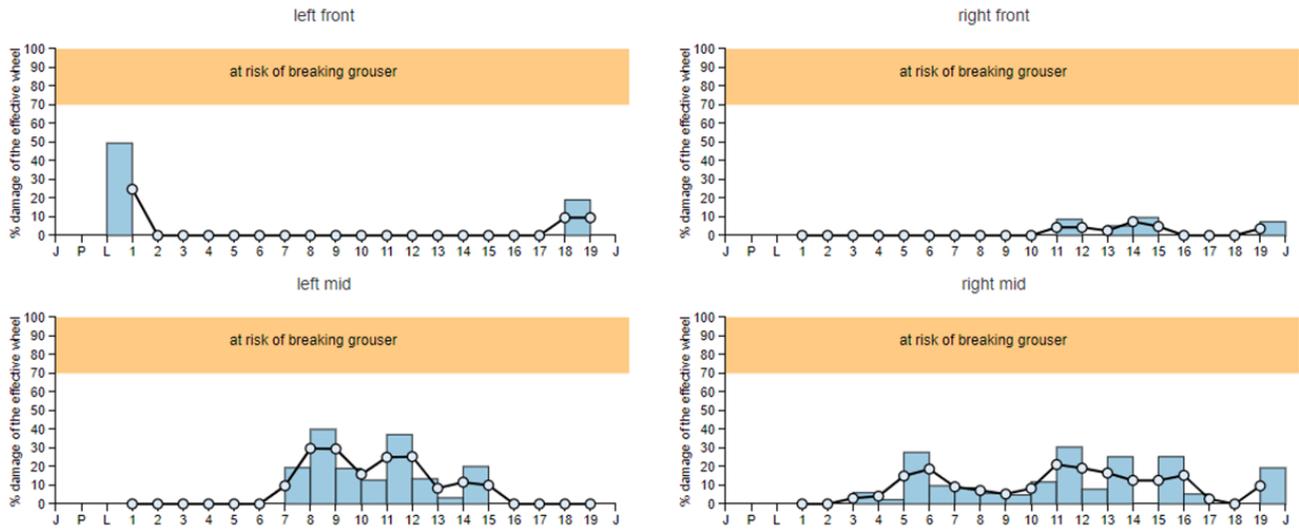
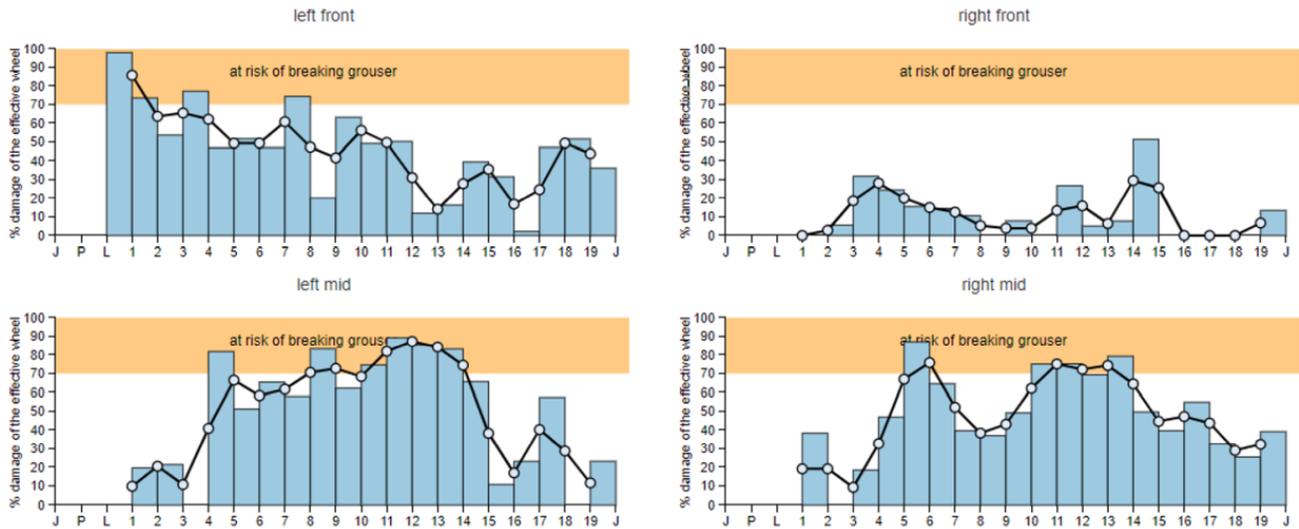
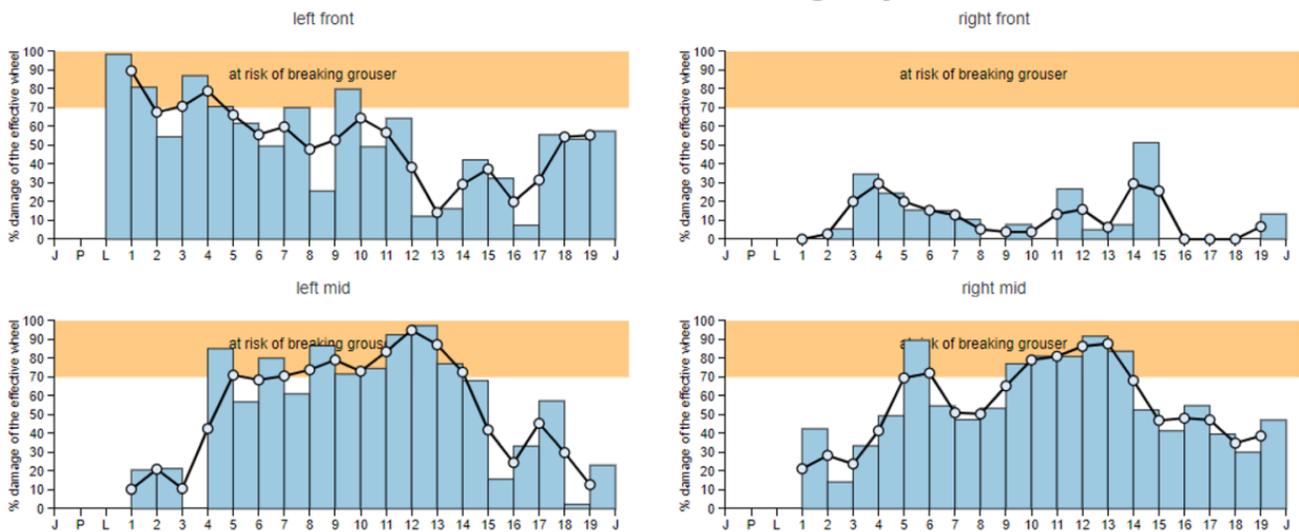
Figure 21. Cumulative damage per wheel sections for sol 490, 1682 and 2115.

The percentage of wheel damage per skin section can be seen in Figure 21. The damage on the RR and LR wheels is not depicted in the figures; this is due to the minimal damage these wheels have experienced. The relatively low damage on the LR and RR wheels is illustrated in Figure 22.

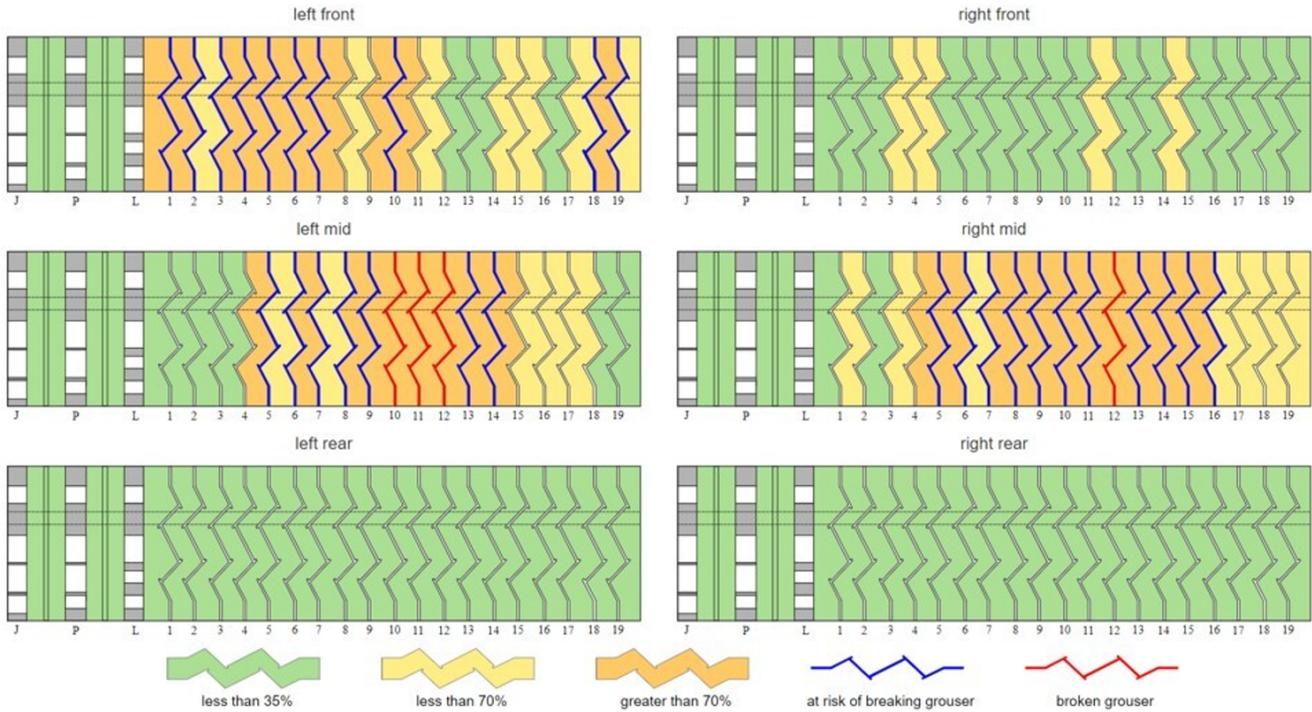
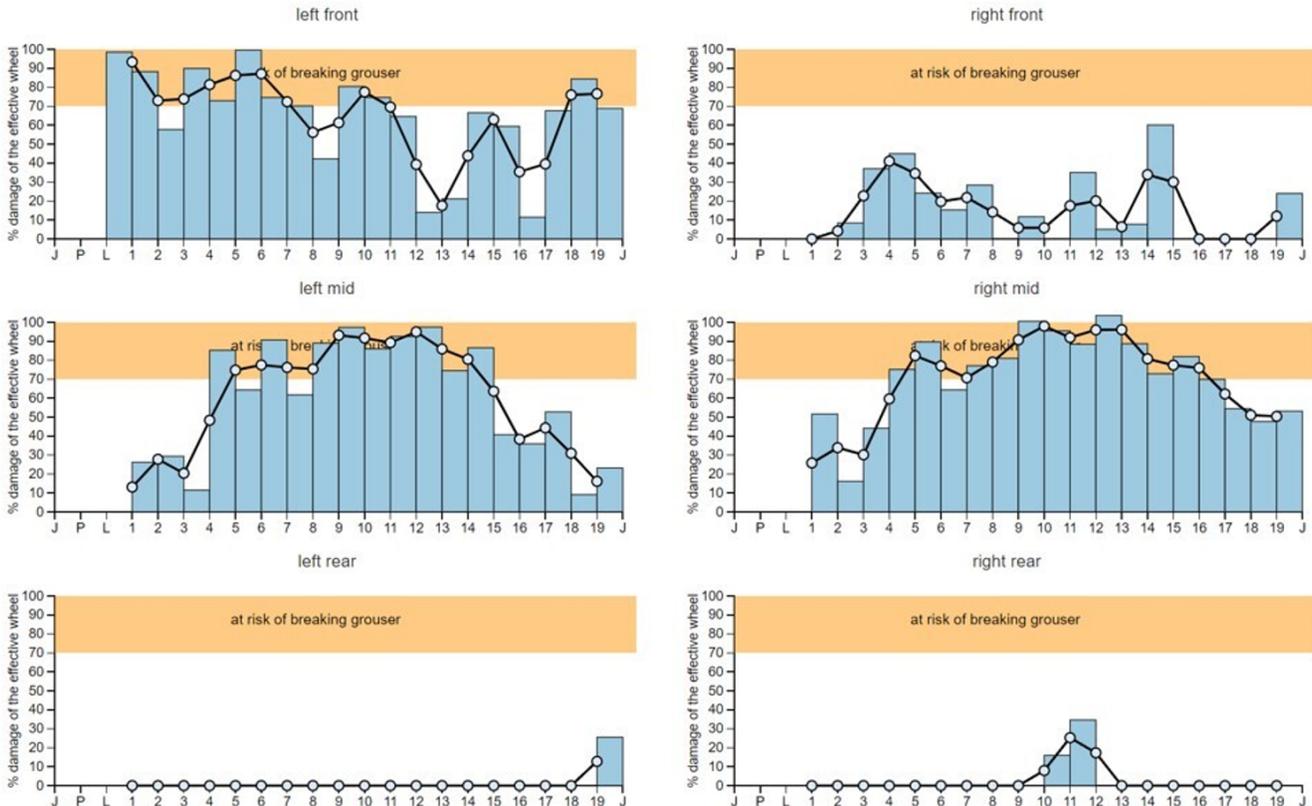
Figure 22. Wheel skin section status and cumulative damage per wheel sections, as of sol 3195

The RM wheel has the most features and largest cumulative crack length, followed by the LF wheel and then the LM

wheel. The LF wheel has nearly twice as many features and 4.3 times the cumulative crack length as the RF wheel. There is no obvious explanation for the disparity in damage between the LF and RF wheel, and although there are several hypotheses, this subject is still under investigation.

Figure 22 shows wheel status per skin section and cumulative damage per wheel section, as of sol 3195. Figures 23, 24, 25 and 26 contain all the front and middle wheel images acquired during the sol 3195 FMWI, with some notable features annotated by their identification numbers.

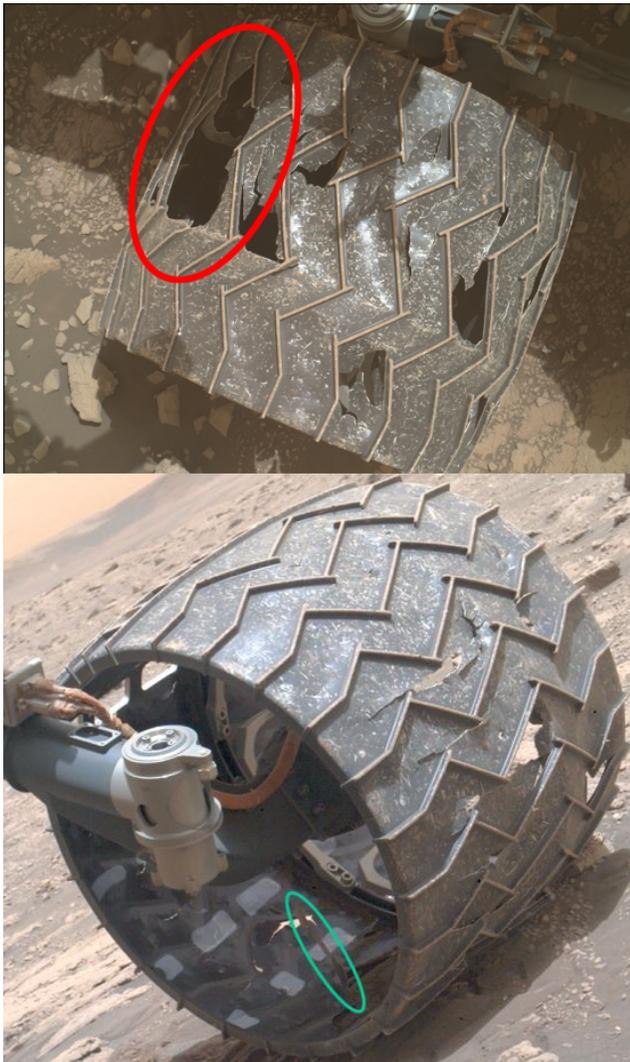
It required analysis to determine the risk to the LM wheel actuator’s cable bundle. The Wheel Wear team agreed that it was not long enough to be an immediate hazard, and since the base of it was a grouser, it could not grow any longer. The risks from skin flaps are discussed in Section 4 and the large skin flap on the LM wheel is illustrated in Figure 27.

**Figure 27.** Sol 3005 overhead MAHLI view (top) and sol 3011 underbelly MAHLI view (bottom) of a flap of skin bent inward on the LM wheel inbetween grousers 12 and 13.

Where there is a large hole in a wheel, a skin section has either broken away from the wheel and fallen onto the Martian surface or the skin section is still attached to the wheel and pushed inward. A skin section that is still attached to the wheel and pushed inward is called a flap. A flap is identified by the wheel it is on and the crack number it is associated with. Figure 27 shows an overhead and underbelly MAHLI view of flap LM-4, acquired on sol 3005 and 3011, respectively. Flap LM-4 is in between grouser 12 and 13 and was first observed in the sol 1127 FMWI.

Theoretically, a flap could be long enough to contact the cable that runs to a wheel actuator. Damage to a wheel actuator cable could cause loss of commandability of that wheel. Therefore, flaps are monitored each FMWI. However, the risk of a flap causing damage to a wheel actuator cable is considered low. Finite element analysis indicates that a flap of wheel skin long enough to reach a wheel actuator cable would break off before contacting a cable.

The length of flap LM-4 is estimated to be 109.8 mm, well short of the 181.5 mm minimum distance between the inner

wheel surface and the wheel actuator cable. The base of flap LM-4 is folded at grouser 13, therefore, flap LM-4 cannot grow any longer.

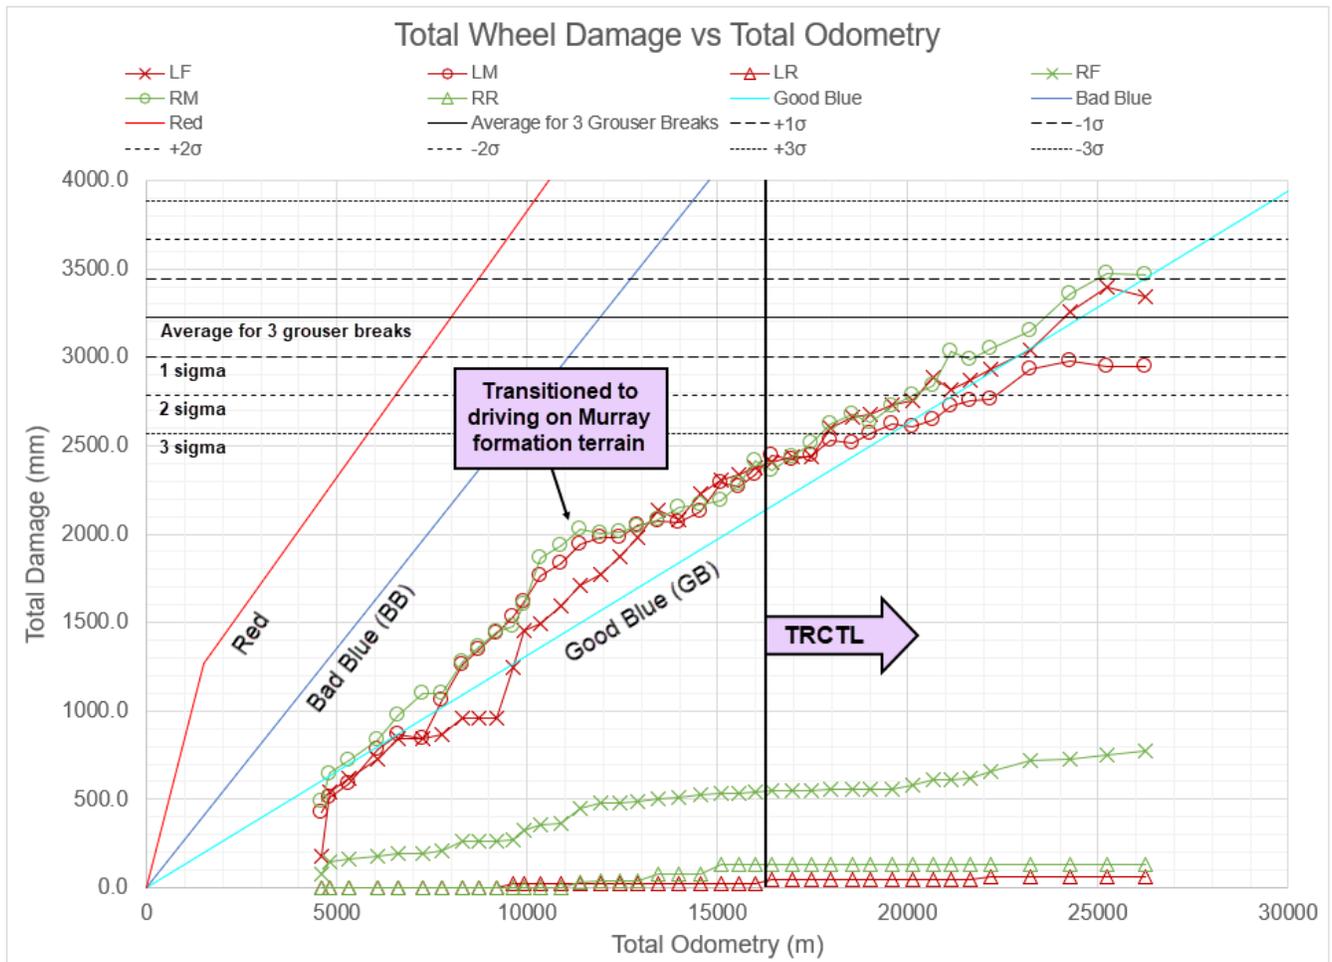
Figure 29. Wheel Damage vs Distance Driven as of the sol 3195 FMWI.

Since reaching approximately 11,000 m on the surface of Mars, wheel damage rates have remained consistently lower than terrain classification-based predictions, even as the rover has traversed multiple distinct geologic regions. This is

While damage rates have remained approximately linear for several years and many kilometers of driving, several major milestones in wheel life have been observed. The sol 1641 FMWI image set revealed the first two broken grousers on the LM wheel just a few sols before the first TRCTL checkout test on Mars on sol 1646. Tiger team testing established three broken grousers on a single wheel as a significant wheel life milestone, equating to a wheel reaching 60% of its life. The Wheel Wear team’s primary goal is to extend the life of Curiosity’s damaged wheels so the mobility system can continue to support MSL’s extended mission science objectives.
