Mars Curiosity Rover Mobility Trends During the First Seven Years

Abstract

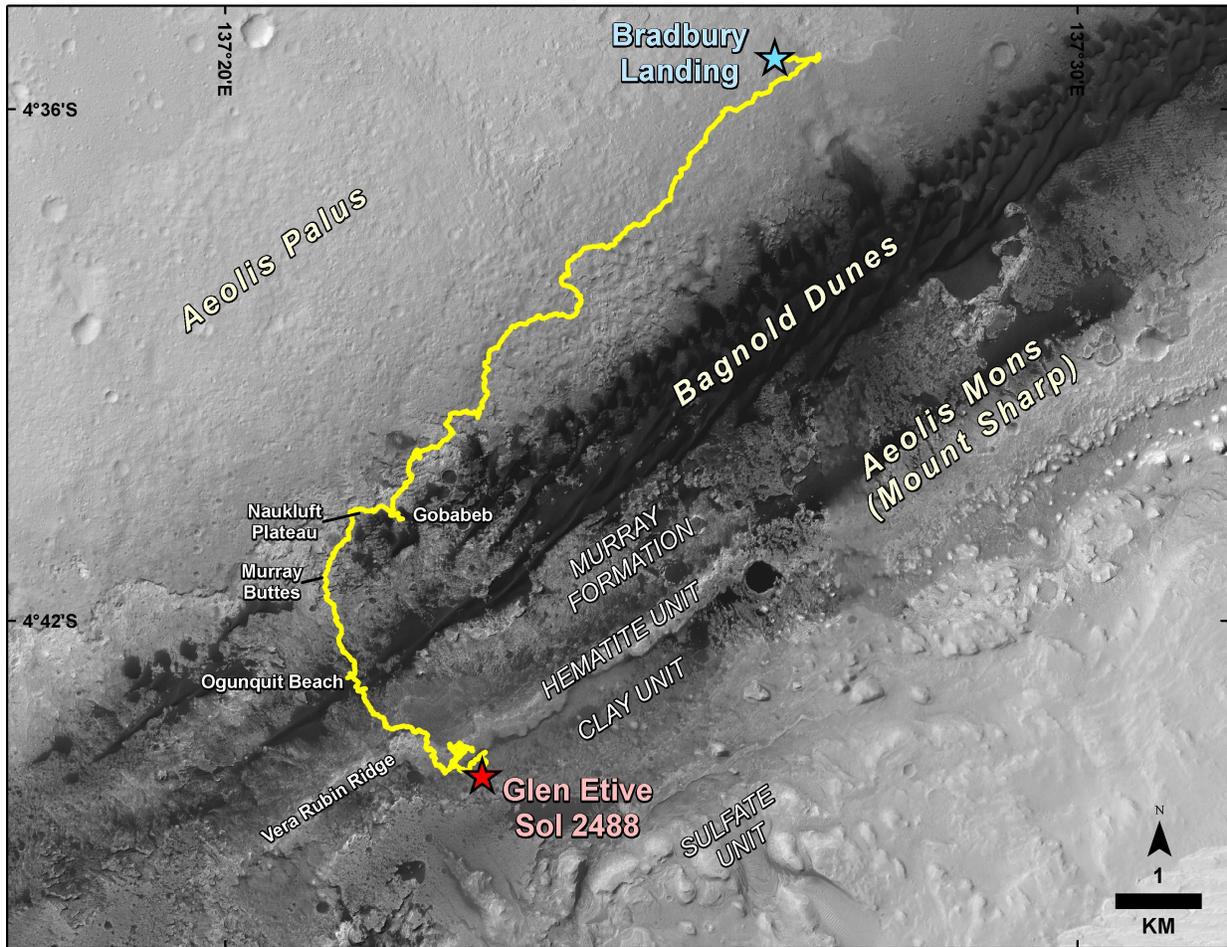
Figure 1: This map shows the route driven by NASA’s Curiosity Mars rover, from its August 2012 landing through August 2019. The blue star near the top center marks “Bradbury Landing,” the site where Curiosity arrived on Mars on August 5, 2012, PDT (August 6, EDT and Universal Time). Curiosity landed on Aeolis Palus, the plains surrounding Aeolis Mons (Mount Sharp) in Gale Crater. The base image for the map is from the High Resolution Imaging Science Experiment (HiRISE) camera on the Mars Reconnaissance Orbiter. Image Credit: NASA/JPL-Caltech/Univ. of Arizona.

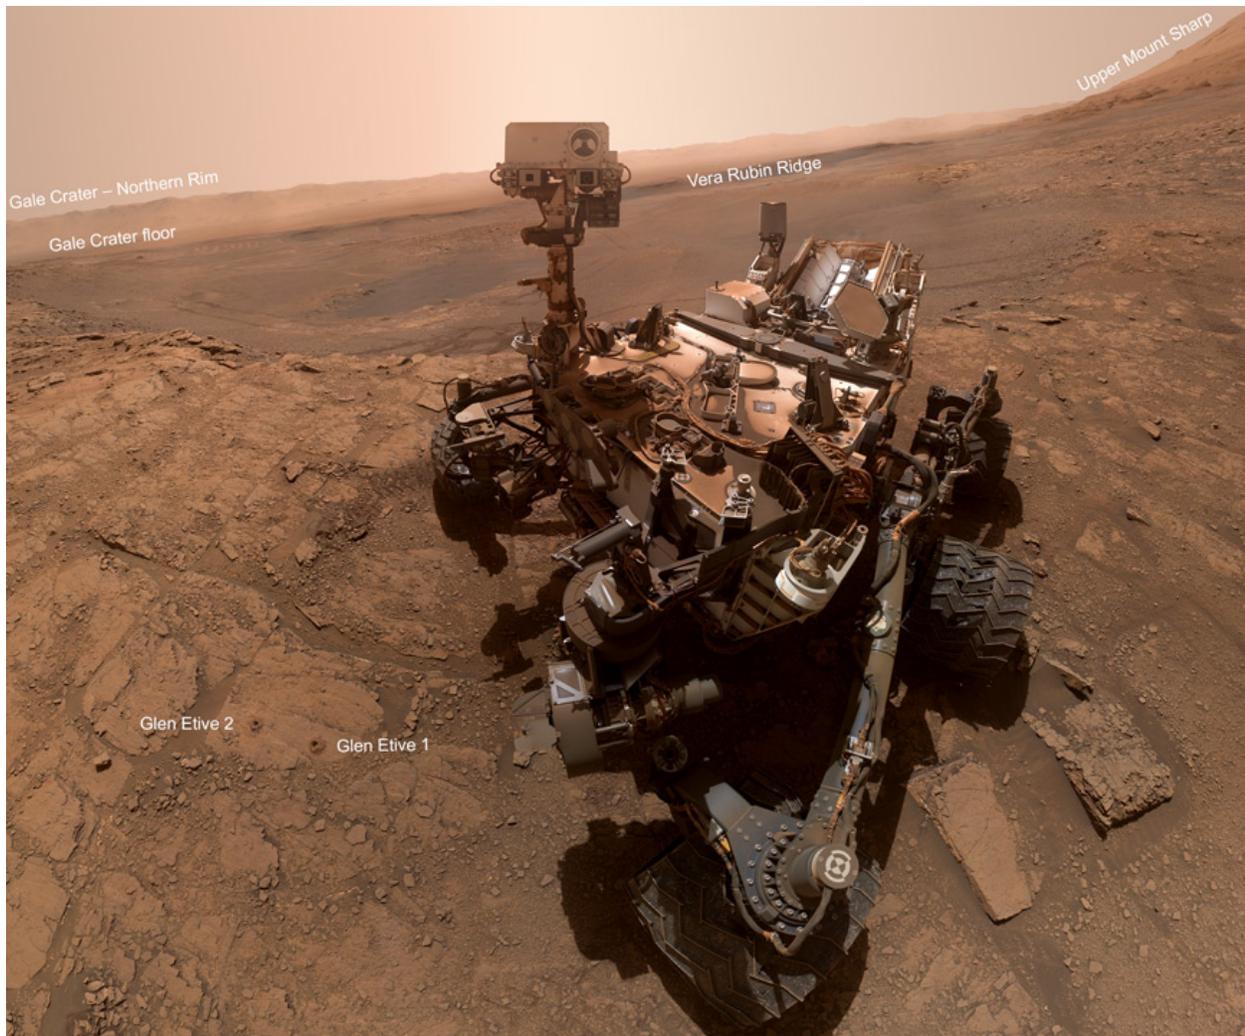
Figure 2: Curiosity selfie image acquired on October 11, 2019 (sol 2553) at Glen Etive, where Curiosity drilled two holes. This selfie was generated by stitching together 57 individual images acquired by the MAHLI, a camera on the robotic arm turret. The robotic arm, which acts as a selfie stick, is not visible in the image. The Remote Sensing Mast, which contains navigation cameras, is mounted to the right side of Curiosity. Image Credit: NASA/JPL-Caltech/MSSS.

parked at Glen Etive until sol 2555 during a drill sampling campaign. Figure 2 contains a selfie of Curiosity at Glen Etive, generated from dozens of images acquired by the Mars Hand Lens Imager (MAHLI) mounted to the robotic arm turret.

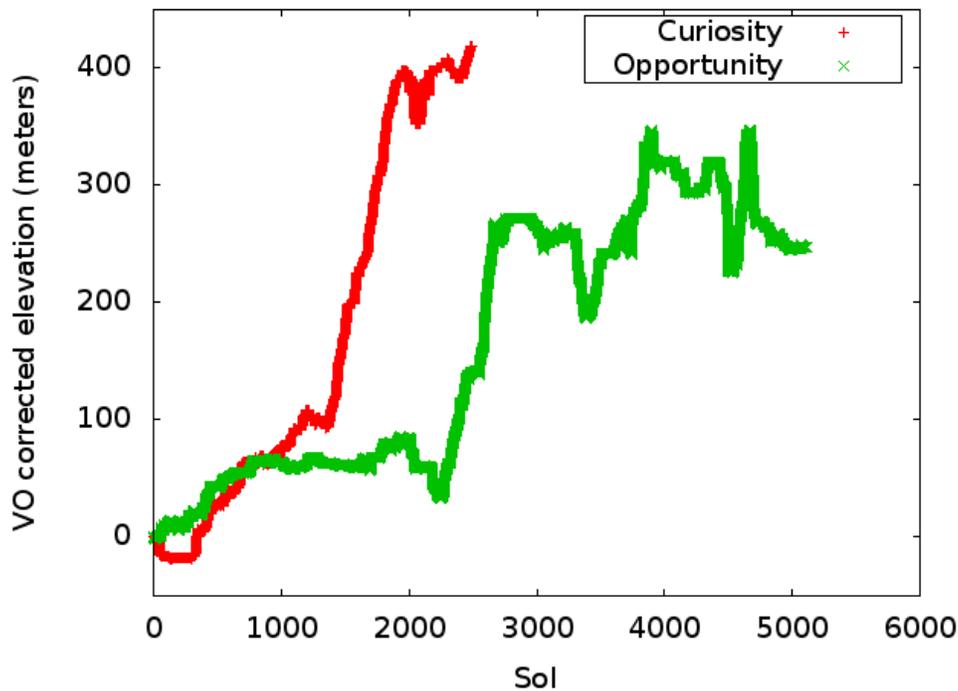
Figure 3: Change in rover elevation for Curiosity over the first seven years of its mission, and Opportunity over its 14.375 year mission. A Mars solar day (sol) is approximately 39 minutes and 35 seconds longer than the 24 hour Earth day.

As illustrated in Figure 3, much of the driving to the lower layers of Mount Sharp has been uphill. As of sol 2488, 60.75% of Curiosity’s driving has been uphill, resulting in a total increase in elevation of 418.4 meters. During the MER mission, the maximum increase in elevation by Opportunity was 347.6 meters, which occurred on sol 4663. Comparing cumulative odometry and change in elevation for Curiosity and Opportunity at the seven year mark for each mission, Opportunity had driven 5.34 km further, but Curiosity has climbed 277.3 meters higher. Mobility choices are guided by each mission’s long term strategic science plan, but are subject to changes due to near term science objectives and engineering constraints arising from terrain features not evident from orbital planning images.

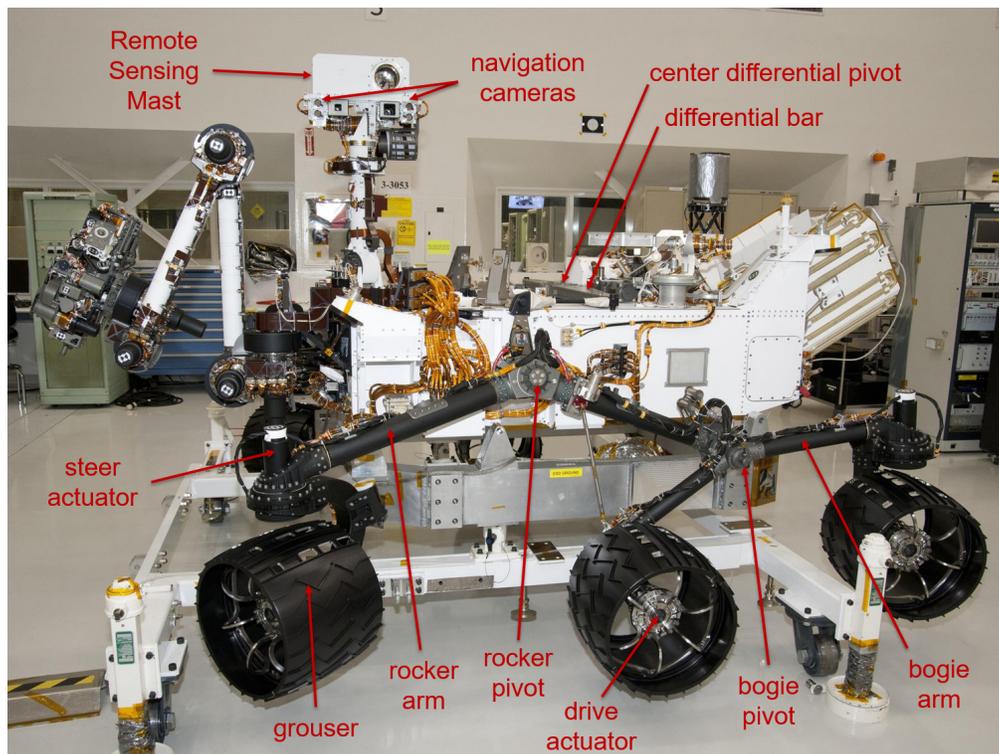
Figure 4: Curiosity in the Jet Propulsion Laboratory (JPL) Spacecraft Assembly Facility. The mobility system consists of six identical aluminum wheels, six drive actuators, four steer actuators, an IMU (mounted inside the rover body), a rocker-bogie suspension, and the flight software related to mobility and navigation, which makes use of ECAMs.

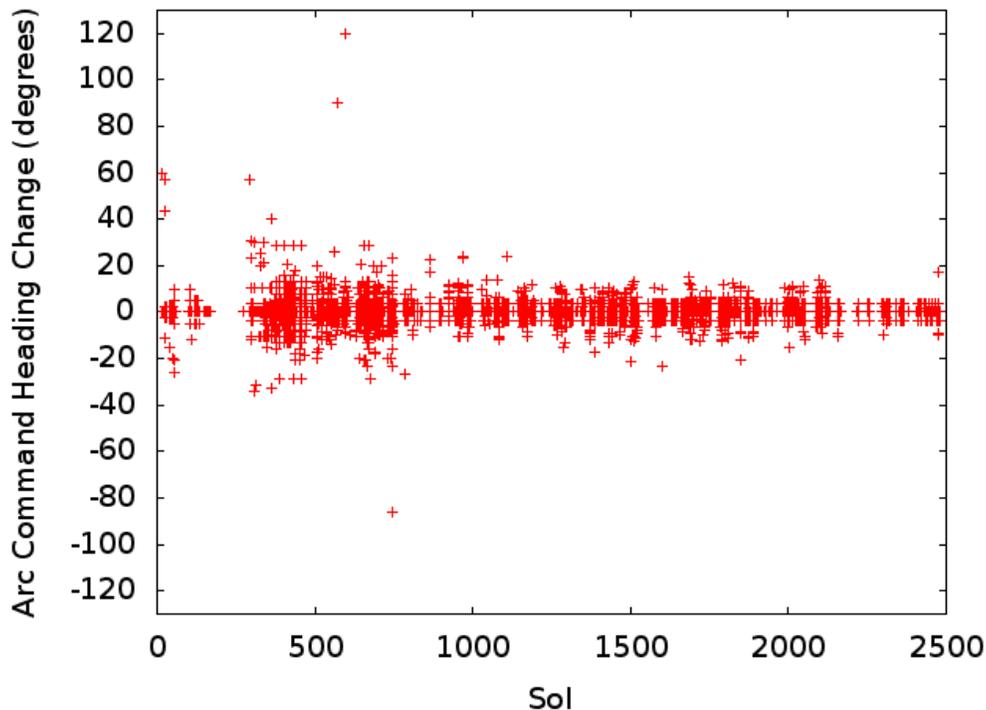
Figure 5: Arc drive steps are specified by an arc length and change in heading. This plot contains the commanded heading change for all 22,312 commanded arc drive step during the first seven years of the mission. Most of the commanded arcs have been straight (81.0%) or with a shallow curvature.

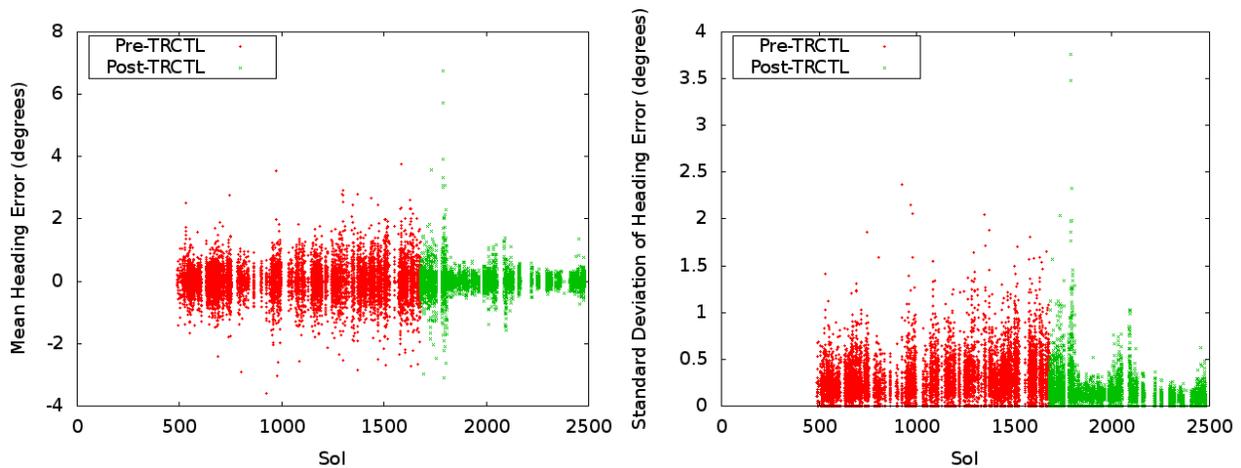
Figure 6: Mean heading error (left) and standard deviation of heading error (right) for each executed straight arc beginning on sol 482, when Curiosity’s flight software was updated to include this data in telemetry. The number of straight arcs executed between sols 482-1677 (pre-TRCTL) and sols 1678-2488 (post-TRCTL) were 9,990 and 4,840, respectively. The average number of samples for each straight arc executed between sols 482-1677 (pre-TRCTL) and sols 1678-2488 (post-TRCTL) were 215.0 and 210.4, respectively. The spike on sol 1789 to 6.75° occurred due to the right wheels being in sand and the left wheels being on firmer terrain. Wheel slip reached 78.3% and the rover heading change caused the yaw limit to be exceeded, stopping the drive early.

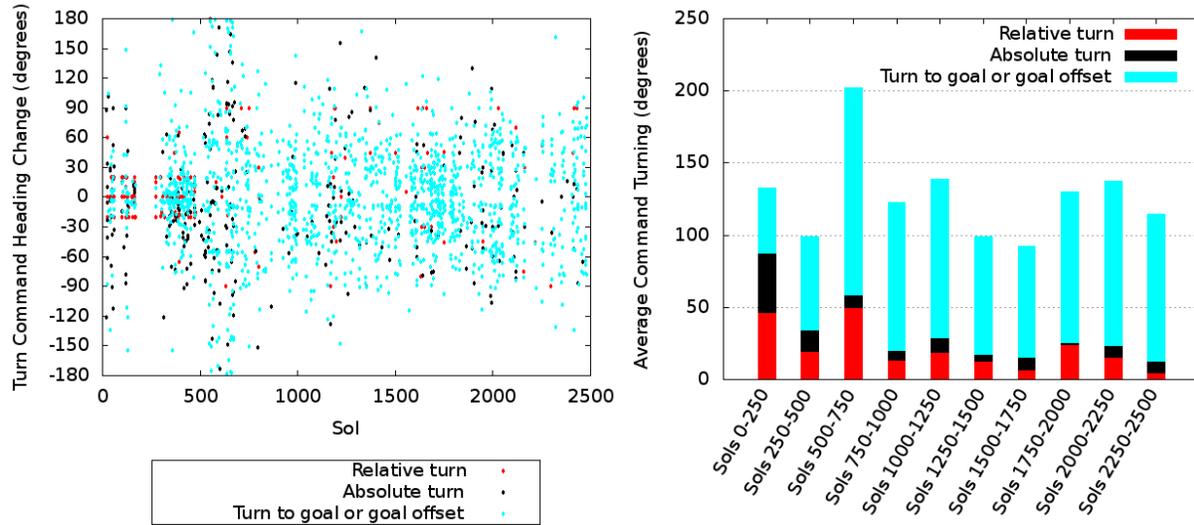
Figure 7: Commanded heading change for all of the closed-loop turn-in-place commands (left) and average command turning for sols that included closed-loop turn-in-place commands (right). The percentage of the total magnitude of relative, absolute, and turn to goal or goal offset turn commands are 7.8%, 17.0%, and 75.2%, respectively. For the average command turning plot, a 250 sol interval was arbitrarily selected. Decreases in average command turning have been temporary.

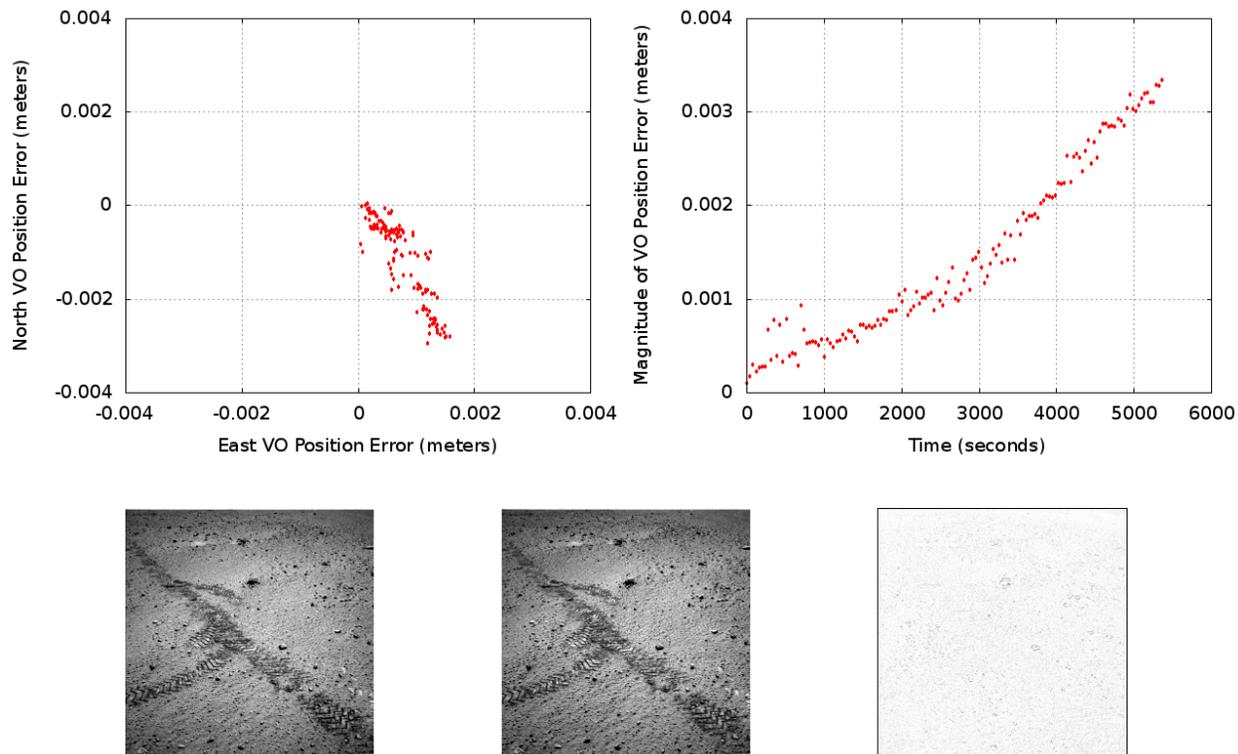
Figure 8: On sol 571, VO was performed 141 times over a 90.5 minute period with Curiosity and the RSM stationary. The NavCams were pointed in the default VO direction (to the right and down) and the test was performed at a time when the terrain in the VO direction was not in the rover’s shadow. For this period, the rover pose was not updated after each VO step; VO was used to monitor the rover state during drill operations, and would have halted drilling had excessive slip been detected. Each VO step used the initial VO seed image. The average 3D VO position error was 1.5 mm with a standard deviation of 0.9 mm. VO 3D position error increased generally linearly with the time between the VO seed image and the VO update. During drives, consecutive NavCam images are used for the VO seed and update images, acquired approximately 1 minute apart, depending upon the selected drive step distance. The graphs in the top row show the position error location offsets and magnitude, respectively. The images in the bottom row are the seed image from 11:40:45 Mars local time, the update image from 13:08:49 Mars local time, and a difference image showing the absolute value of each pixel’s intensity difference between those two images, illustrating the small shadow changes that resulted from the Sun’s motion.

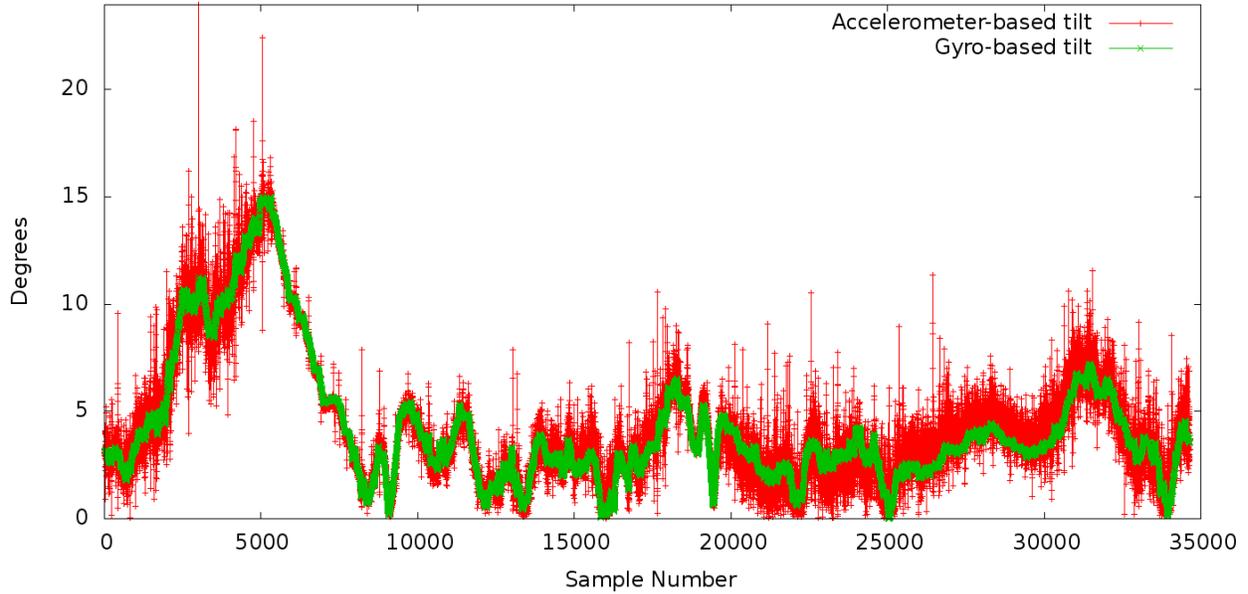
Figure 9: Example comparison of gyro-based tilt estimates vs accelerometer-based tilt estimates from the longest drive on sol 665 (shown in Figure 22). The X axis is the number of the tilt sample collected (at 8 Hz) during all driving, the Y axis is the overall vehicle tilt. The green points are tilt estimates generated by integrating IMU gyro readings over time, the red points are tilt estimates derived from the instantaneous accelerometer readings. Gyro readings are far more stable, because unlike accelerometers they are not influenced by outside forces acting on the rover (e.g., wheel drops off small rocks, compression and release within the rover suspension).

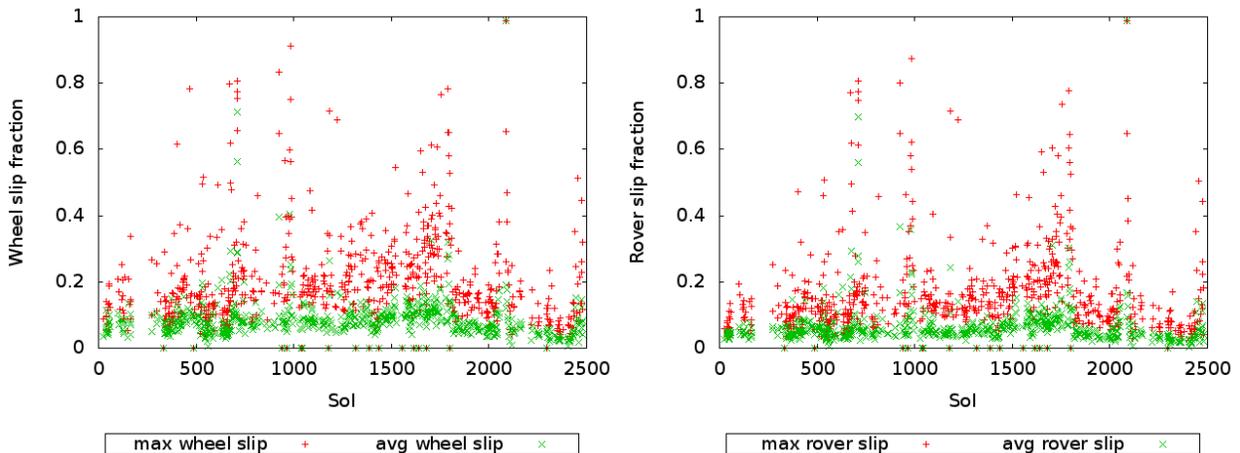
Figure 10: Rover and wheel slip fraction. Slip can vary widely over a drive as rover tilt and terrain type changes.

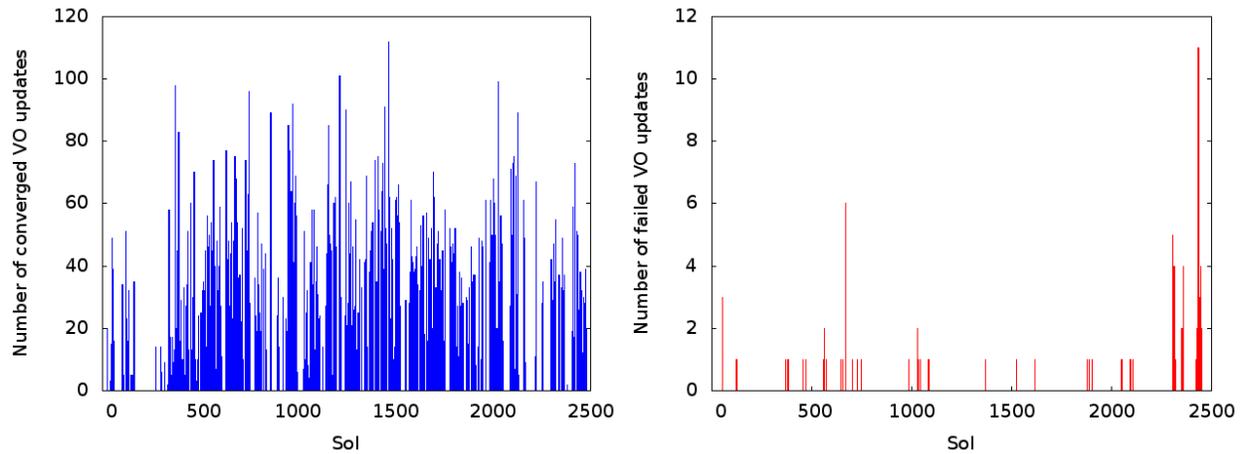
Figure 11: As of sol 2488, VO has been performed 20,682 times during mobility activities with only 94 failures. The max VO failures in a single drive was 11, occurring on sol 2434. Because the terrain surrounding the planned drive was feature-poor, a high number of VO failures was anticipated. The max number of VO failures was set to 10. When the 11th VO failure occurred, it set a mobility goal error, stopping the drive 2.82 meters short of the predicted odometry.

During mobility operations on Mars thus far, MSL VO has successfully converged to a solution 20,588 times out of 20,682 attempts, yielding a remarkable success rate of 99.55%. See Figure 11 for a per-sol breakdown and Table 5 for additional overall statistics. These numbers do not include VO use during non-mobility activities. The different categories of VO failures that have occurred are summarized in Table 6 and Figure 12. The five categories from that table are:

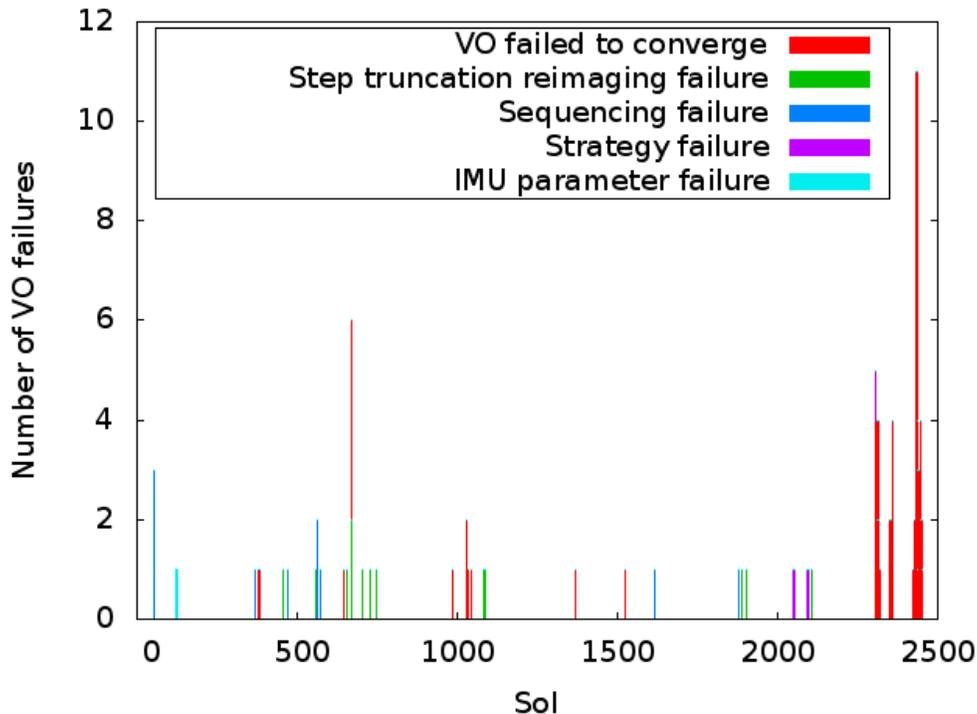
Figure 12: Number of VO failures per sol for each type of VO failure. The category that has had the most VO failures is ‘VO failed to converge’, which often happens on all-sandy terrain with few obvious unique features.

VO failed to converge The majority of failures (66) were due to the algorithm failing to detect enough self-consistent features to be confident in its estimate and thus failing to converge on a solution; that often happens when the cameras are pointed at all-sandy terrain with few obvious unique features, for instance.

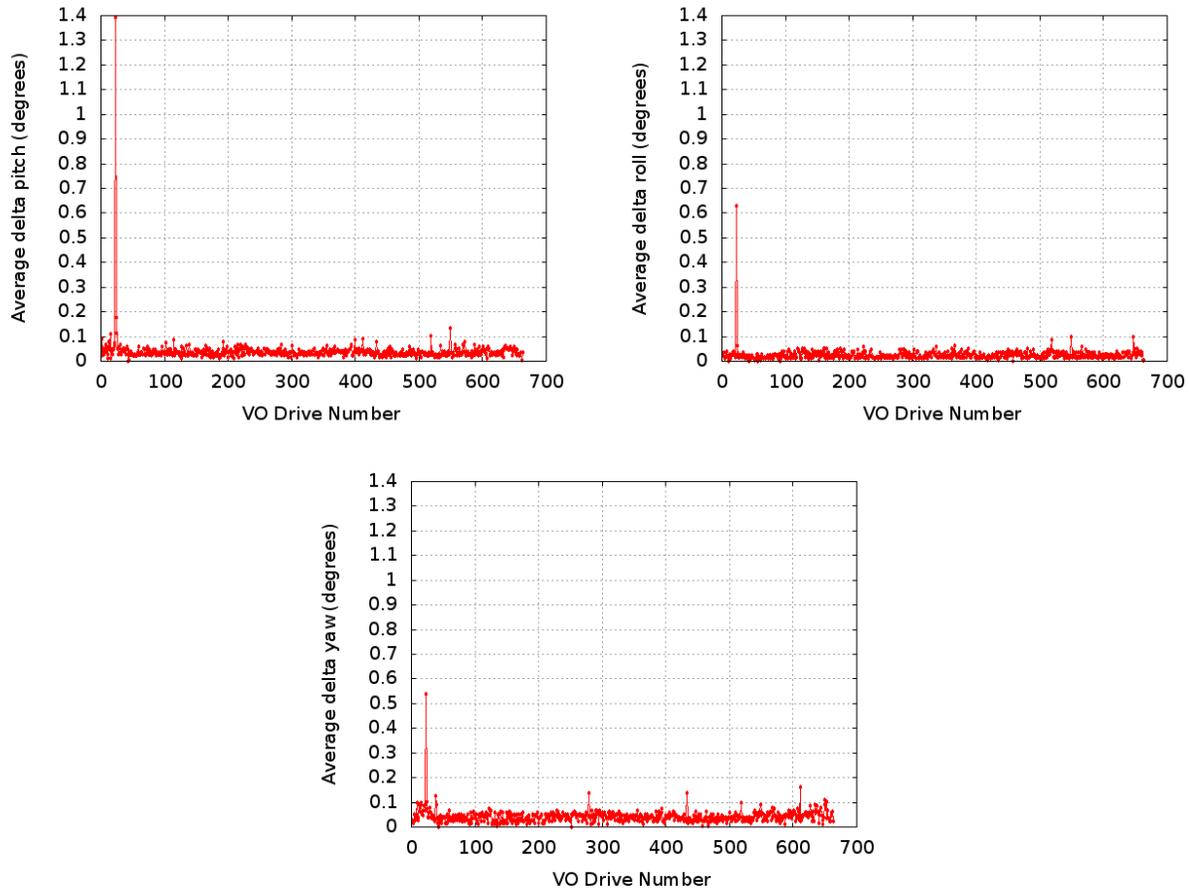
Figure 13: The average difference between IMU and VO rover attitude angles for each drive where VO has been below 0.18° except for on sols 122-124. On sol 124, a bug in a IMU parameter setting was fixed.

IMU parameter failure On sols 122, 123, and 124, one of the built-in sanity checks triggered, forcing one VO estimate to be rejected each sol. The check was that the VO attitude estimate should match the IMU-generated one within 1° in roll, pitch, and yaw, and each time, the pitch estimate differed by more than 1° (-1.391° , -1.072° , -2.195° , respectively). Subsequent investigation led to the conclusion that the VO update was actually correct, but there was a bug in the IMU parameter settings (subsequently fixed) that inadvertently dropped attitude updates under high acceleration. Figure 13 shows that there has been little disagreement since those events.

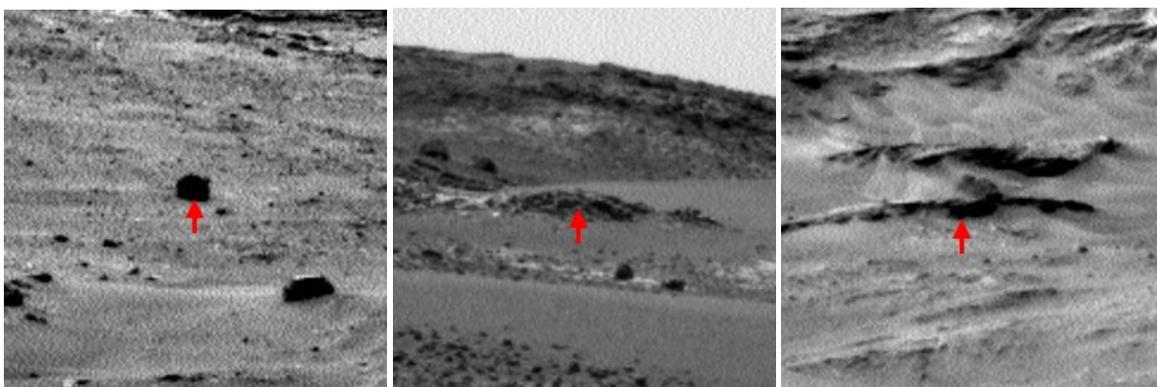
Figure 14: Examples of VTT features successfully tracked by Curiosity on sols 743, 923, and 967 for 6, 11, and 36 frames respectively. Visit <https://mars.nasa.gov/msl/multimedia/raw-images/>, select “Left Navigation Camera” and choose the sol number to see all the tracked frames.

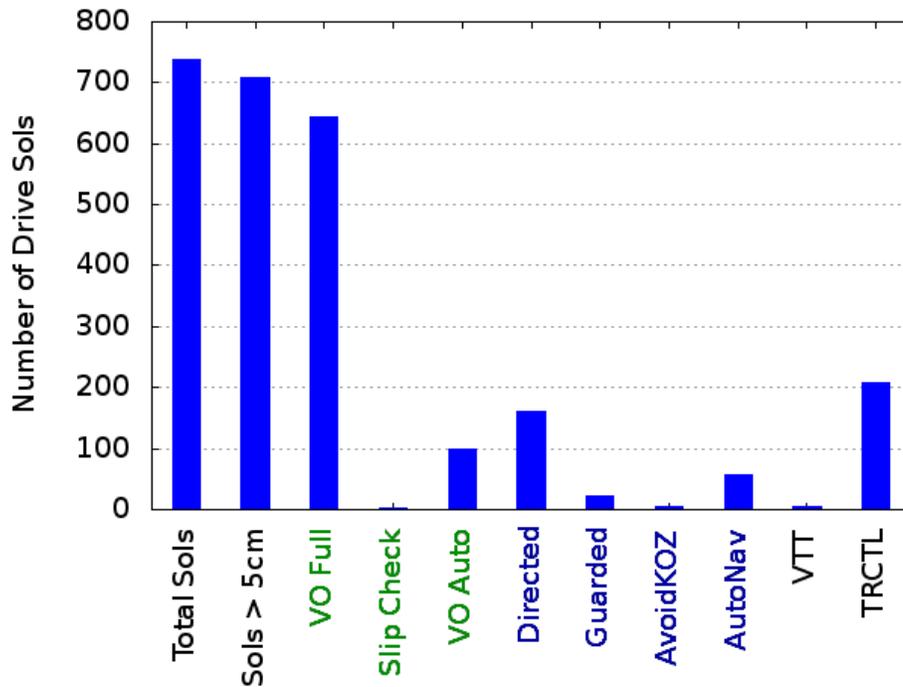
Figure 15: Number of sols using each drive mode. The VO modes have green labels and the path selection modes have blue labels. The sum of the usage of drive modes is more than the number of drive sols because multiple drive modes can be used in a single drive. The odometry on 29 drive sols was under 5 cm. The purpose of drives that short is typically to better position the rover with respect to a selected target for robotic arm activities.

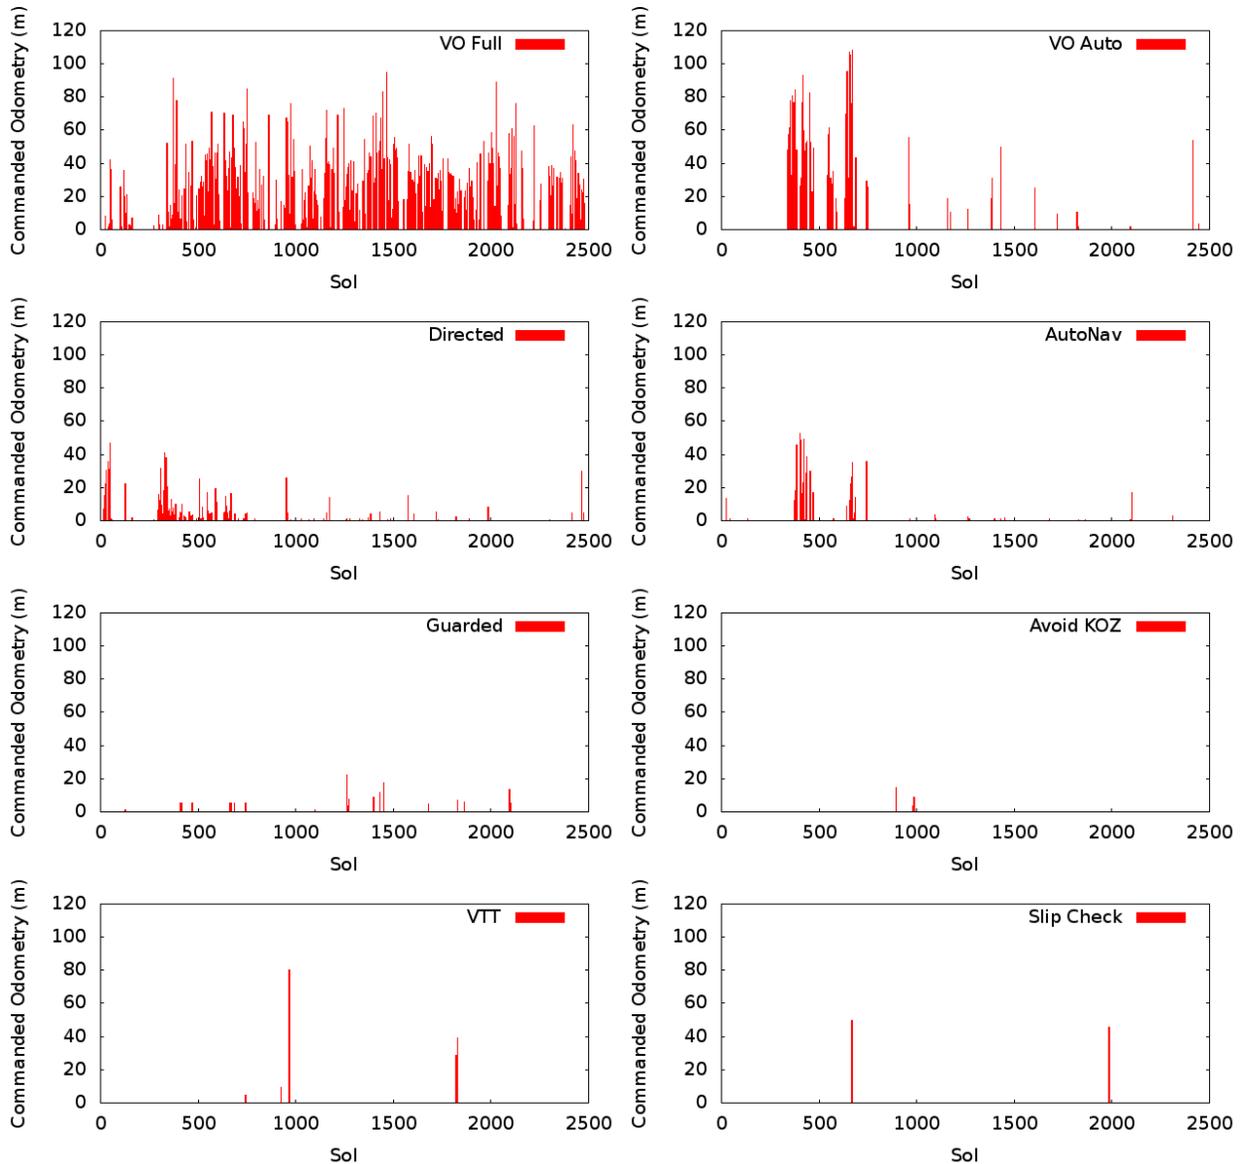
Figure 16: Curiosity commanded odometry in each drive mode per sol. Multiple drive modes can be used in a single drive. Drive commands with VTT enabled are categorized as VTT odometry, drive commands with VTT disabled and a path selection mode selected are categorized as odometry for the selected path selection mode, and remaining drive commands with a VO mode selected are categorized as odometry for the selected VO mode. VO Full is the most often-used drive mode. The least used drive modes are AvoidKOZ (commanded on sols 896, 978, 986, and 987), Slip Check (commanded on sols 665, 668, and 1986), and VTT (commanded on sols 743, 923, 967, 1822, and 1829).

and the distance-per-sol records in Figure 16. Discovery of wheel skin damage around sol 490 and our first partial embedding event on sol 672 (see Figure 19) each led to downturns in drive rate during the subsequent weeks. Those events and the discovery around sol 710 (in “Hidden Valley”) that the rover’s performance in polygonally-rippled sand was insufficient to make good progress led us to favor somewhat slower VO Full drives ever since, given that mode can react most quickly to any unexpected slip events (Arvidson et al., 2017b).

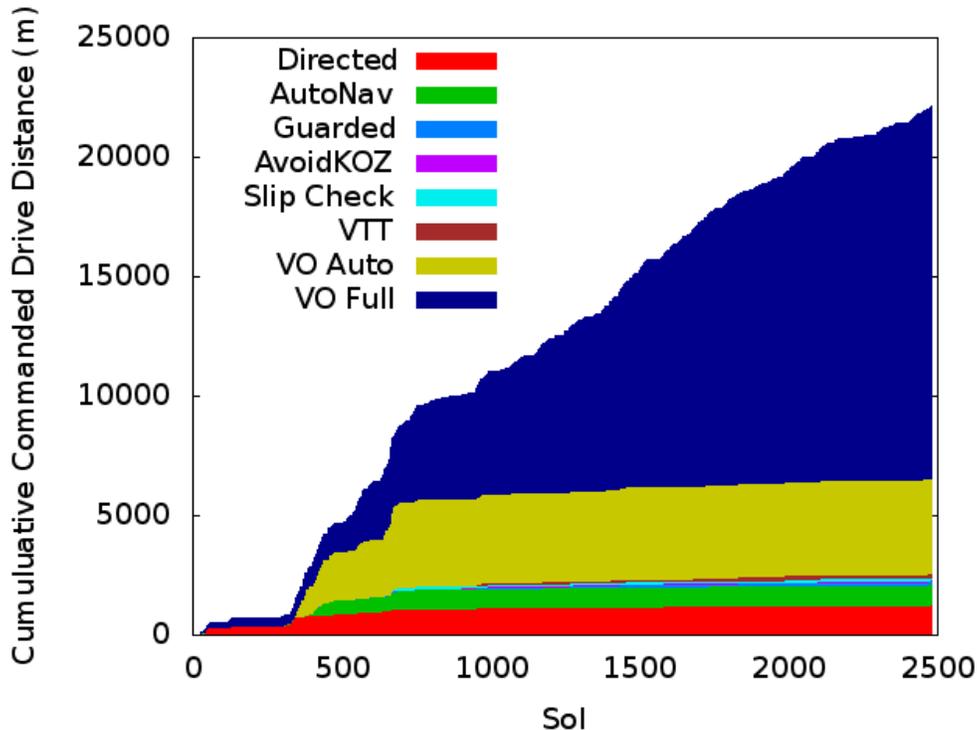
Figure 17: Curiosity cumulative commanded odometry by drive mode. Multiple drive modes can be used in a single drive. The most often-used drive modes are VO Full, VO Auto, Directed, and AutoNav.

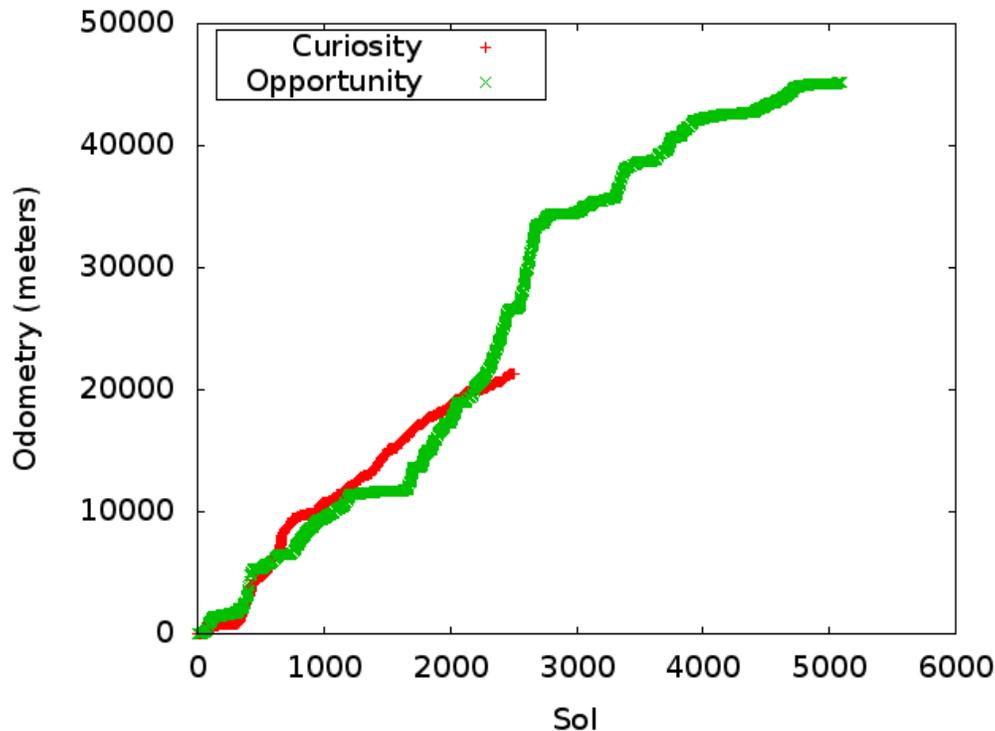
Figure 18: Curiosity and Opportunity cumulative actual odometry. Although of historic interest, drive decisions are guided by each mission’s long-term strategic science plan, near-term science objectives, and terrain-dependent engineering safety constraints.

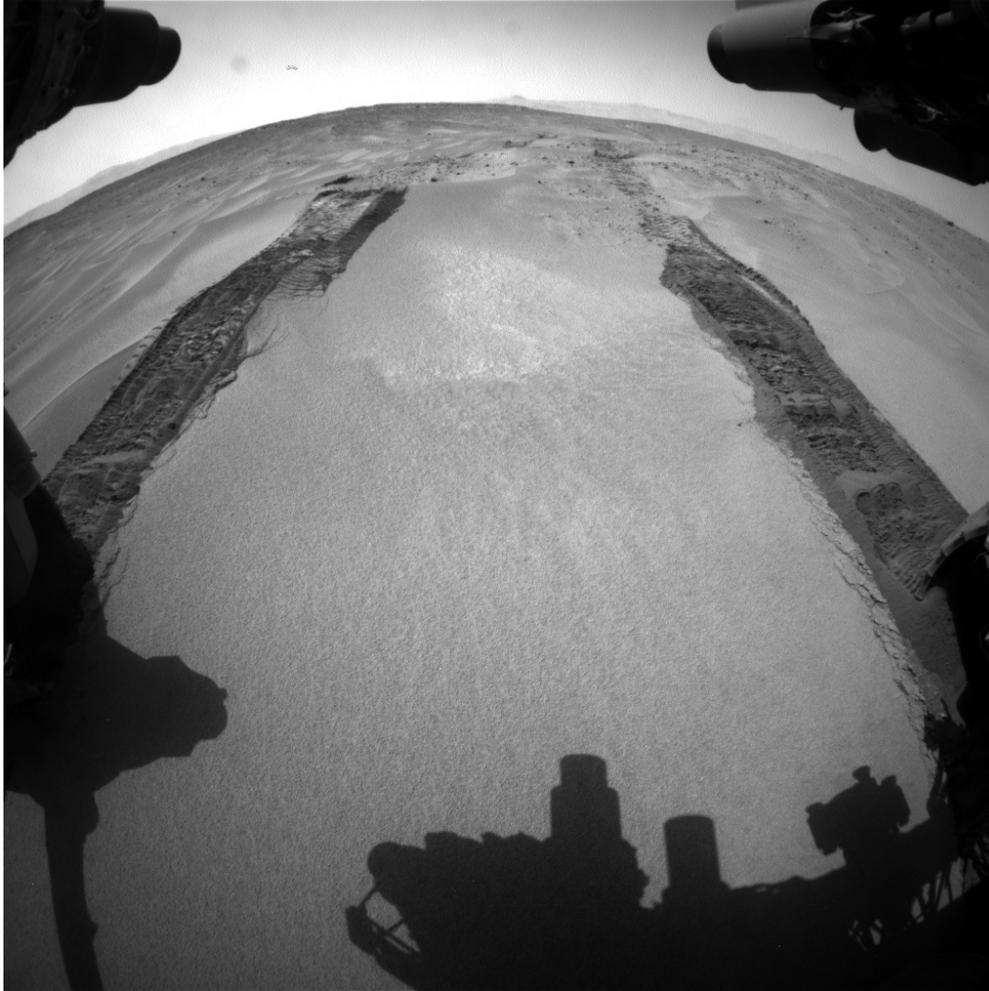
Figure 19: Front hazcam view of the sol 672 partial embedding event where VO Auto stopped the backwards drive early.

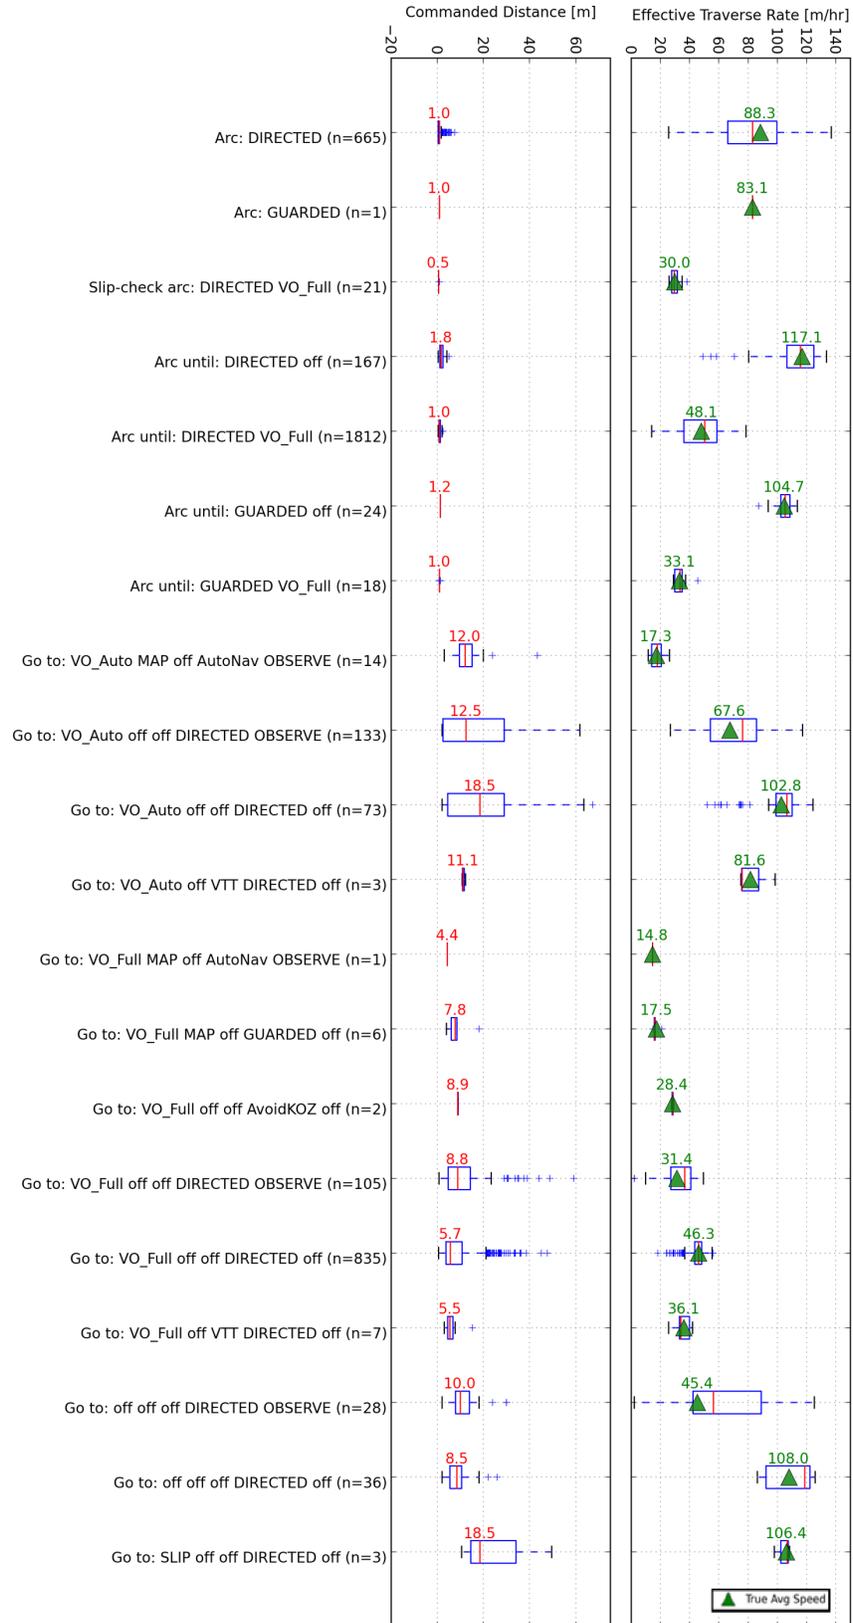
Figure 20: Effective drive rates without TRCTL. Boxplot showing interquartile range (blue) and median (red) for traverse rate and duration of each drive command by mode. Rather than reporting the "mean of the achieved speeds," which is not a meaningful quantity, we instead indicate the true average speed (quotient of total drive distance and total drive duration) for each mode with a green triangle and numeric label. The order of the arguments for "Go to" are VO mode, whether or not to update the Hazard Detection map, whether or not to perform VTT, path selection mode, and whether or not to run an observation sequence to acquire mid-drive images.

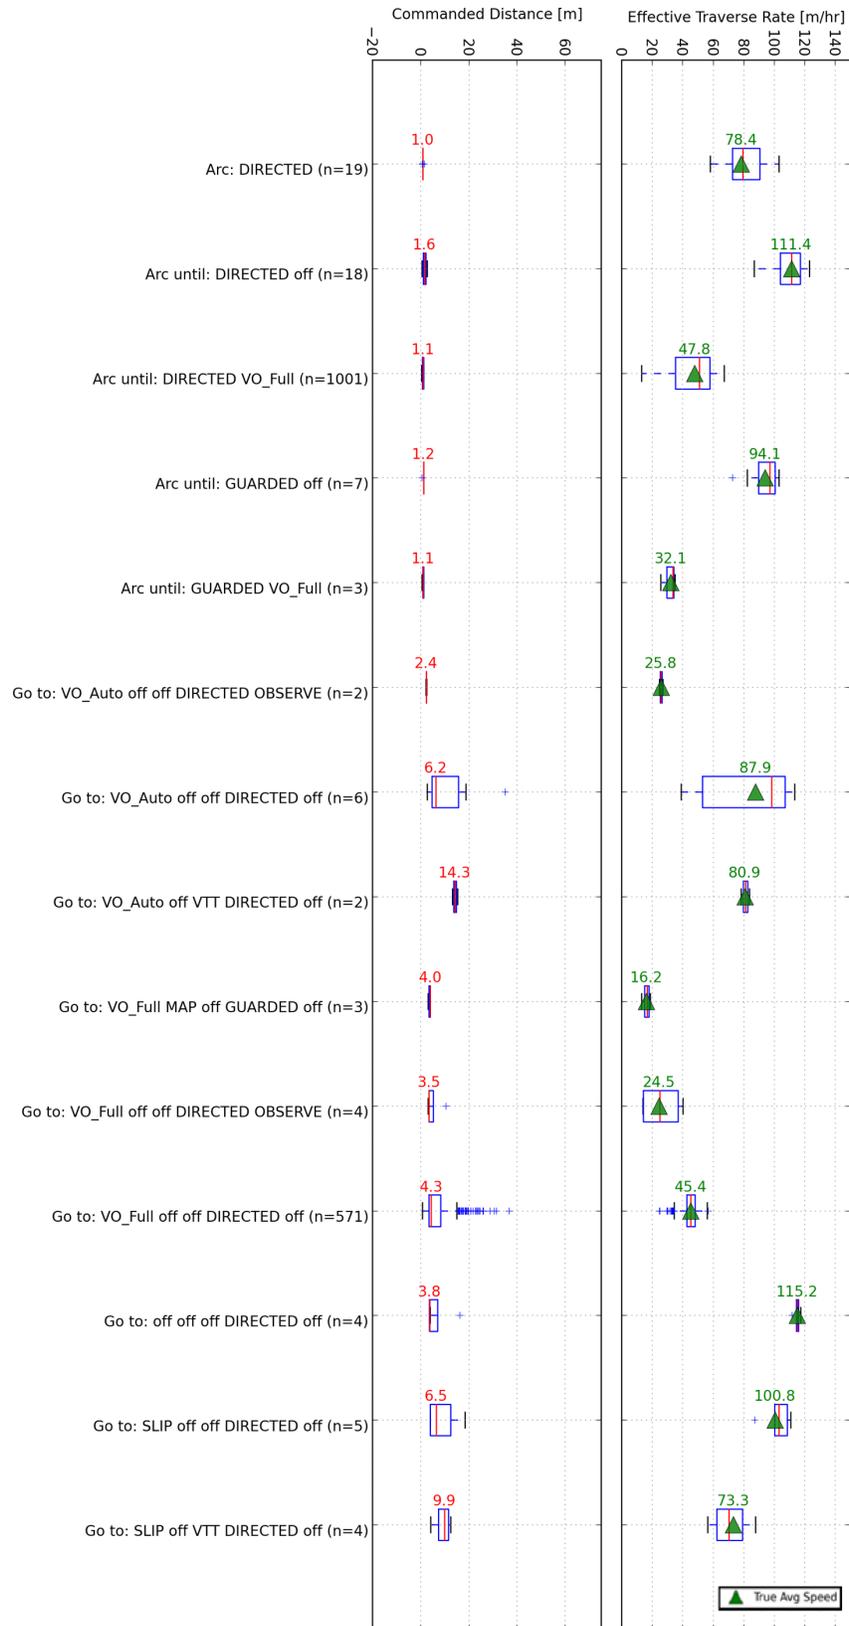
Figure 21: Effective drive rates with TRCTL enabled.

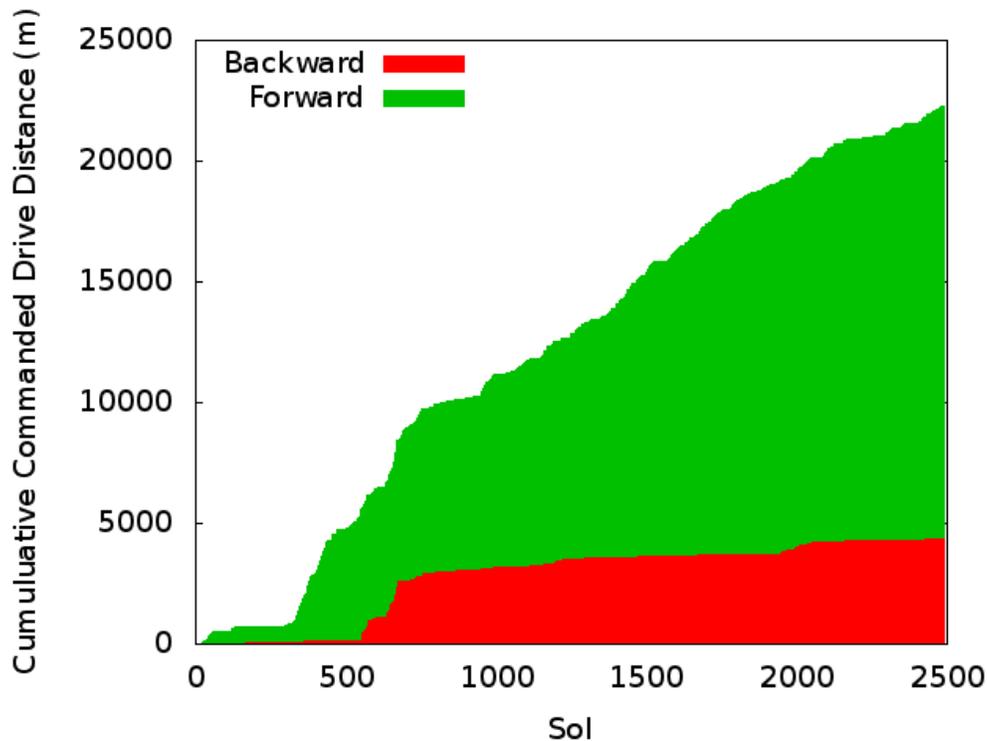
Figure 23: Curiosity cumulative commanded odometry by drive direction. Backwards driving was increased on sol 546 in response to observed wheel damage, but was reduced on sol 671 because it did not reduce the wheel damage rate but reduced the overall drive distance achievable in the allocated time.

Figure 23 shows the cumulative commanded forward and backward odometry up through sol 2488. The cumulative commanded forward and backward odometry are 17,805.671 meters (80.1%) and 4,435.860 meters (19.9%), respectively. On sol 546, backwards driving usage sharply increased in response to wheel wear test results from the JPL Mars Yard indicating forces on wheels are lower for backward driving than forward driving. However, there was no change in Curiosity's wheel damage rate due to the additional wheel odometry from turning in place. On sol 671, backwards driving usage was sharply decreased, given it did not decrease Curiosity's wheel damage rate but reduced the overall drive distance achievable in the allocated time.

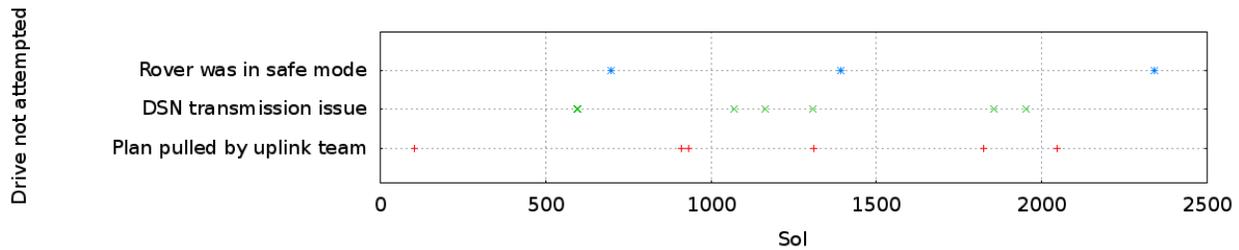
Figure 24: Sixteen drives were planned but not attempted by the rover.
