Mars Curiosity Rover Mobility Trends During the First Seven Years

Abstract

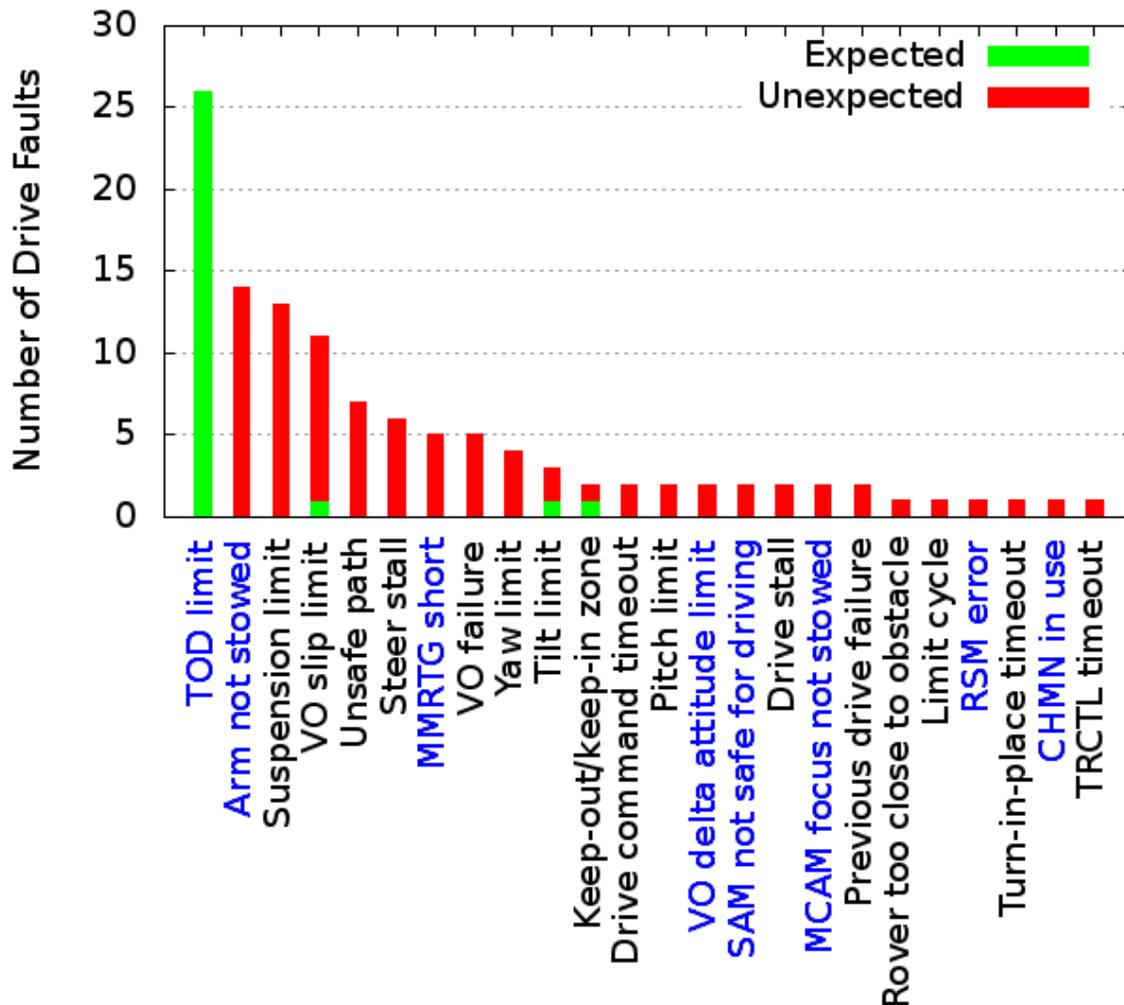
Figure 25: Number of expected and unexpected drive faults for the 24 categories of fault protection that have caused incomplete drives. The categories are ordered from most numerous (left) to least numerous (right). Eight of the categories are from general fault protection (blue) and sixteen are from mobility fault protection (black).

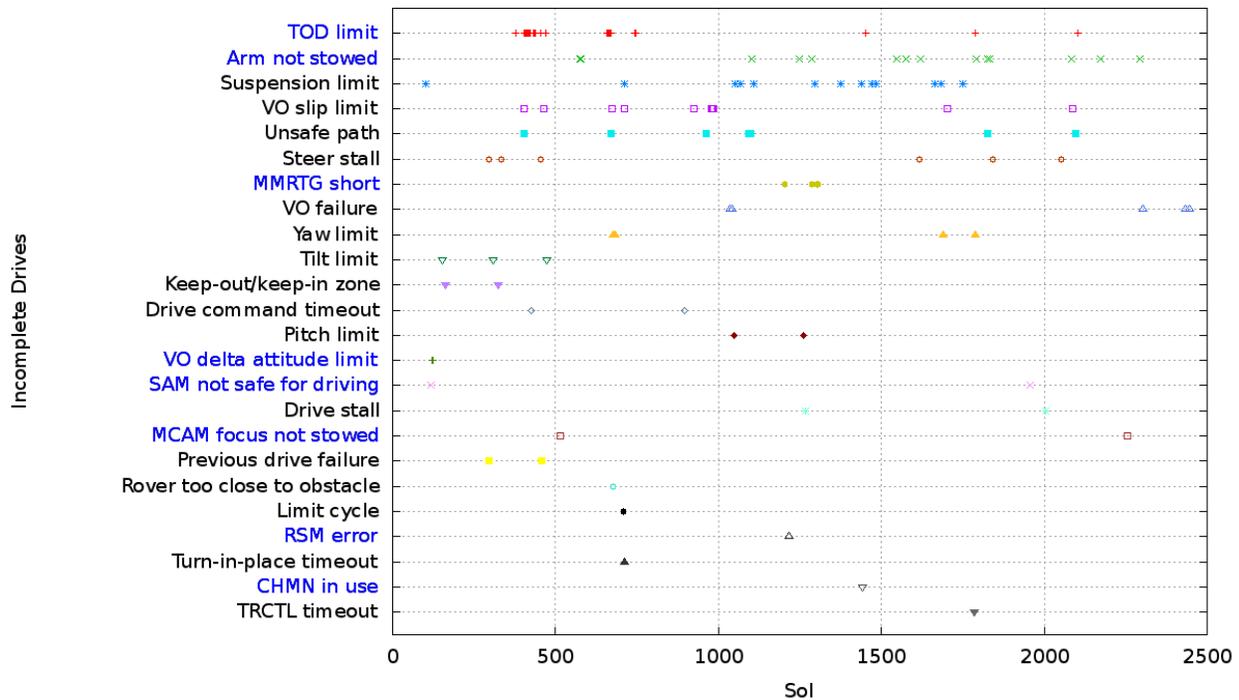
Figure 26: Temporal distribution of all the drive faults for the 24 categories of fault protection that have caused incomplete drives. The categories are ordered from most numerous (top) to least numerous (bottom). Eight of the categories are from general fault protection (blue) and sixteen are from mobility fault protection (black).

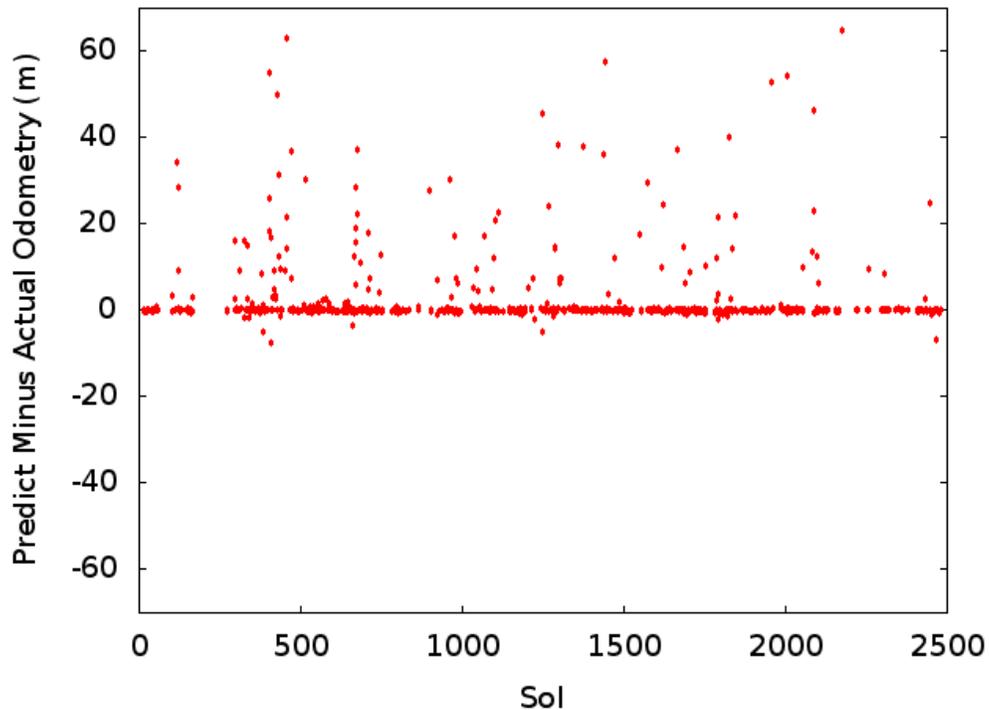
Figure 27: Difference between the predicted and actual odometry for each drive sol. For most drives, the difference is close to zero.

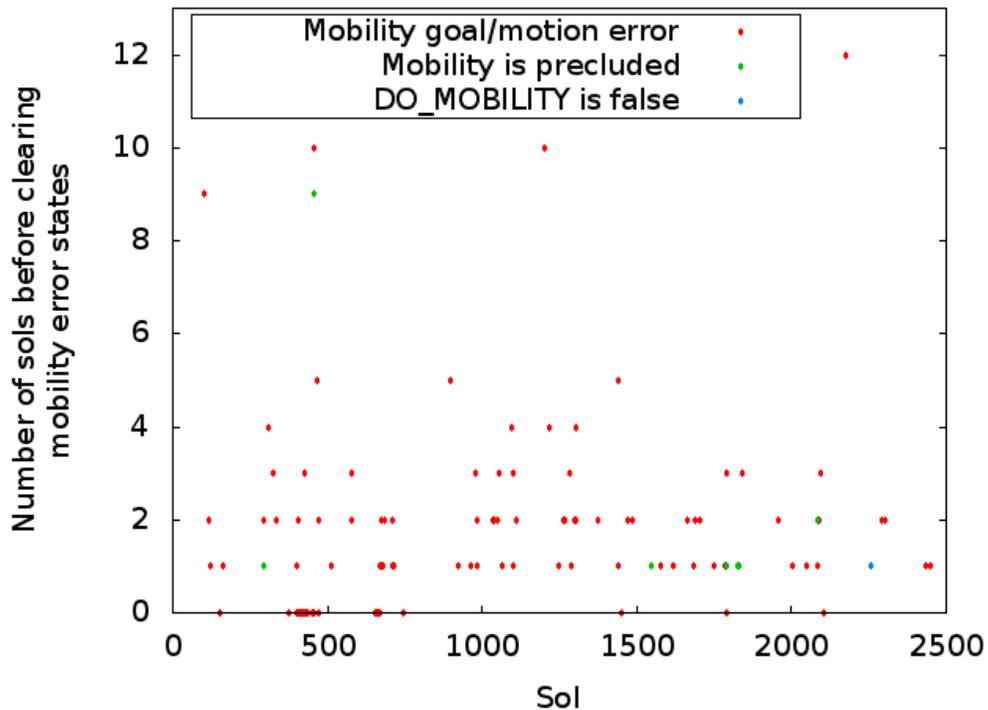
Figure 28: Number of sols after each drive fault the mobility error states were cleared, enabling additional driving. The mobility error states that prevent driving are a mobility goal error, a mobility motion error, mobility is precluded, or DO_MOBILITY is set to false.

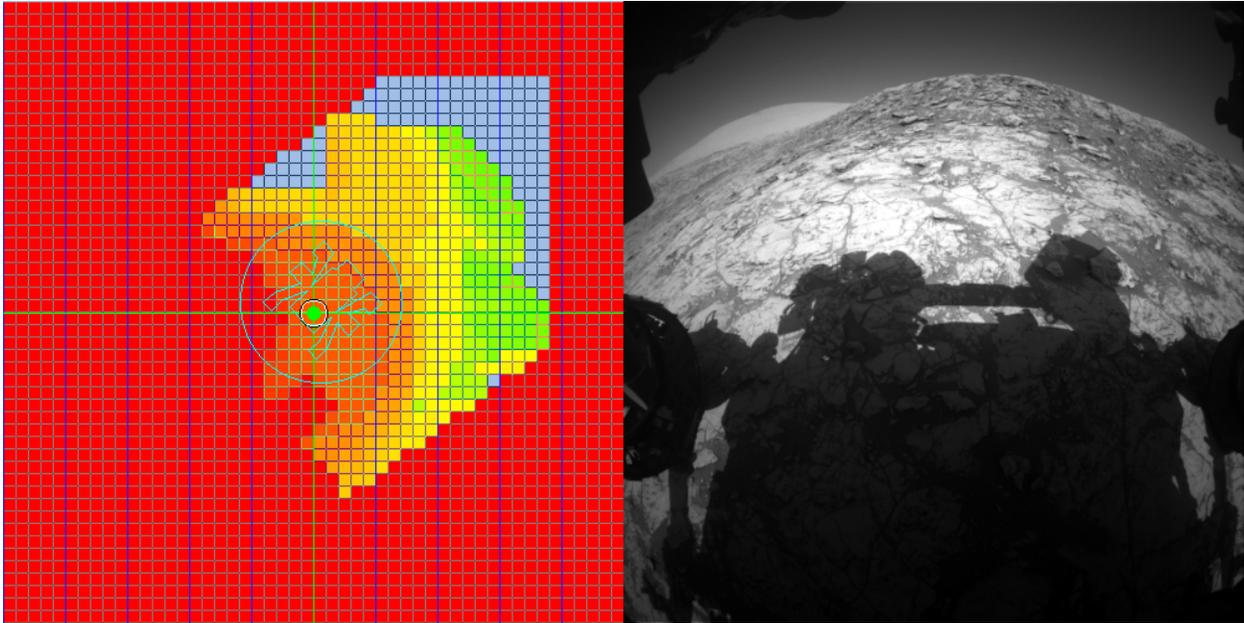
Figure 29: Final rover-centered, auto-generated terrain World Map (left) and front left HazCam image (right) from the sol 1828 guarded drive that faulted with an unsafe path due to the higher terrain tilt ahead of the rover. Curiosity was driving in the direction of the bottom left corner of the map. The map size is $10 \times 10 \text{ m}^2$ and the resolution of each map cell is $40 \times 40 \text{ cm}^2$. The red map cells correspond to hazardous terrain or terrain outside of the keep-in zone.

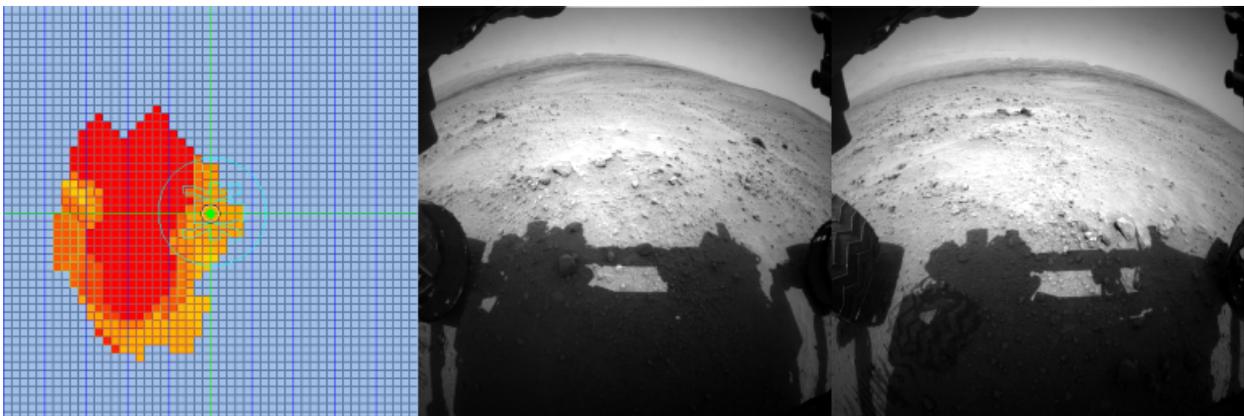
Figure 30: Sol 677 final rover-centered, auto-generated terrain World Map (left), the corresponding left front HazCam image (middle), and the left front HazCam image after the next drive step (right). Curiosity was driving to a navigation goal in the direction of the left side of the World Map. AutoNav took a sharp turn to the left to avoid the ridge in front of it in the middle image. After the drive step, AutoNav determined Curiosity was too close to the hazard to continue and stopped the drive 36.8 meters short of the navigation goal. The map size is $10 \times 10 \text{ m}^2$ and the resolution of each map cell is $40 \times 40 \text{ cm}^2$. Map cells with a color close to red are not traversable.

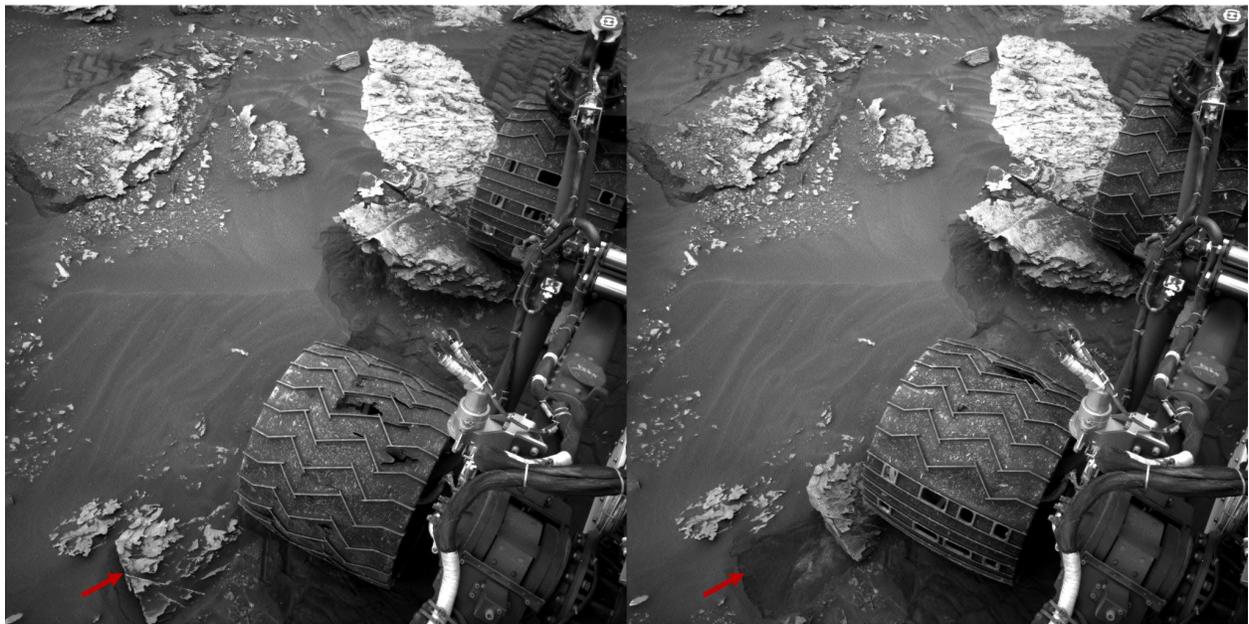
Figure 31: NavCam images of the RM and RR wheels on sols 2086 (left) and 2087 (right). The sol 2087 forward drive faulted when 98.7% wheel slip occurred, exceeding the 90% limit set for this drive. No forward progress was made. Note that a rock was dragged backward by the RM wheel.

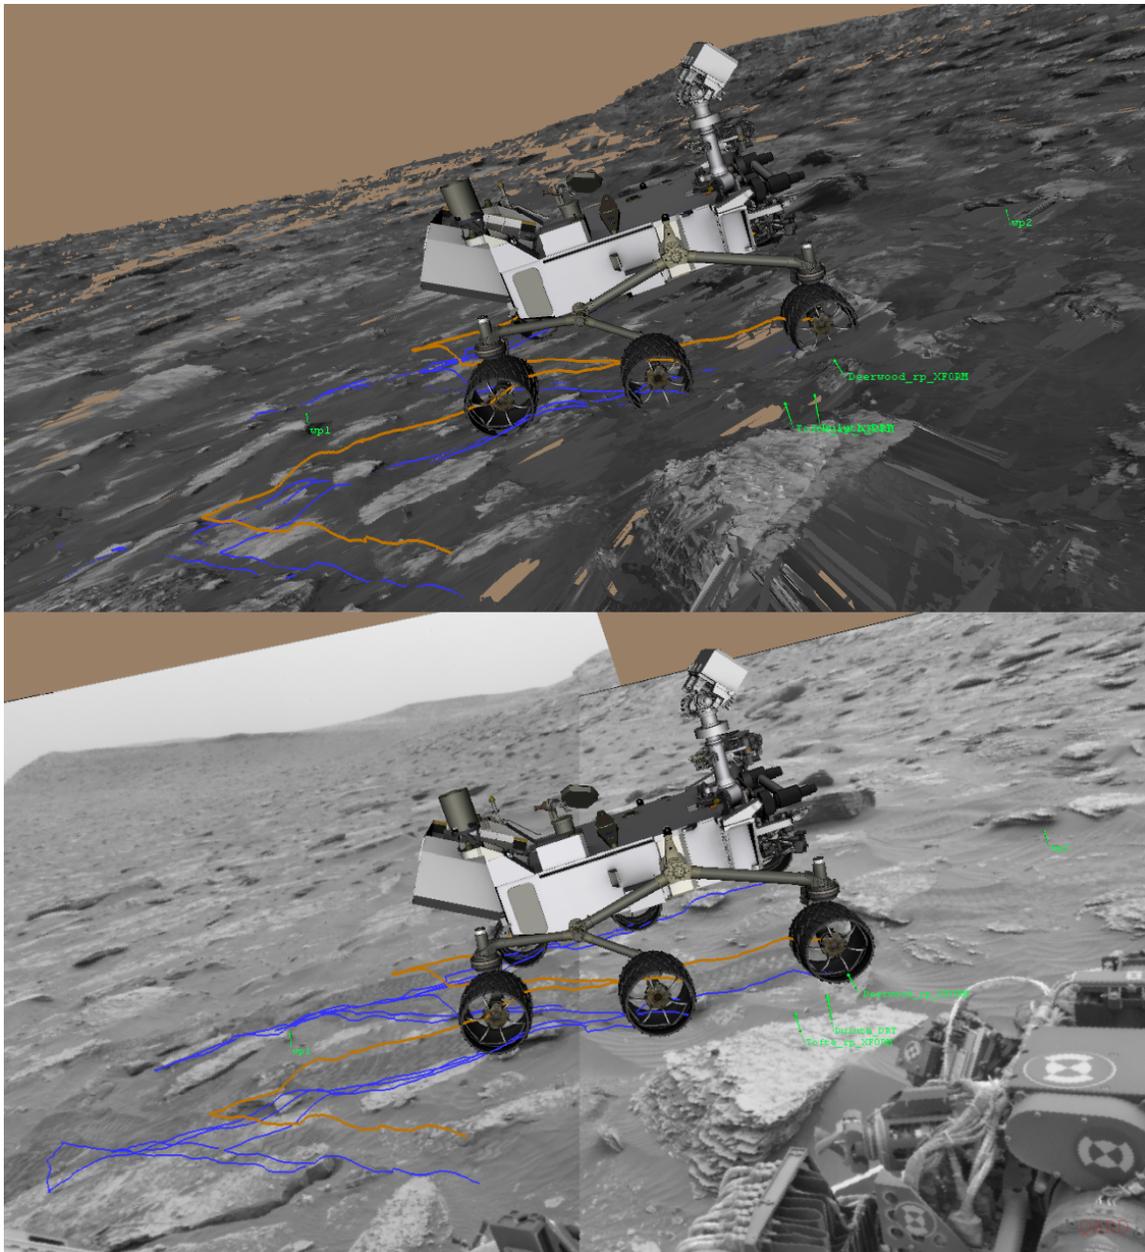
Figure 32: Visualizing the Sol 2086 drive, which failed due to high wheel slip. The upper image shows the actual rover path projected into the “planning mesh,” a visualization of the terrain used by RPs to create drive command sequences. Orange lines track the wheel centers, blue lines track the lowest point on the wheel (i.e., ground contact). The lower image shows the same data projected into NavCam images taken on sol 2089, after the drive completed. Actual drive tracks are visible in the lower image. Images rendered by the rover planning tool RSVP.

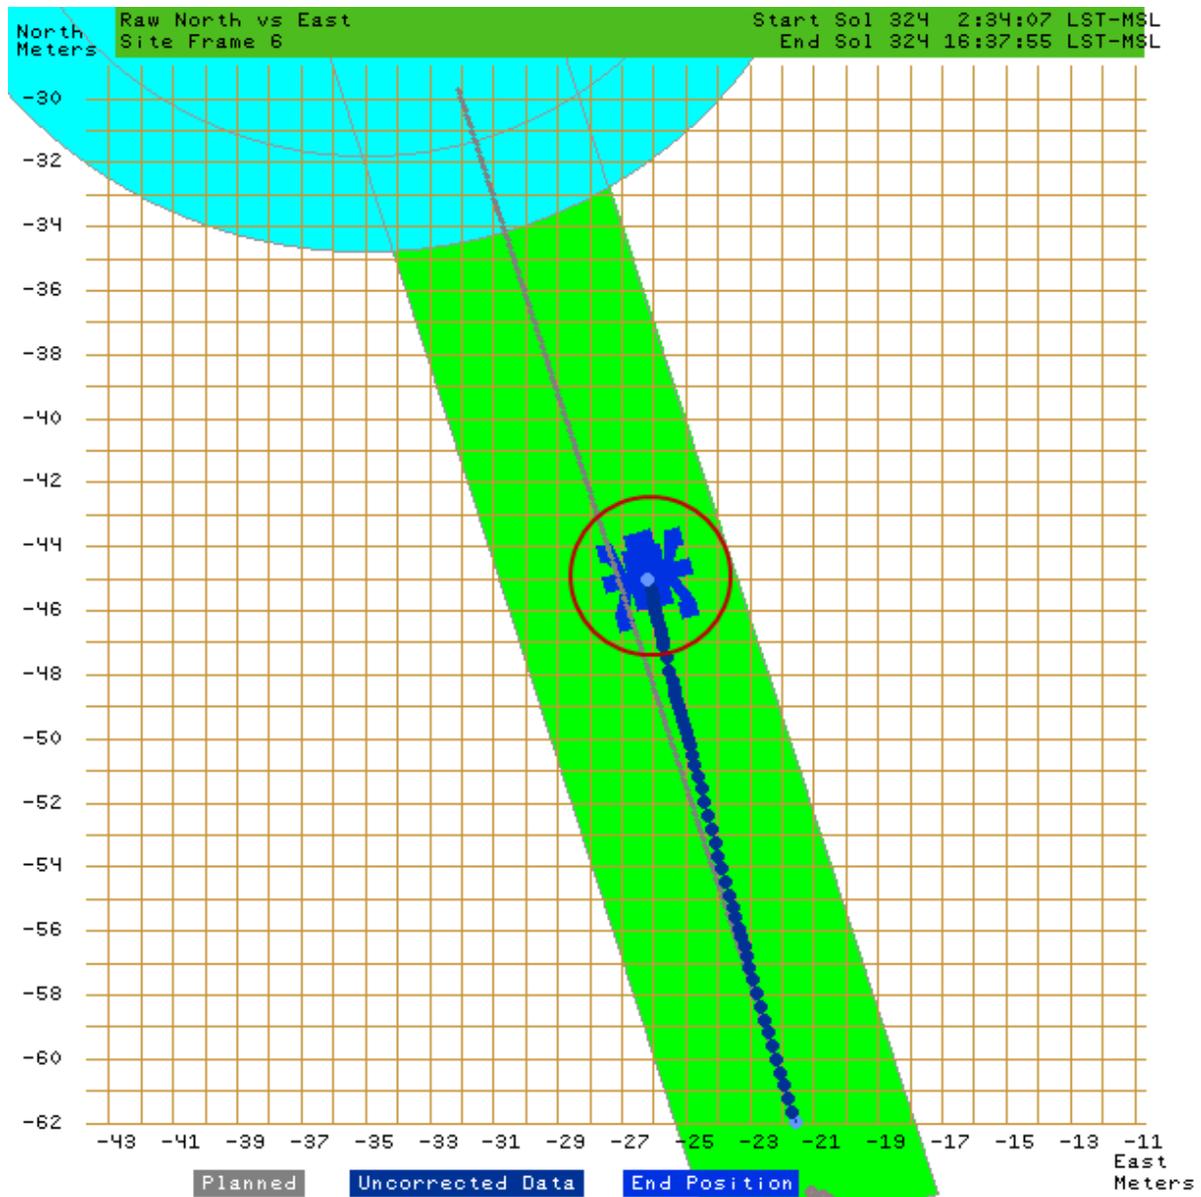
Figure 33: Course plot of the sol 324 drive auto-generated by ground tools for mobility performance assessment. The sol 324 drive stopped after 18 meters of backward driving with a keep-in zone violation because mobility fault protection determined the next drive step would cause a 2.5 meter radius around the rover to intersect the boundary of the green keep-in zone. The red circle with a 2.5 meter radius was overlaid on the course plot to illustrate how close the rover was to the edge of the keep-in zone. Grid lines in the map indicate 1 meter spacing.

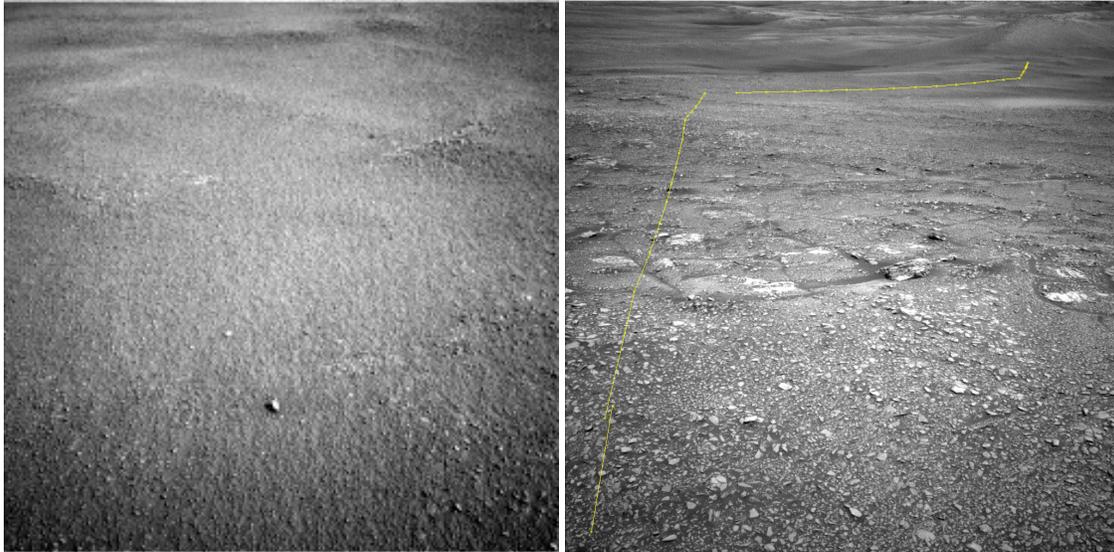
Figure 34: NavCam VO image and overall drive path from sol 2434 on terrain with a lack of autonomously detectable and trackable features. The max number of VO failures in a single drive (11) occurred here. Low expected wheel slip on this terrain, and a lack of hazards near the planned path, led the RPs to set the max allowable number of VO failures to a high number. The max wheel slip measured during the drive was 13.5%. The yellow points show the path taken by the rover origin, plotted in a planning NavCam image taken two sols before the drive.

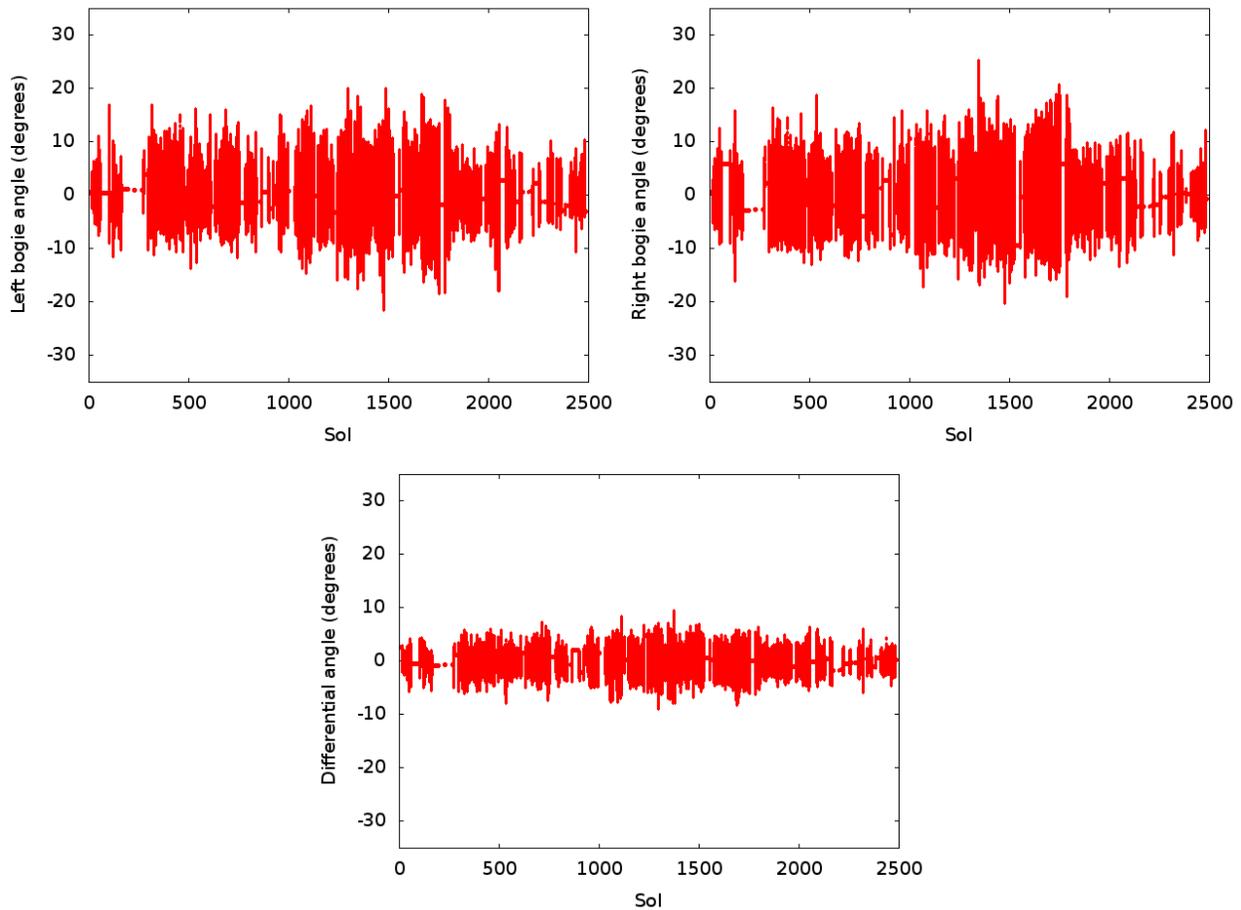
Figure 35: Curiosity suspension angles during the first seven years of the mission. The plot illustrates the passive suspension constantly reacts to the terrain profile, which has not been planar.

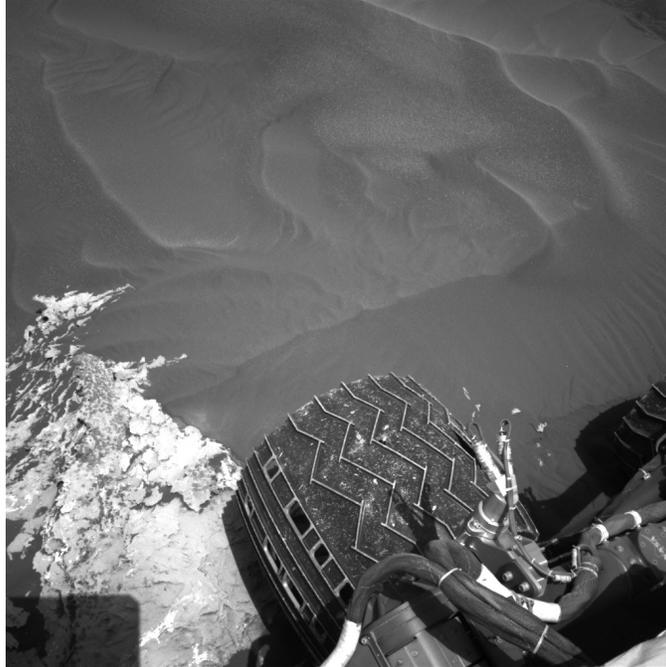
Figure 36: NavCam image acquired after the sol 1751 drive faulted when the right bogie angle exceeded the bogie limit of 17° due to the RM wheel (in the center of the image) traversing a tall rock. The RR wheel is to the right of the image.

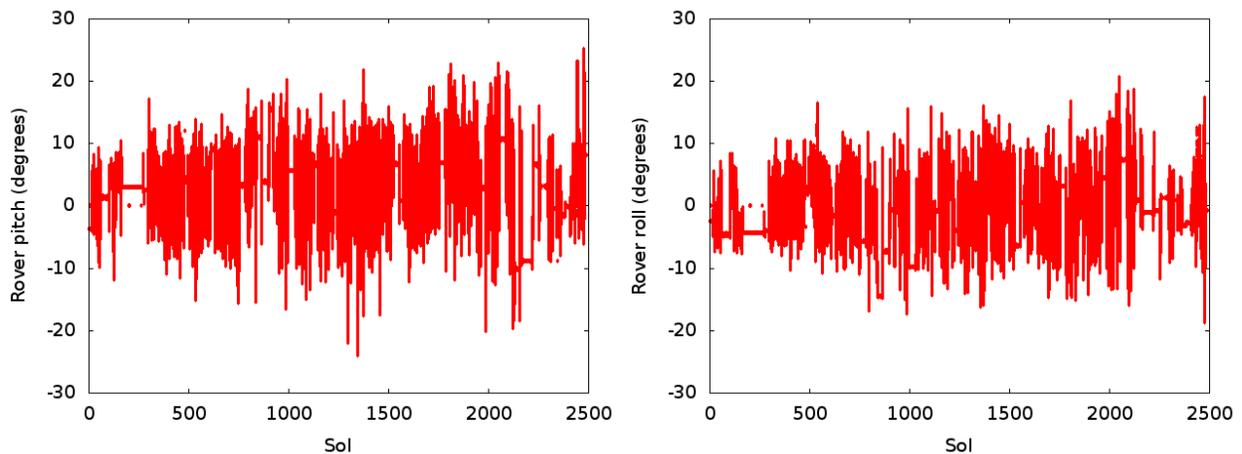
Figure 37: Curiosity pitch and roll angles during the first seven years of the mission. The max absolute values of pitch and roll angles experienced by Curiosity are 25.22° and 20.69° , respectively. Rover pitch and roll fault protection are disabled by default, but can be enabled on a drive-by-drive basis. When enabled, the pitch and roll limit for a drive is typically set to slightly higher than the max pitch and roll of the simulated drive. There have been no drive faults due to the roll limit. Exceeding the pitch limit has caused drive faults on two sols (1049 and 1262). The pitch limit on those sols were 15.0° and 6.0° , respectively.

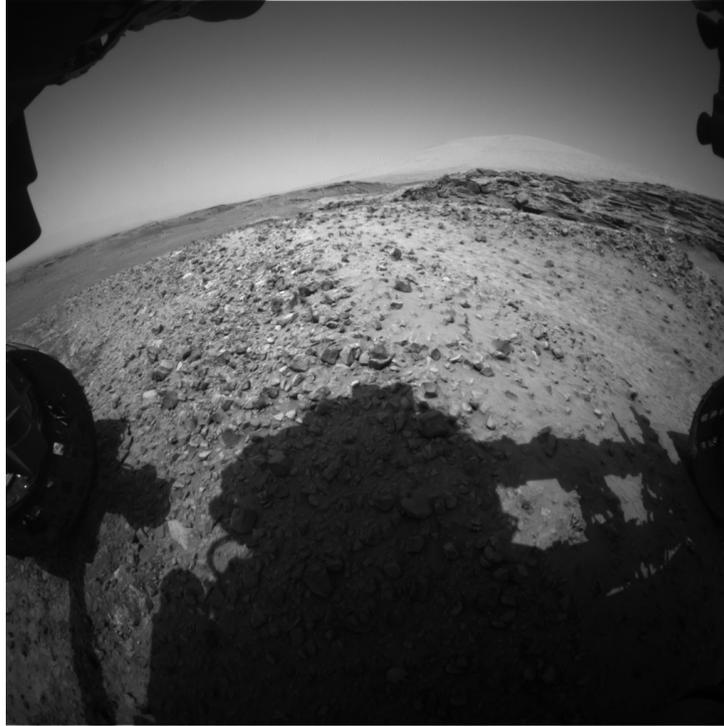
Figure 38: Front HazCam image acquired after the sol 1049 drive faulted when the rover pitch angle exceeded the max limit, which was set to 15° .

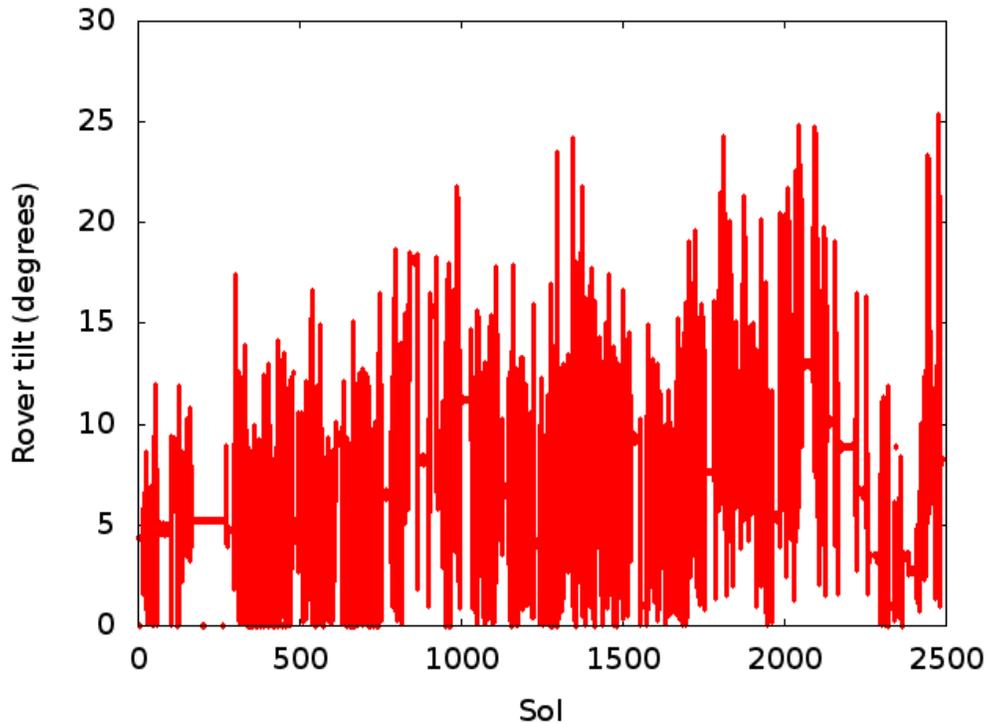
Figure 39: Curiosity tilt angle during the first seven years of the mission. The max tilt angle experienced by Curiosity was 25.34° , occurring on sol 2477. The tilt limit for each drive is typically set to slightly higher than the max tilt of each simulated drive. Exceeding the tilt limit has caused drive faults on three sols (151, 309, and 472). The tilt limit on those sols were 6.9° , 12.0° , and 12.0° , respectively.

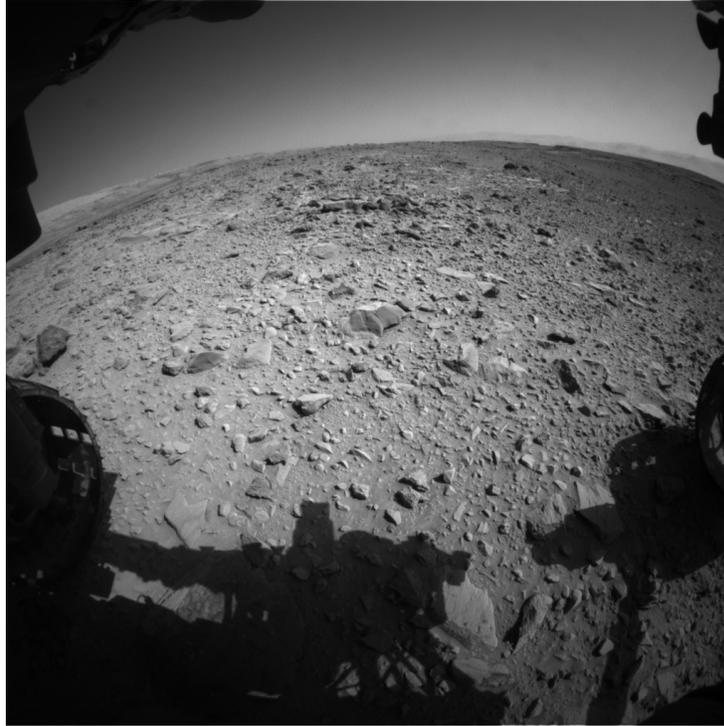
Figure 40: Front HazCam image acquired after the sol 472 drive faulted when the rover tilt angle exceeded the max limit, which was set to 12°.

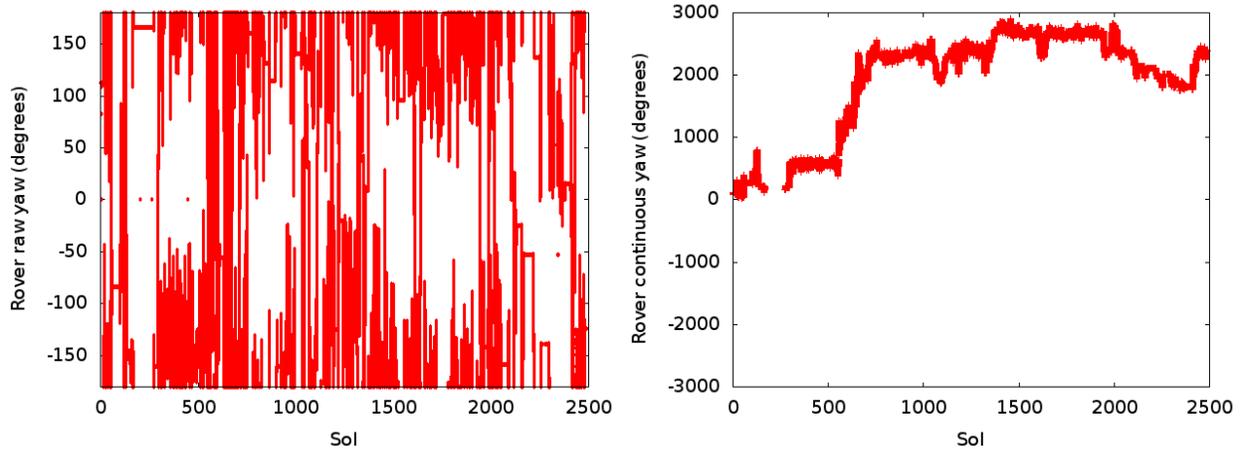
Figure 41: Curiosity raw yaw angles (left) and continuous yaw angles (right) during the first seven years of the mission. North corresponds to a heading of 0°. Increases in heading corresponds to turning to the right and decreases in heading corresponds to turning to the left. From sol 546-671, driving was predominantly backwards. During that period, the continuous yaw plot reflects a preference to turn to the right to avoid occlusions from the rover when acquiring post-drive images from the NavCams for planning the next drive. The cumulative turning performed by Curiosity is equivalent to 6.3 revolutions to the right.

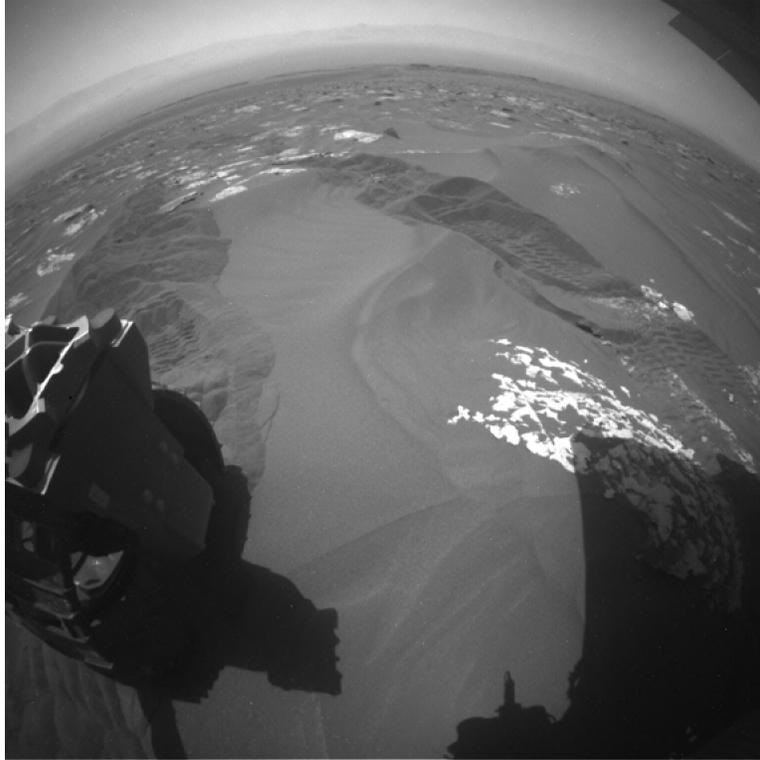
Figure 42: Rear HazCam image acquired after the sol 1789 drive. The RR wheel is visible in the image. High slip in sand caused Curiosity to exceed a $149.265 \pm 30^\circ$ yaw limit, faulting the drive.

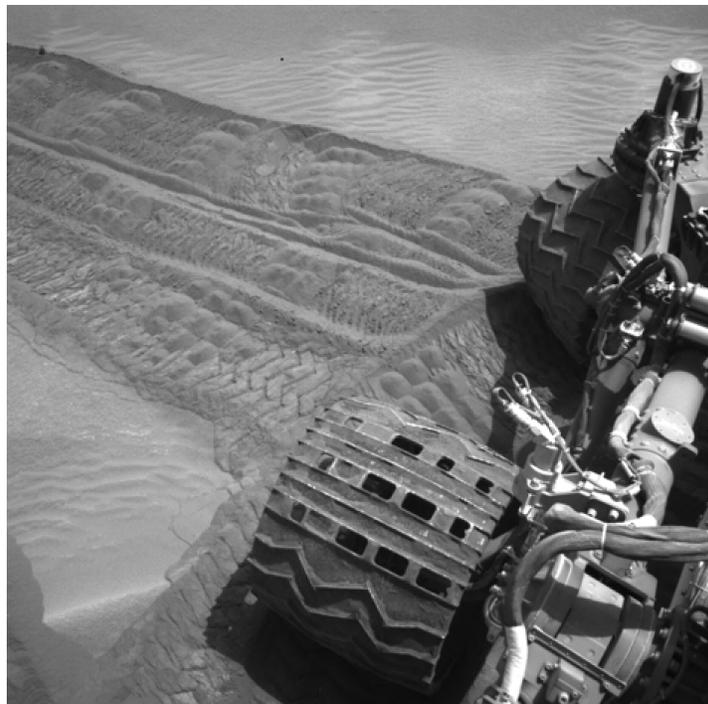
Figure 43: Sol 711 NavCam image of the RM and RR wheel after a turn-in-place command timed out. According to IMU data, the turn slip was 40.4%.

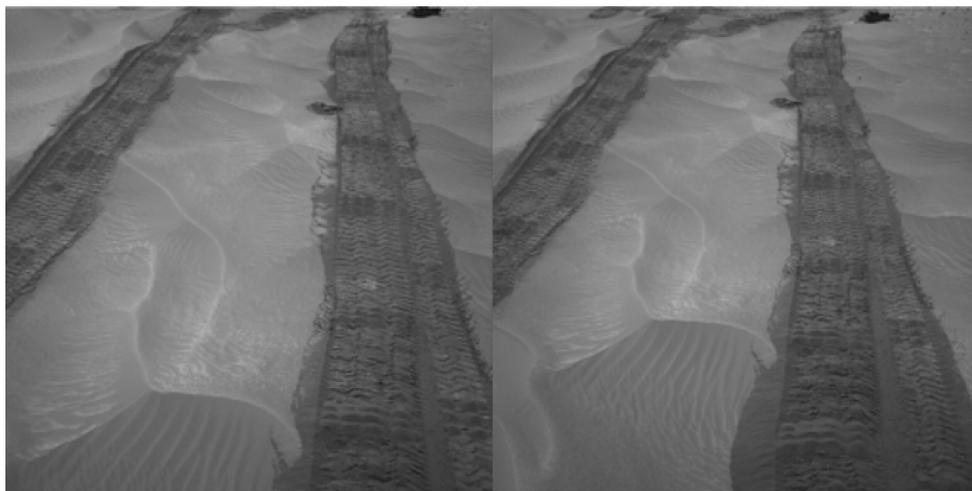
Figure 44: NavCam VO images of wheel tracks from sol 709. The commanded drive distance between the left and right image was 2 meters, but the actual distance covered was 0.54 meters. Because Curiosity was not making enough progress towards the navigation goal, a limit-cycle drive fault was declared. During the final step of the drive, the wheel slip was 77.5%, below the 90% single occurrence limit set for this leg of the drive.

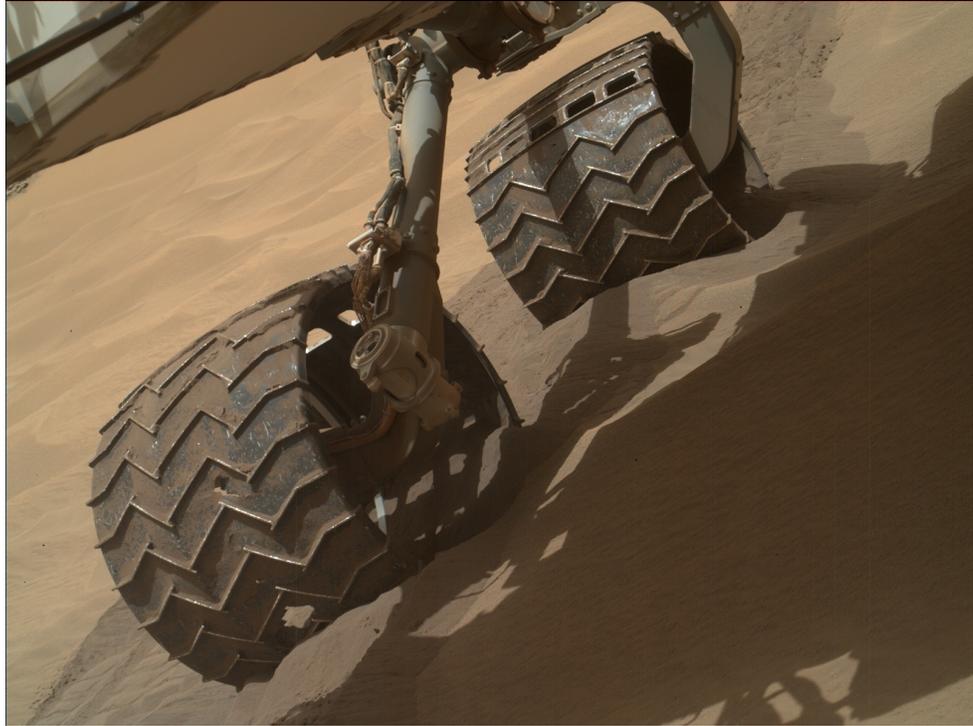
Figure 45: On sol 711, an under-belly MAHLI image of the wheels was acquired to assess wheel sinkage.

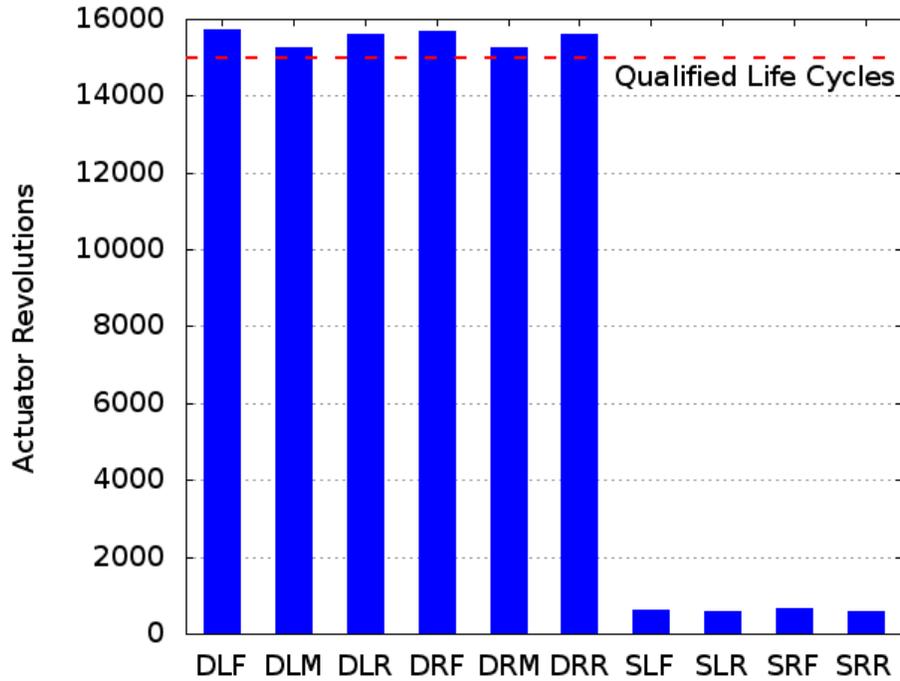
Figure 46: Drive and steer actuator revolutions as of sol 2488. DLF=drive left front, DLM=drive left middle, DLR=drive left rear, DRF=drive right front, DRM=drive right middle, DRR=drive right rear, SLF=steer left front, SLR=steer left rear, SRF=steer right front, SRR=steer right rear.

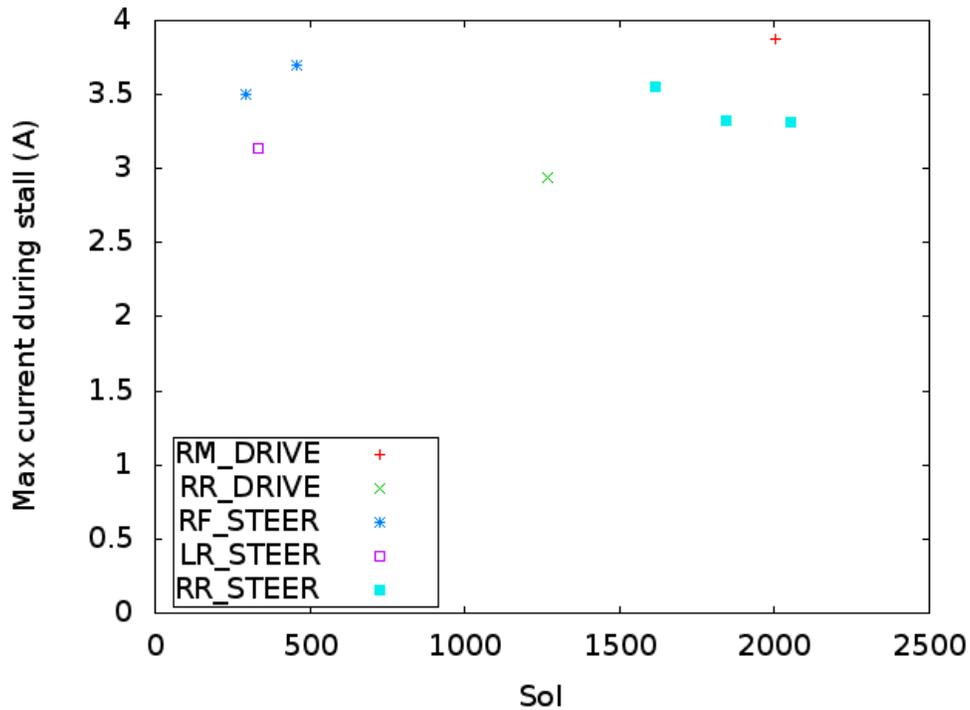
Figure 47: Each max actuator current measured during the 2 drive actuator stalls and 6 steer actuator stalls was always less than 4.0 A, well below the 10 A max current rating for the WSA. There have been no front drive actuator stalls during the mission. During the 435 sols prior to sol 2051, there were three RR steer stalls, but no RR steer stalls have occurred over the last 437 sols.

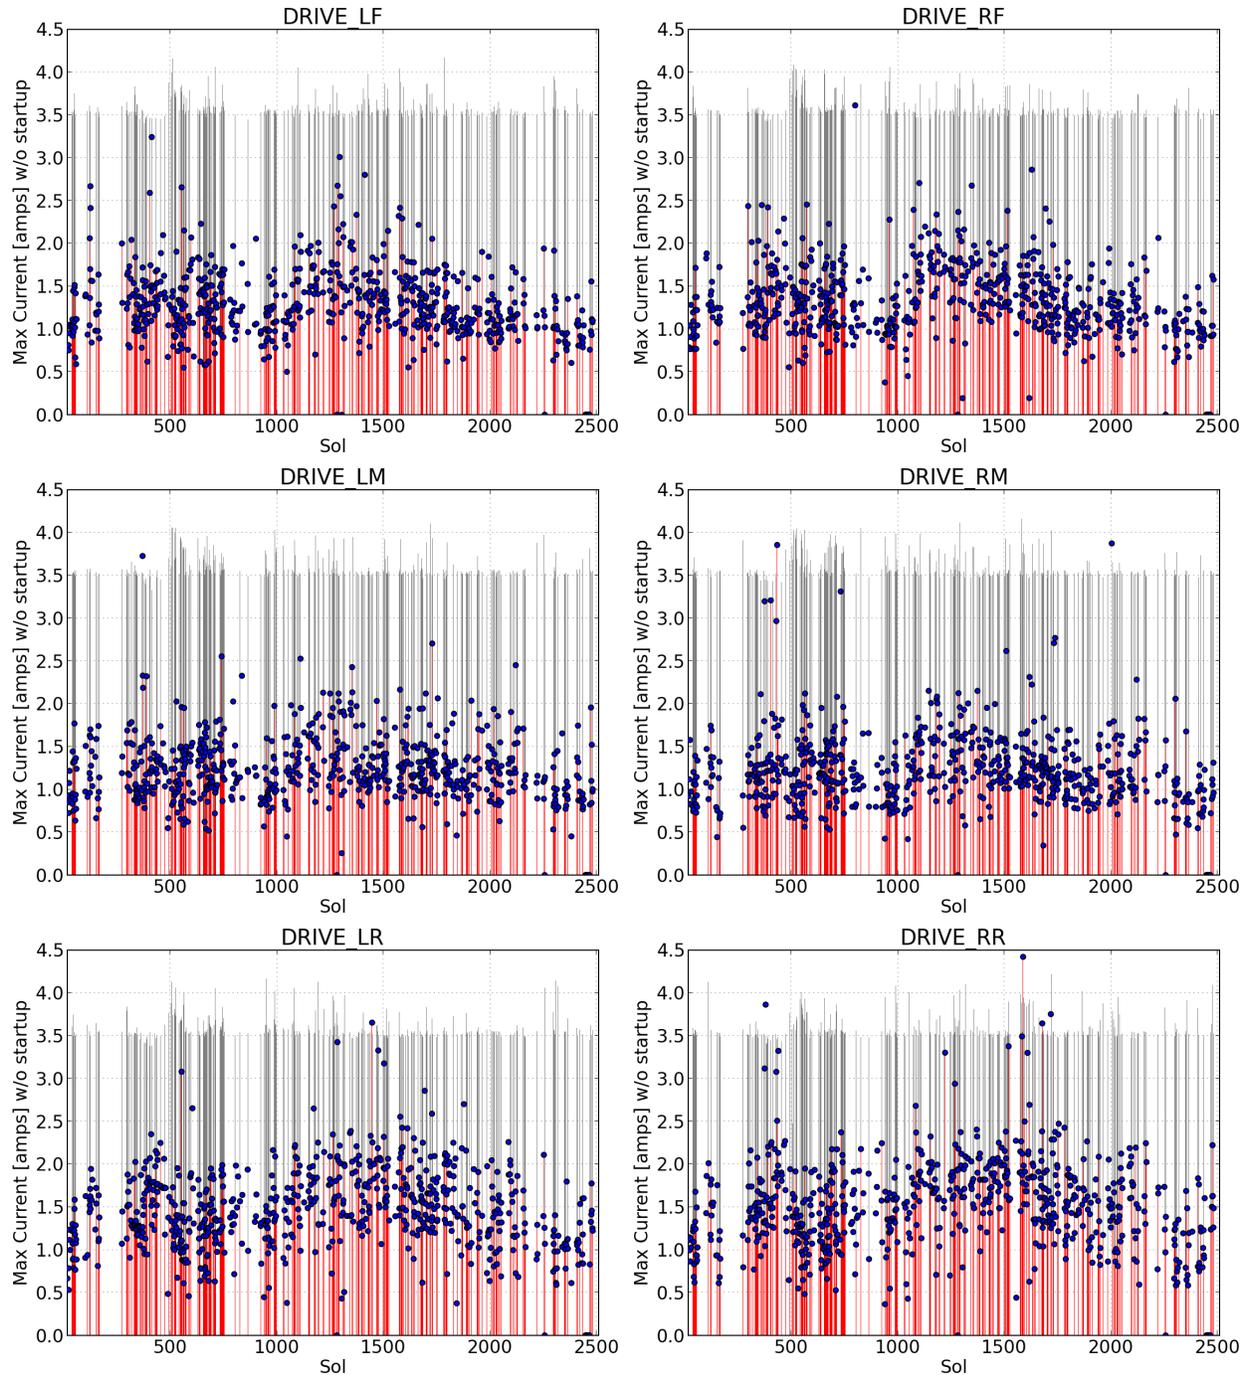
Figure 48: Max drive actuator currents per drive sol. Startup current during commutation for the first drive actuator usage on each drive sol is shown in gray. Max drive current on each drive sol due to wheel interaction with the terrain is shown in red, with a blue dot at the top of each red line.

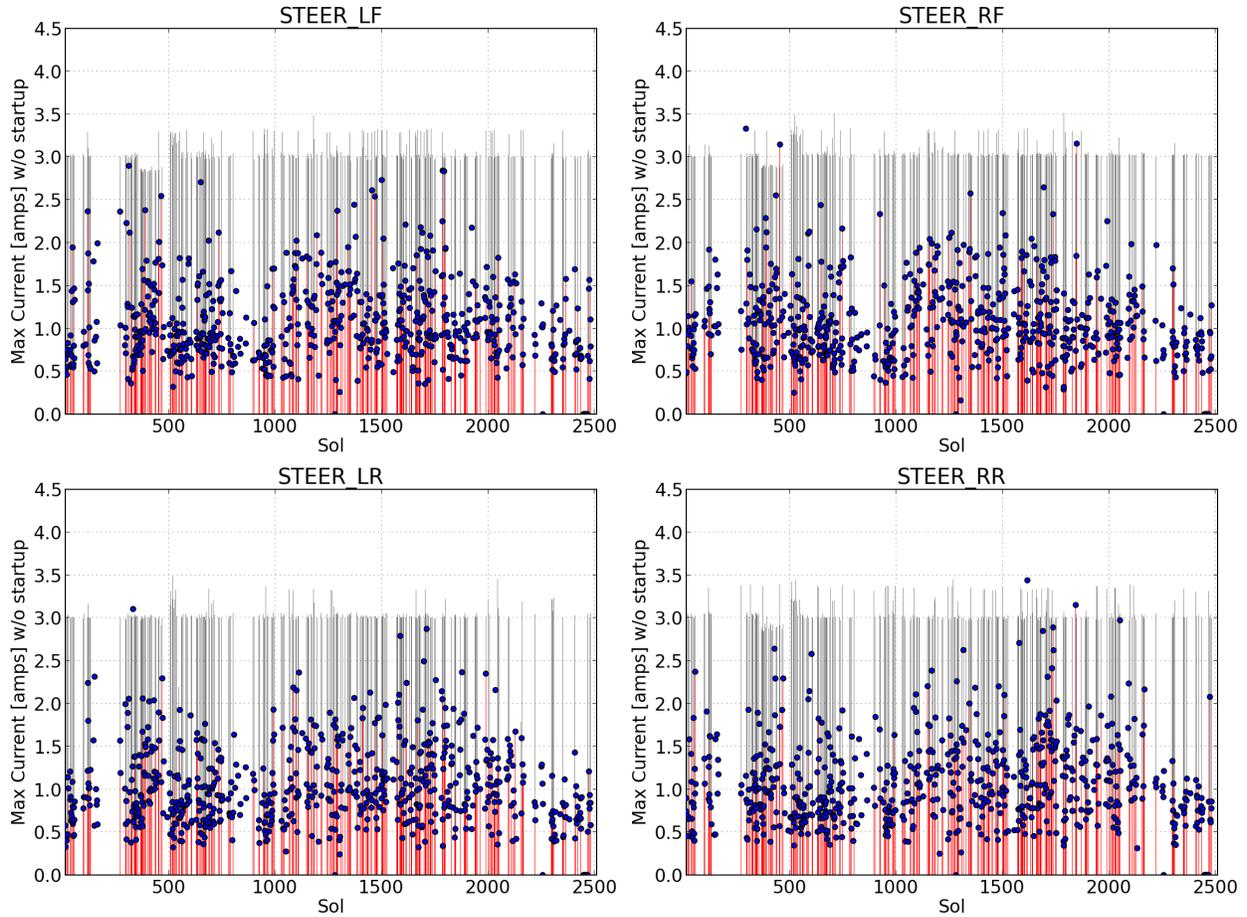
Figure 49: Max steer actuator currents per drive sol. Startup current during commutation for the first steer actuator usage on each drive sol is shown in gray. Max steer current on each drive sol due to wheel interaction with the terrain is shown in red, with a blue dot at the top of each red line.

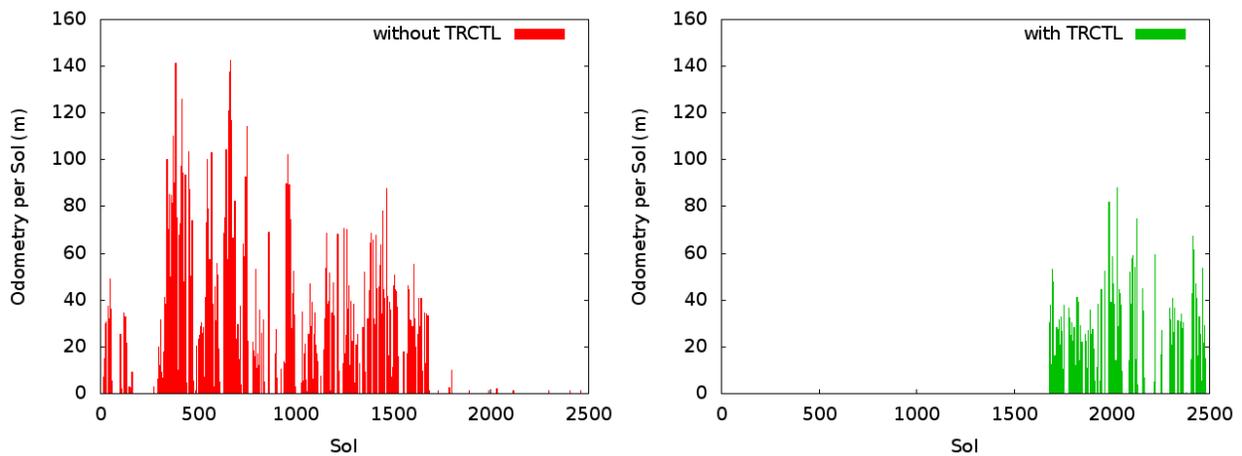
Figure 50: Since TRCTL was approved for nominal use on Curiosity on sol 1678, 99.48% of Curiosity's odometry has been with TRCTL enabled.
