Mars Curiosity Rover Mobility Trends During the First Seven Years

Abstract

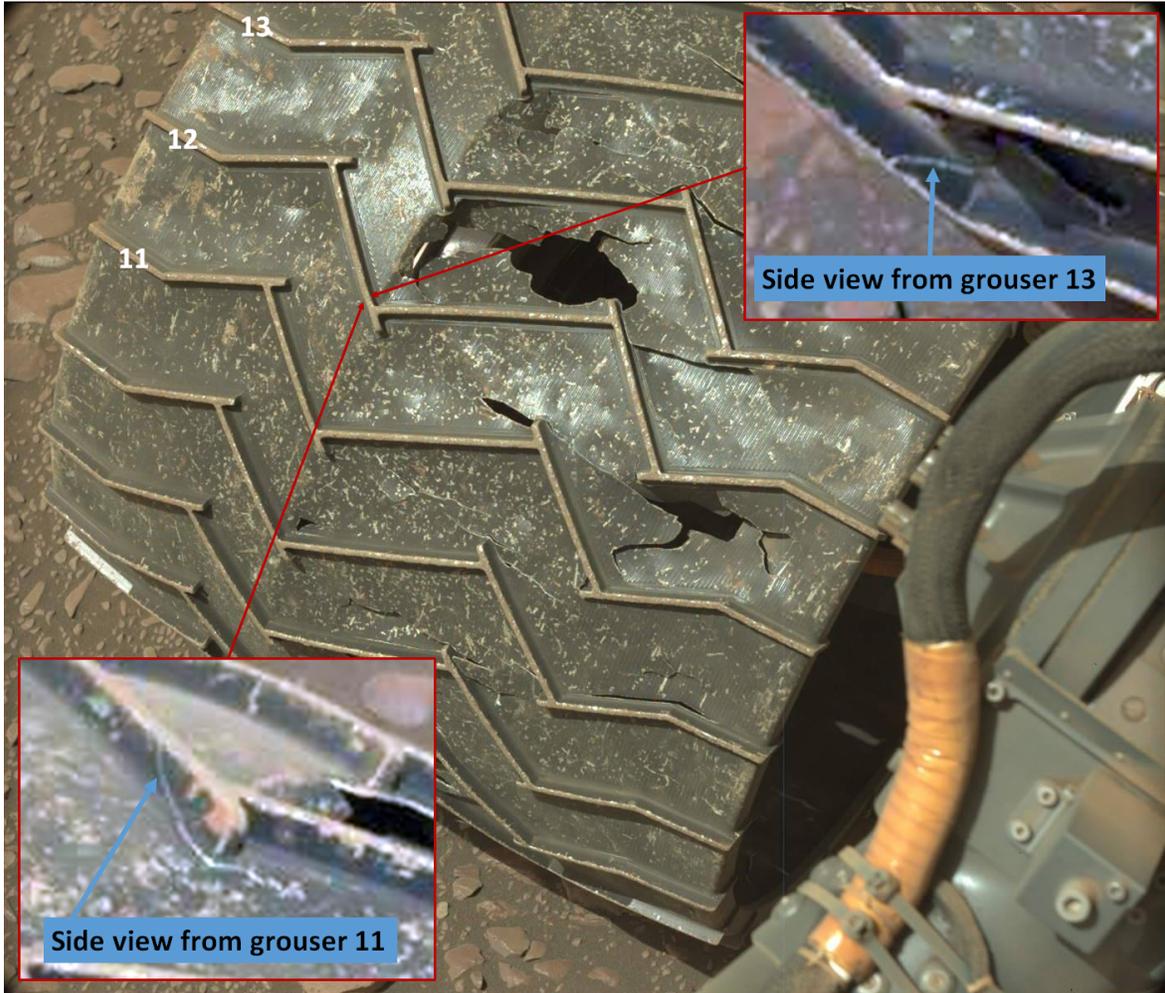
Figure 51: The single grouser break on the RM wheel is on grouser 12. It is visible from NavCam views of both sides of grouser 12, but not from an overhead view of grouser 12. Image Credit: NASA / JPL-Caltech / MSSS.

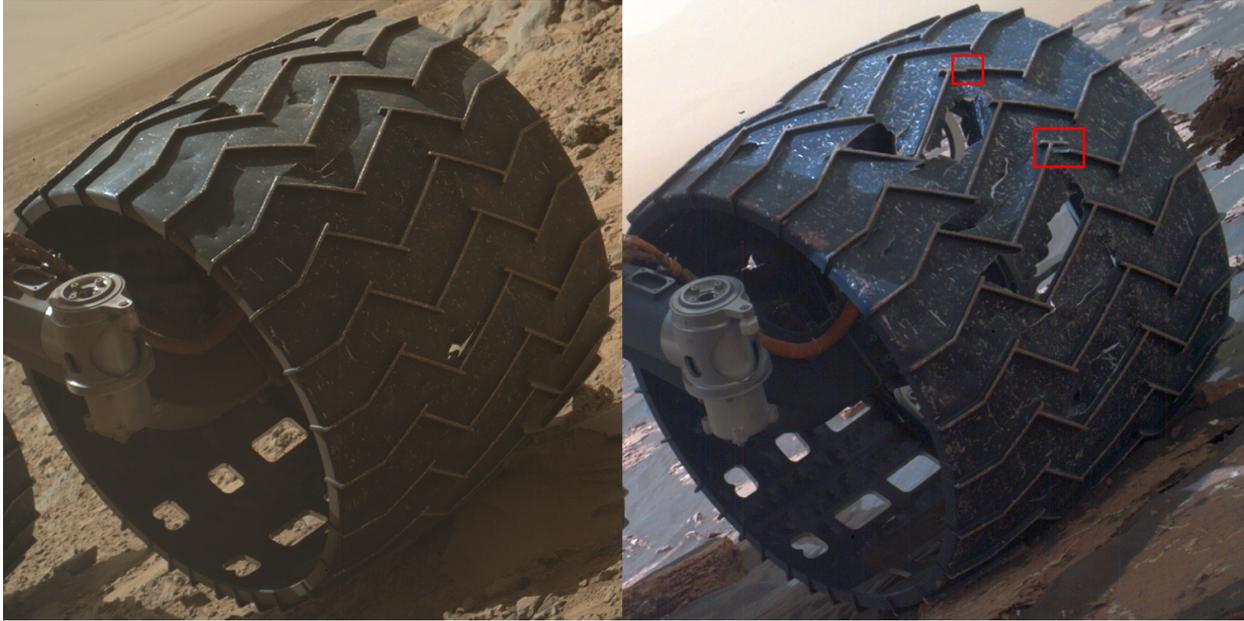
Figure 52: MAHLI images of the LM wheel from sol 490 (left) and sol 1641 (right). Two grouser are visibly broken in the image from sol 1641. These images provide a good view of the path of the electrical cable to a drive actuator. Image Credit: NASA / JPL-Caltech / MSSS.

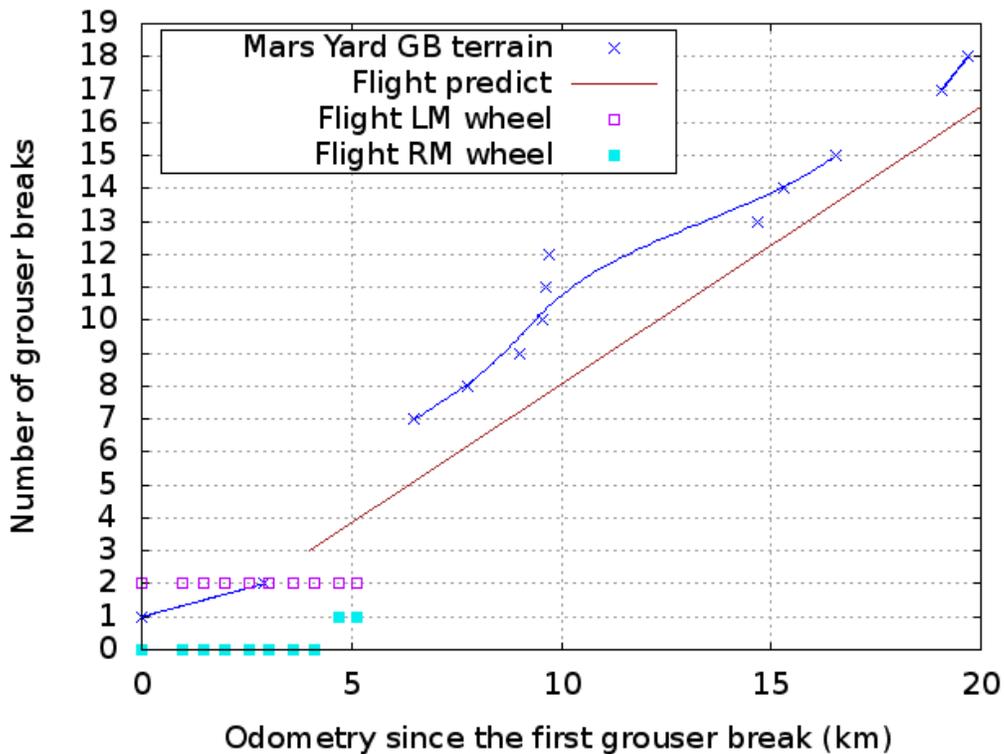
Figure 53: Number of grouser breaks on each wheel, measured since the first grouser break. Thus far, only the left middle and right middle wheels have grouser breaks. GB = good blue terrain, i.e., relatively benign terrain. Given a terrain difficulty assessment of the 5 km of driving since the first grouser break has not been conducted, the lower-than-predicted grouser break rate could be due in part to driving over more benign terrain than predicted.

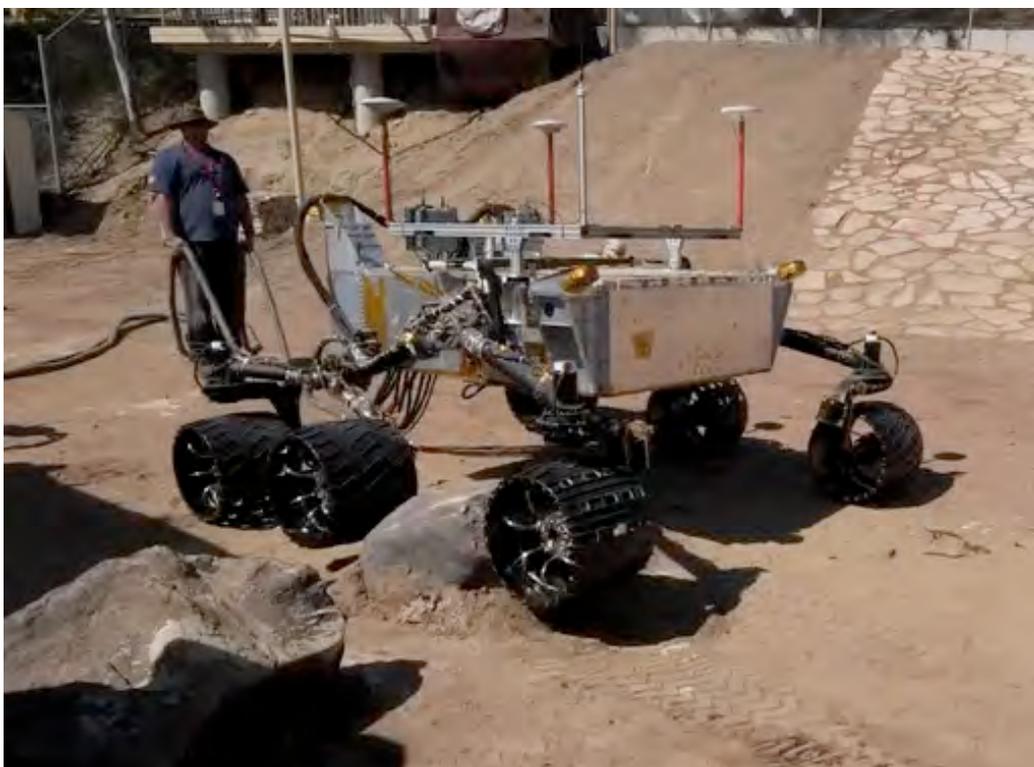
Figure 54: A 50 cm tall rock with a length of approximately 0.68 meters became wedged between the RF and RM wheels of the MSL Dynamic Test Model rover while driving backward over the rock.
