# Rimmed Wheel Performance on the Mars Science Laboratory Scarecrow Rover

**Abstract**—The Mars Science Laboratory (MSL) Curiosity rover experienced increasing wheel damage beginning in October 2013. While the wheels were designed to operate with considerable damage, the rate at which damage was occurring was unexpected and raised concerns regarding wheel life expectancy. As of Sol 2555 (10-14-19), there are two broken grousers on the left middle wheel, and one broken grouser on the right middle wheel. One possible scenario, albeit remote, is that enough grousers break on a wheel such that unconstrained portions of the wheel could contact the cable running from the rover motor controller assembly to the wheel’s drive actuator. If the cable to a drive actuator is damaged, that wheel may no longer respond to commands. To make progress towards a navigation goal position, that wheel would need to be dragged. To mitigate the risk of damaging a cable running to a wheels drive actuator, the unconstrained portion of a wheel could be strategically shed by performing driving maneuvers on an immovable rock. What would remain after wheel shedding is a rimmed wheel (the outer 1/3 of the wheel)

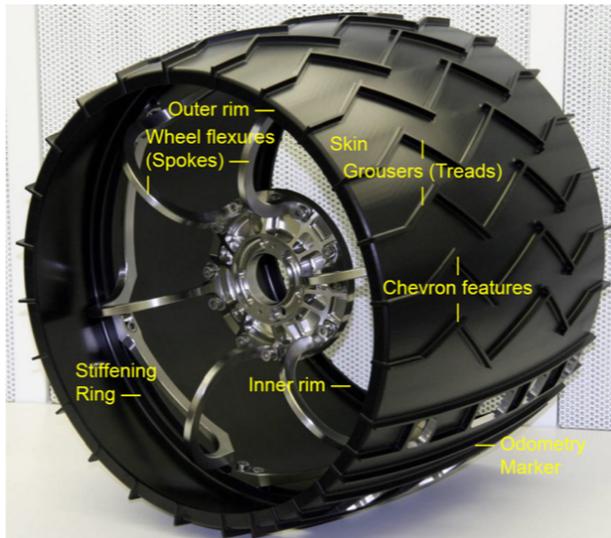
**Figure 2. Features of an MSL Flight Wheel.**

Each wheel contains a stiffening ring around the interior of the wheel, located two-thirds of the wheel width from the inside edge of the wheel. A drive actuator is attached to a wheel’s stiffening ring via spindles. The stiffening ring also provides support to the 19 cleat-like features (called grousers) in between the inner and outer edge of each wheel. Figures 1 and 2 identify the sections and features of an MSL wheel. The current damage on each wheel is assessed after approximately 500 meters of driving by acquiring MAHLI images of the left front (LF), left middle (LM), left rear (LR), and right front (RF) wheels, and MastCam images of the right middle (RM) and right rear (RR) wheels in five 1.257 radian wheel-

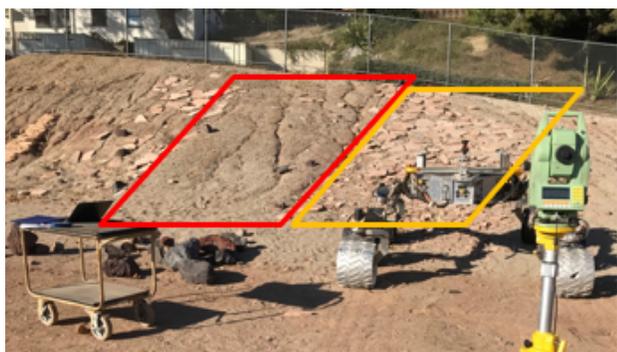
Figure 4. JPL Mars Yard North Slope Terrain.

**Methods**—Operating the rover with rimmed wheels presents several concerns for mobility performance. A rimmed wheel has a reduced footprint, with less surface area and grouser area contacting the surface to provide traction. To characterize this impact, the Scarecrow rover was tested in the JPL Mars Yard north slope, performing straight drives on two terrain types including gravel (representative of cohesive martian soil or gravel) and flagstone (representative of martian bedrock). Test trials were done on the 18 degree slopes available to us (Figure 4), which provide a challenging degree of steepness that is within the range of tilts that the flight vehicle can and has traversed. Trials included straight 10m drives up and down each slope while maintaining a consistent starting position and heading. Slope testing was done for all three rimmed wheel configurations: Baseline, 2Rim, and 3Rim.

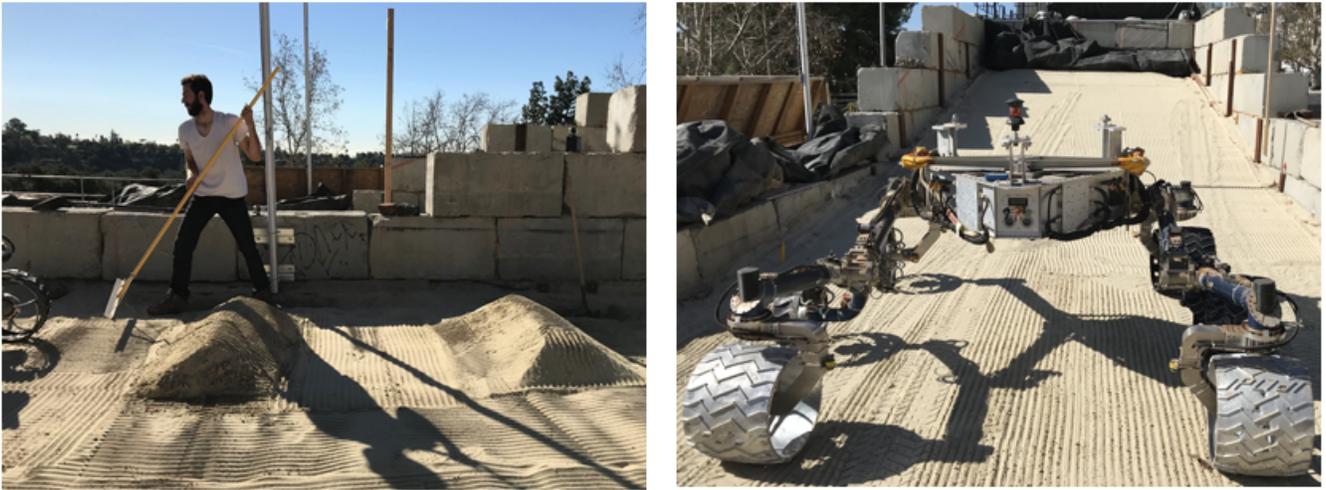
Figure 10. Mars Yard Sand Box (Left). Scarecrow on Mar Yard Sand Slope (Right).

Driving in sand is a high risk activity for Mars rovers due to the high amounts of induced slip and the ability for wheels to sink and potentially get stuck in sand. The Baseline, 2Rim, and 3Rim configurations of wheels were tested using Scarecrow in the Mars Yard sand boxes shown in Figure 10. While testing in the flat sand box, the test team prepared sand dunes of 25cm to drive the full and rimmed wheels over. The sand slope was used to again perform forward and backward straight drives for the various wheel configurations.

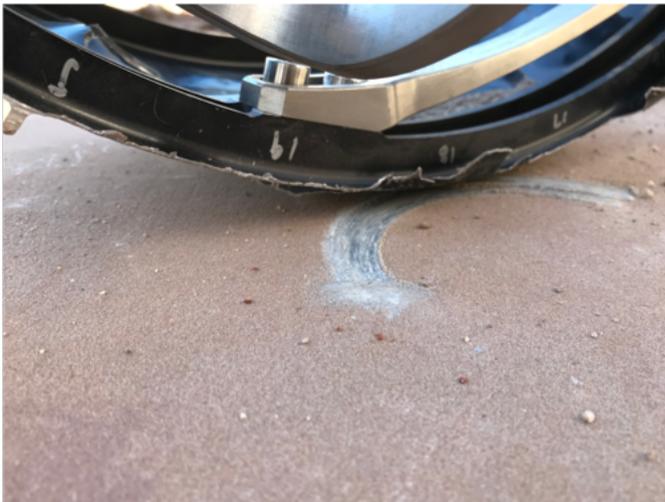
**Figure 15. Contact Point of a Rimmed Wheel Due to Steer Axis Offset.**

Qualitatively, the lateral shift in the nominal ground contact point introduces the risk of getting a rimmed wheel caught on a rock or other terrain feature that a full wheel would otherwise rest on top of. In flight, this would require additional attention by MSL's rover planners when steering rimmed wheels.

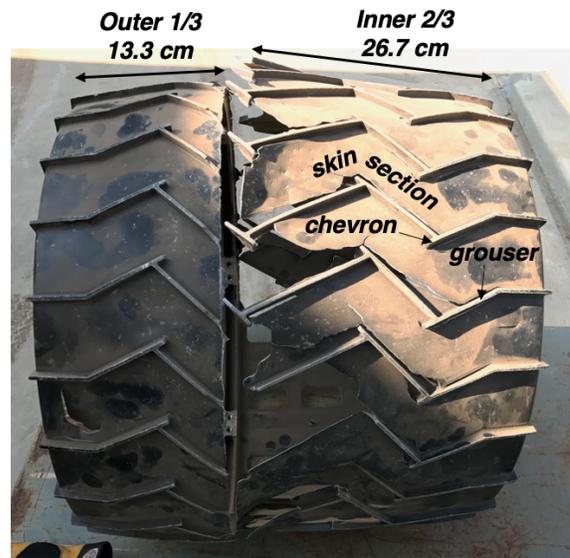
**Figure 16. MSL Flight Wheel with 19 Broken Grousers.**

The primary threat of accumulated damage to Curiosity's wheels is the risk posed to electrical cabling running along the wheel struts between the motors and motor controller assembly (MCA). Once all 19 grousers on a wheel have broken, the inner 2/3 section of the wheel excluding the odometry feature becomes unconstrained and is capable of contacting exposed cabling. Figure 16 shows a Curiosity wheel with 19 broken grousers, a state colloquially referred to as a Heavily Damaged wheel.

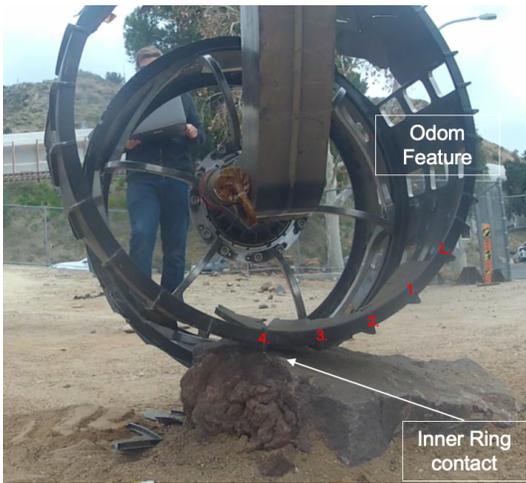
Figure 19. LF after being driven onto the shed rock.

**Break 1 - The Twist and Shout Maneuver**—After identifying a shed rock, the rover is positioned such that the stiffening ring runs parallel to the steepest face of the rock. The shed wheel LF is positioned so that the rotation of LF as the rover is driven forward will result in the inner ring of the wheel being in contact with the rock along the range of grousers 2-5 (Figure 19). The center axis of the wheel should be above the peak or protrusion of the rock as pictured.

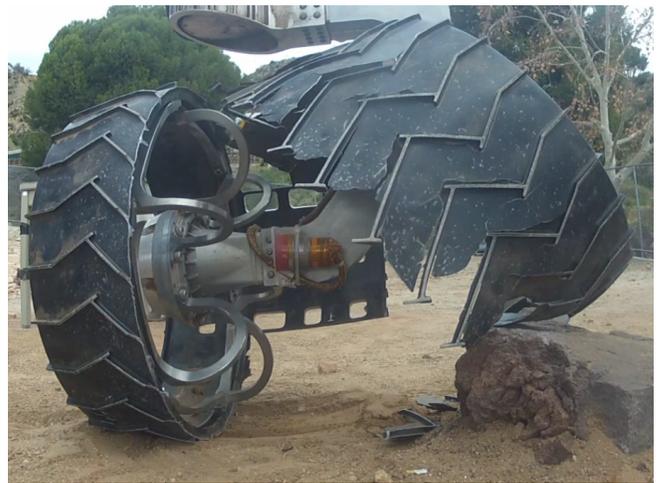
Figure 21. Rotated LF After Break 1.

on the rock, the inner ring bends and ultimately breaks in Location 1 (The Shout). Figure 20 shows LF while the rover is driving backwards, just prior to the inner ring breaking. Break location 1 is circled. Figure 21 shows LF following the completion of the Twist & Shout with the first inner ring break achieved.

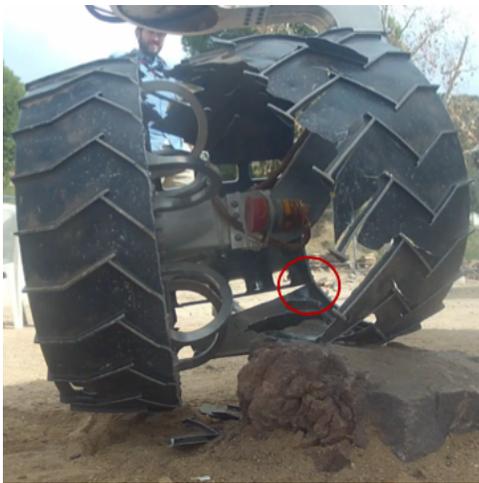
Figure 20. Rotated LF Prior to Break 1. Break Location 1 Circled.

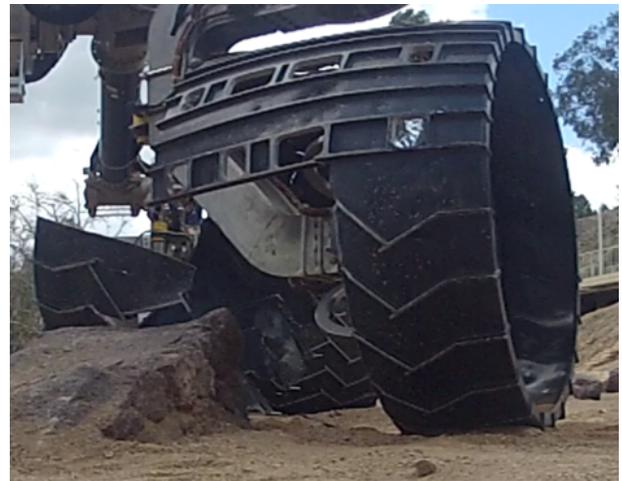
Figure 22. Unconstrained LF portion pinned to the rock.

**Break 2 - The Pigeon Toe Maneuver**—Following the first break, LF is straightened and the rover is backed up to take LF off the rock. LF is rotated such that, when pushed forward, the now unattached inner 2/3 section will be pressed up against the shed rock (Figure 22).

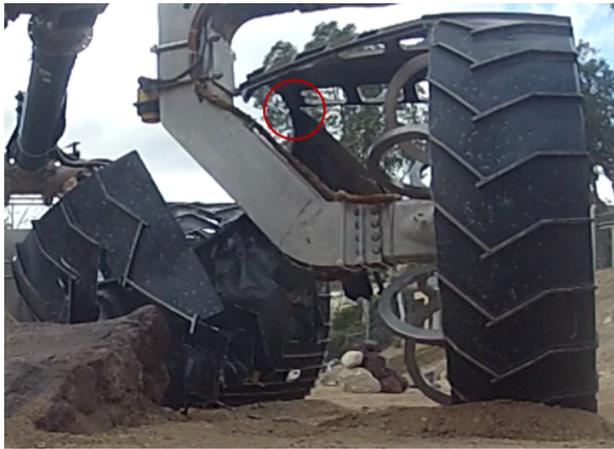
**Figure 23. Unconstrained LF During the Pigeon-Toe Maneuver. Break Location 2 Circled.**

motions increases the stress on the inner ring at break location 2. Figure 23 shows LF during this process, with the break location circled.

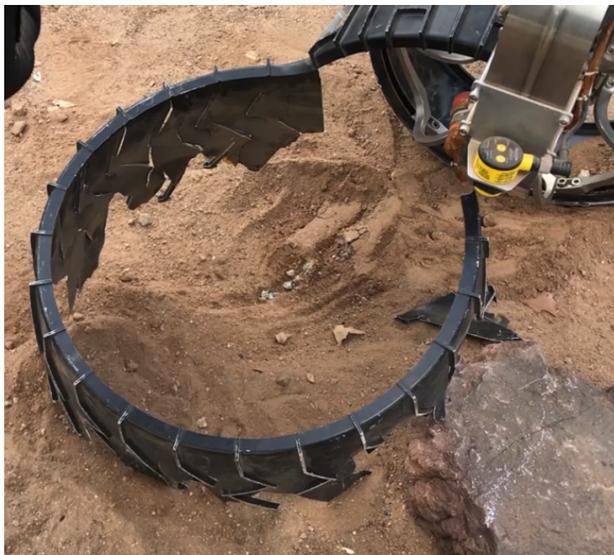
**Figure 24. Overhead View of LF During the Pigeon-Toe Maneuver.**

Eventually, the stress required to break the inner ring at break location 2 is achieved, and the inner 2/3 section separates completely. The rover can then continue on a newly rimmed wheel. Figures 24 and 25 show an overhead view of LF before and after the second break occurs.

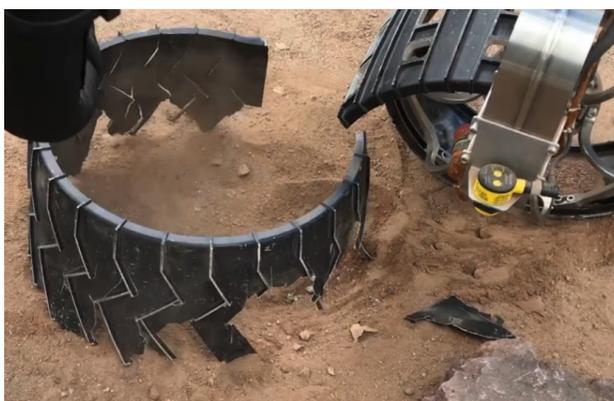
**Figure 25. Overview View of LF After Shedding**
