Driving Curiosity: Mars Rover Mobility Trends During the First Seven Years

Arturo Rankin, Mark Maimone, Jeffrey Biesiadecki, Nikunj Patel, Dan Levine, Olivier Toupet
Jet Propulsion Laboratory, California Institute of Technology
4800 Oak Grove Dr.
Pasadena, CA 91109
(818) 354-9269
arankin@jpl.nasa.gov

Abstract—NASA’s Mars Science Laboratory (MSL) mission landed the Curiosity rover on Mars on August 6, 2012. As of August 6, 2019 (sol 2488), Curiosity has driven 21,318.5 meters over a variety of terrain types and slopes, employing multiple drive modes with varying amounts of onboard autonomy. Curiosity’s drive distances each sol have ranged from its shortest drive of 2.6 centimeters to its longest drive of 142.5 meters, with an average drive distance of 28.9 meters. Real-time human intervention during Curiosity drives on Mars is not possible due to the latency in uplinking commands and downlinking telemetry, so the operations team relies on the rover’s flight software to prevent an unsafe state during driving. Over the first seven years of the mission, Curiosity has attempted 738 drives. While 622 drives have completed successfully, 116 drives were prevented or stopped early by the

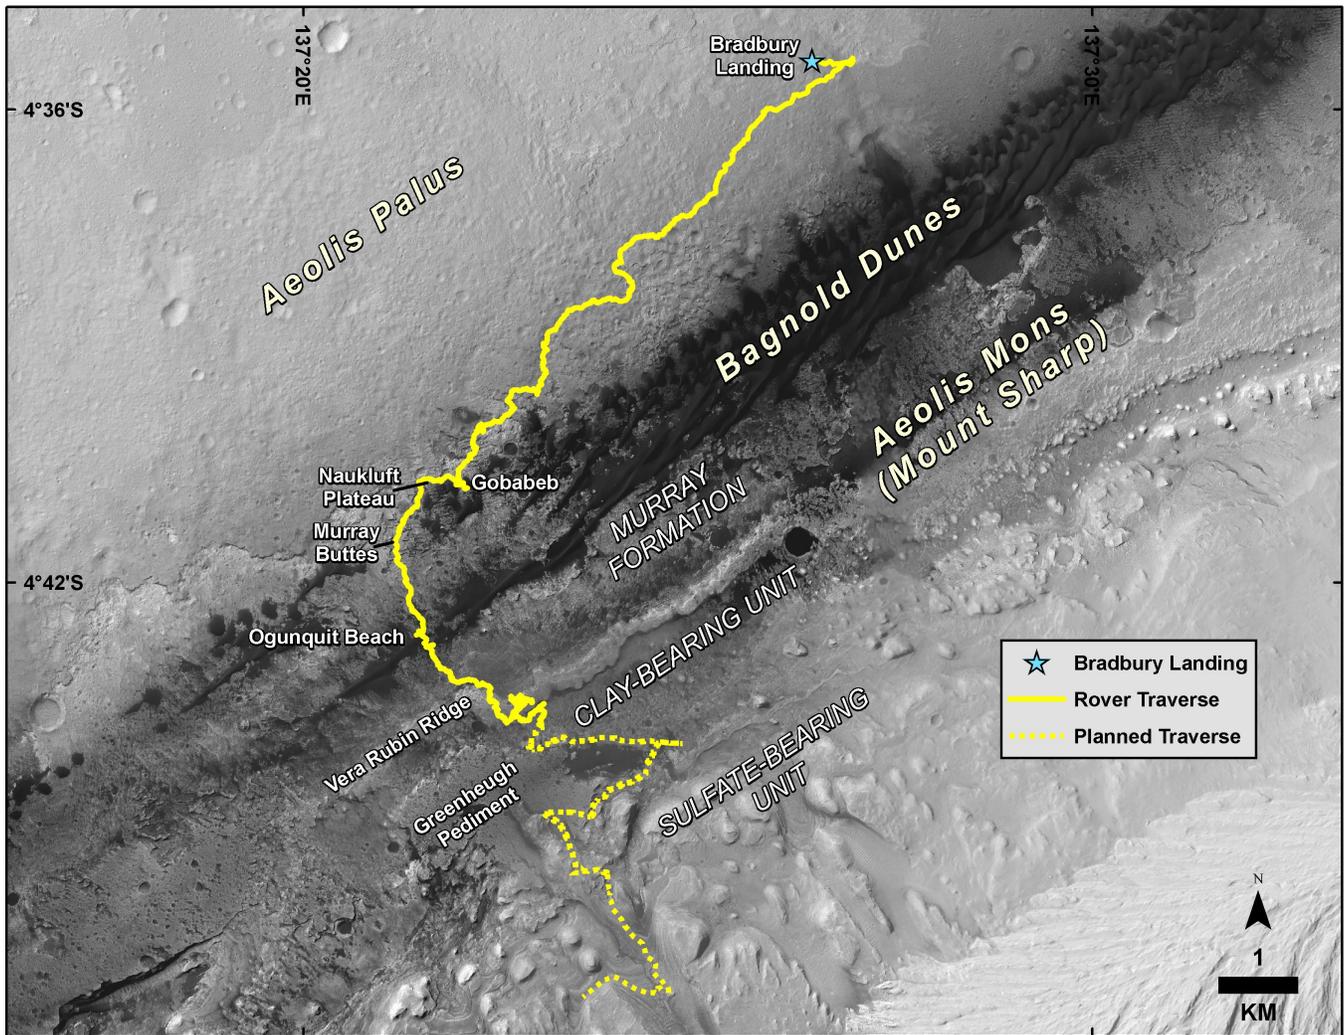
Figure 1. This map shows the route driven by NASA’s Curiosity Mars rover, from its August 2012 landing through August 2019, and the planned path through additional geological layers of lower *Mount Sharp*. The blue star near top center marks “Bradbury Landing,” the site where Curiosity arrived on Mars on Aug. 5, 2012, PDT (Aug. 6, EDT and Universal Time). Curiosity landed on Aeolis Palus, the plains surrounding Aeolis Mons (Mount Sharp) in Gale Crater. The base image for the map is from the High Resolution Imaging Science Experiment (HiRISE) camera on the Mars Reconnaissance Orbiter. Image Credit: NASA/JPL-Caltech/Univ. of Arizona.

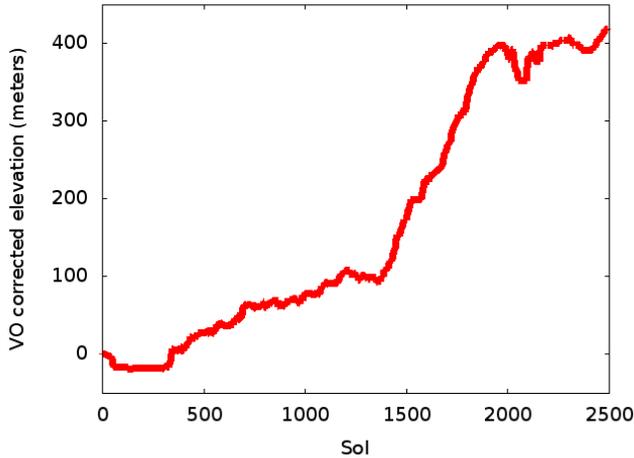
Figure 2. Curiosity change in elevation during the first seven years of the mission.

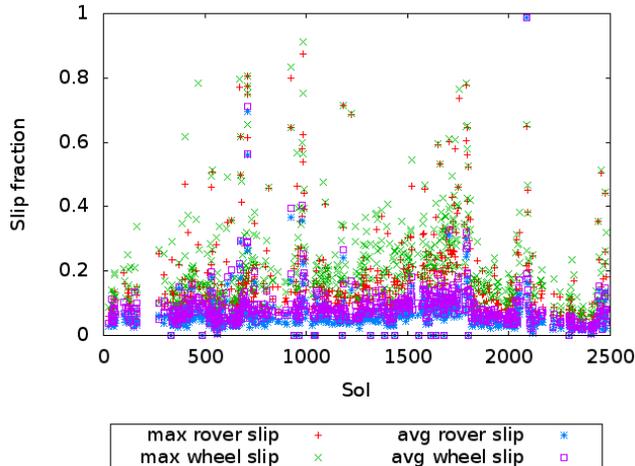
Figure 3. Rover and wheel slip fraction.

For example, a wheel slip fraction of 0.0 means there was no slip; VO confirmed the rover was at its no-slip position. On the other hand, if the rover commanded a straight arc but VO determined it did not move at all, the wheel slip fraction would be 1.0.

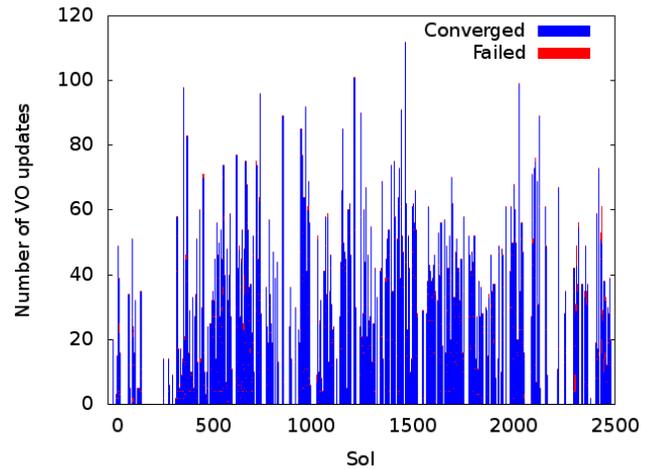
Figure 4. As of sol 2488, VO has been performed 20,682 times during mobility activities with only 94 failures.

During mobility operations on Mars thus far, MSL VO has successfully converged to a solution 20,588 times out of 20,682 attempts, yielding a remarkable success rate of 99.55%. See Figure 4 for a per-sol breakdown and Table 2 for additional overall statistics. These numbers do not include VO use during non-mobility activities. The different categories of VO failures that have occurred are summarized in Table 3 and Figure 5. The five categories from that table are:

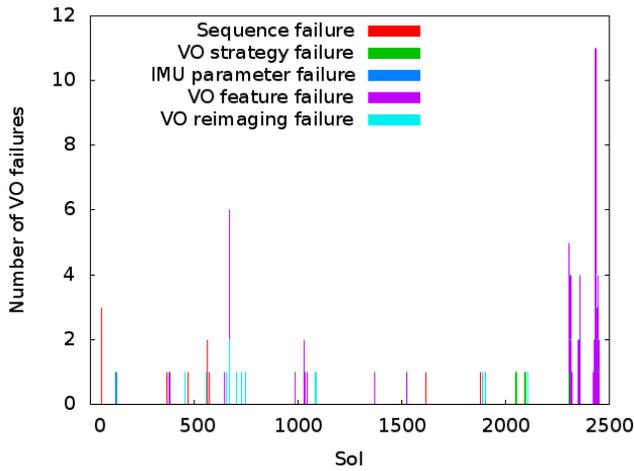
Figure 5. Number of VO failures per sol for each type of VO failure.

VO failed to converge The majority of failures (66) were due to the algorithm failing to detect enough self-consistent features to be confident in its estimate and thus failing to converge on a solution; that often happens when the cameras are pointed at all-sandy terrain with few obvious unique features, for instance.

Step truncation reimaging failure When driving to a goal location, the rover may autonomously command a turn so sharp that there would be little or no overlap between VO image pairs. Although the FSW was designed to recognize that possibility and automatically truncate any large steps to enable VO to keep working, a bug in the FSW prevented VO reimaging from occurring in those cases. A fix has been developed and is being considered for uplink.

Sequencing failure Rover Planners sometimes realize during plan construction that their command sequences may result in VO failing to converge, but decide to send them anyway (e.g., on the last leg of a drive if precise localization is not required). Or they may send commands outside the normal recommended bounds (e.g., driving a longer distance between image pairs).

Strategy failure Sometimes a fault unrelated to VO causes a mobility command sequence to stop executing. In that off-nominal case, VO can sometimes accidentally try to match images with completely different pointing configurations, resulting in a failure to converge. But since the original plan did follow the best practices, we categorize these as Strategic failures rather than sequence failures.

IMU parameter failure On sols 122, 123, and 124, one of the built-in sanity checks triggered, forcing one VO estimate to be rejected each sol. The check was that the VO attitude estimate should match the IMU-generated one within one

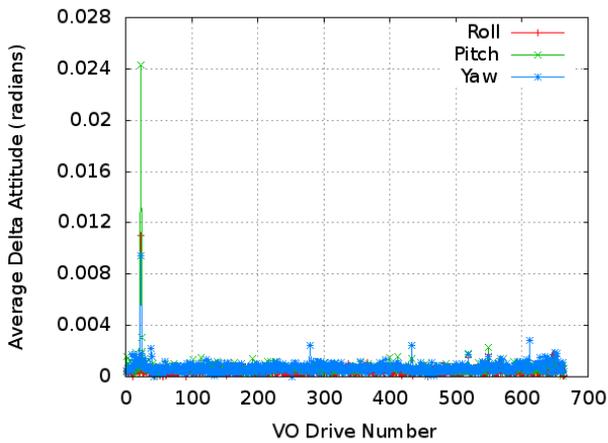
Figure 6. The average difference between SAPP and VO rover attitude angles for each drive where VO was performed.

degree in roll, pitch, and yaw, and each time, the pitch estimate differed by more than one degree (-1.391, -1.072, -2.195 degrees, respectively). Subsequent investigation led to the conclusion that the VO update was actually correct, but there was a bug in the IMU parameter settings (subsequently fixed) that inadvertently dropped attitude updates under high acceleration. Figure 6 shows that there has been little disagreement since those events.

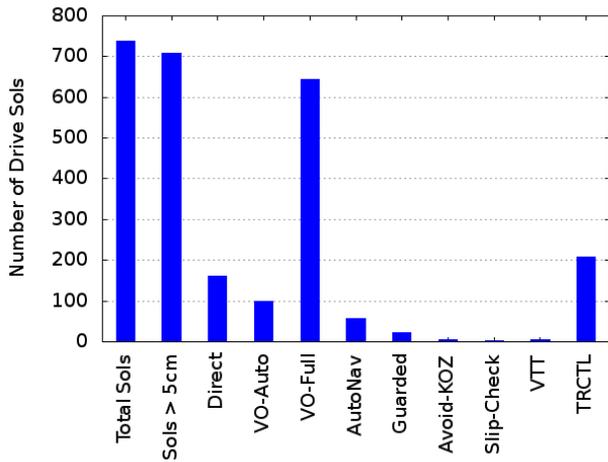
Figure 7. Number of sols using each drive mode.

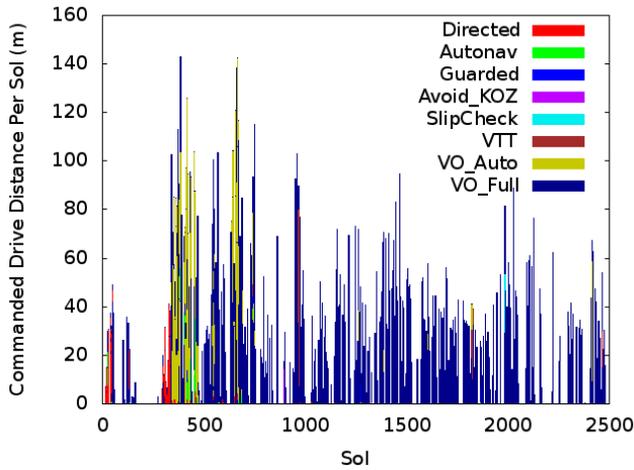
Figure 8. Curiosity odometry per sol by drive mode.

(“Yellowknife Bay”). It did not take long to reach them, so we mainly exercised directed driving with occasional VO for the first 200 sols. After the first year we started driving as fast and far as possible, making use of VO-Auto for slip safety and AutoNav to enable the rover to extend human-planned drives safely into terrain unseen by human eyes. See the increasing slope in Figure 9 and the distance-per-sol records in Figure 8.

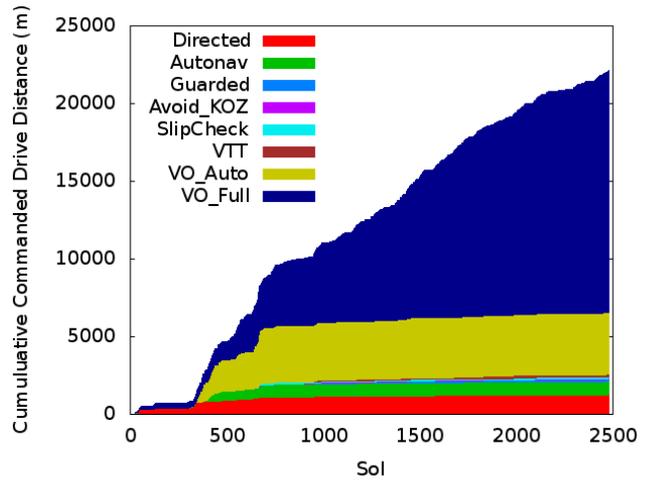
Figure 9. Curiosity cumulative commanded odometry by drive mode.

Referring to Figure 9, the rover drove relatively little during the first year, mainly because we had the good fortune to land in an area rich with targets of interest to the science team

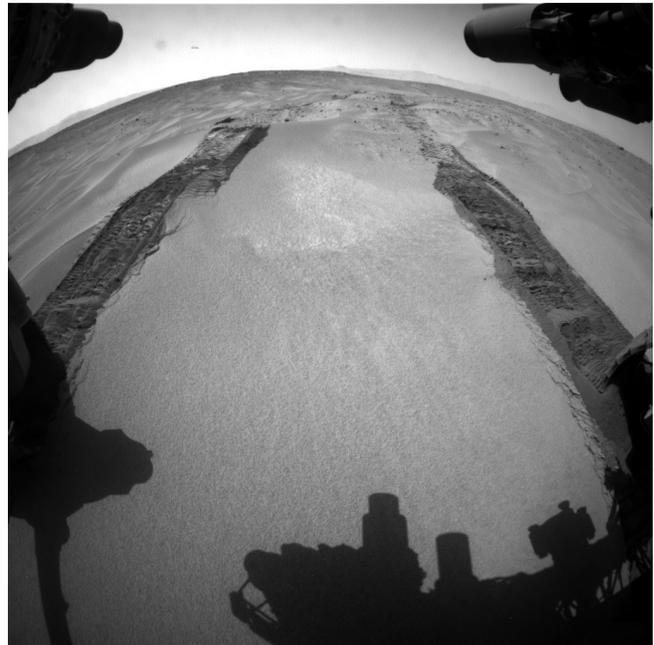
Figure 10. Front hazcam view of the sol 672 partial embedding event where VO Auto stopped the drive early.

Discovery of wheel skin damage around sol 490 and our first partial embedding event on sol 672 (see Figure 10) each led to downturns in drive rate during the subsequent weeks. Those events and the discovery around sol 710 (in “Hidden Valley”) that the rover’s performance in polygonally-rippled sand was insufficient to make good progress led us to favor somewhat slower VO-Full drives ever since, since that mode can react most quickly to any unexpected slip events.

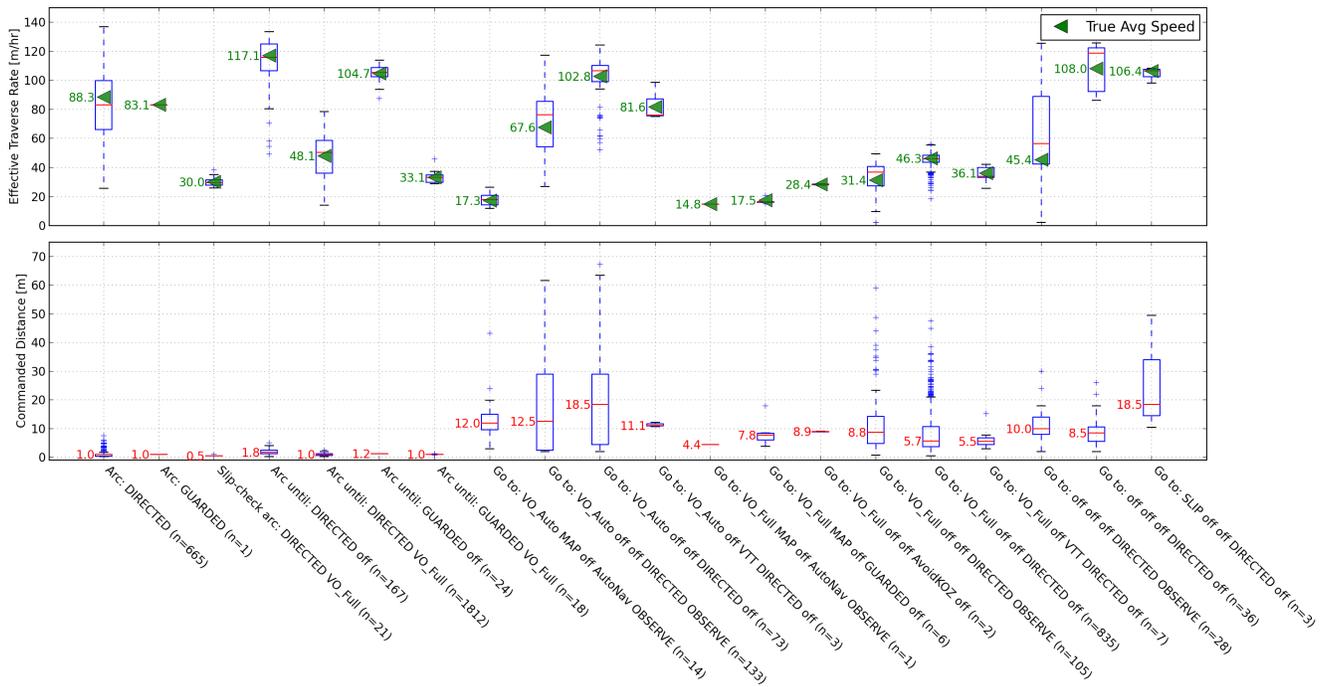
Figure 11. Effective Drive Rates without TRCTL. Boxplot showing interquartile range (blue) and median (red) for traverse rate and duration of each drive command by mode. Rather than reporting the "mean of the achieved speeds," which is not a meaningful quantity, we instead indicate the true average speed (quotient of total drive distance and total drive duration) for each mode with a green triangle and numeric label. The order of the arguments for "Go to" are VO mode, whether or not to update the Hazard Detection map, whether or not to perform Visual Target Tracking, path selection mode, and whether or not to run an observation sequence to acquire mid-drive images.

Figure 11 and Figure 12 show the overall drive speed with TRCTL disabled and enabled, respectively. Recall that since TRCTL entails only one wheel guaranteed to be traveling at

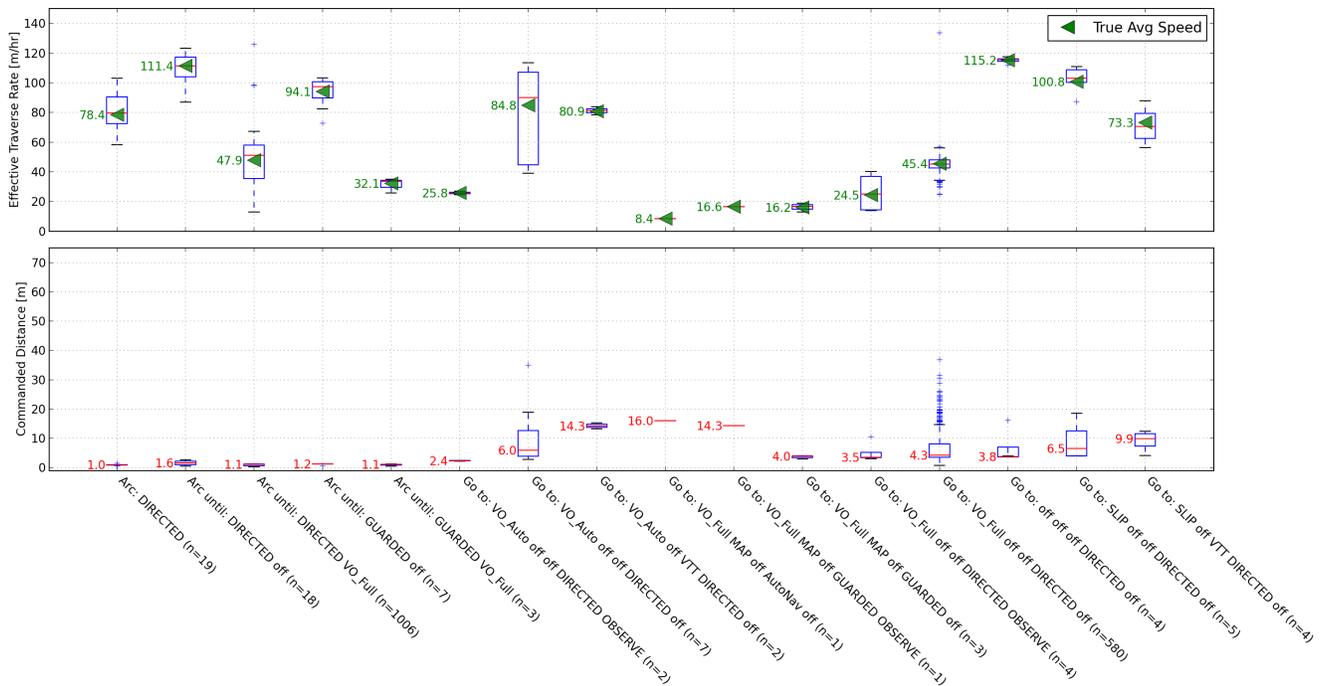
Figure 12. Effective Drive Rates with TRCTL enabled.

the max wheel speed, one might expect longer drive times for achieving the same drive distance. Indeed, this can be seen in the empirical effective traverse rates with TRCTL

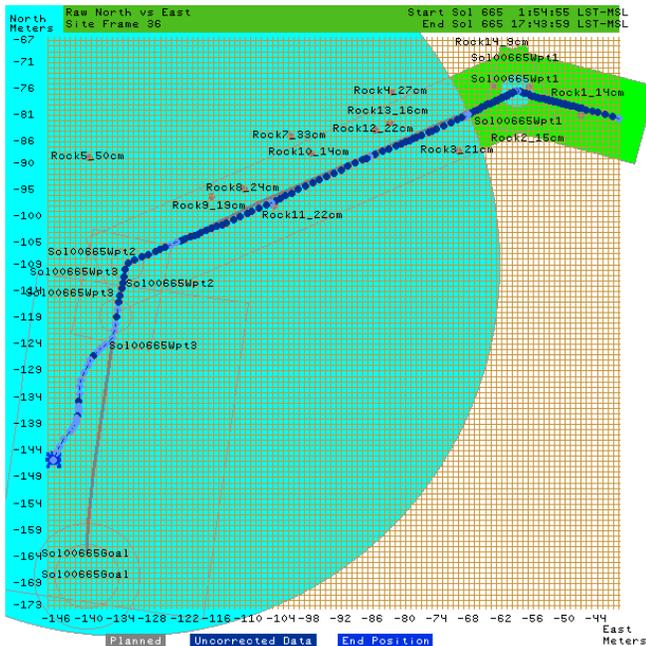
Figure 13. Map of the longest single-sol drive (sol 665, 142.5 meters). The drive started in the upper right and ended on the way to the goal at the bottom left. The grey path was the simulated path, the circles indicate the route actually taken. Dark blue circles indicate drive steps without VO, light blue circles indicate steps with VO and/or Hazard Detection images, grey circles indicate terrain features individually labelled by Rover Planners. Grey boundaries indicate keep-in zones and waypoints (including commanded tolerances). The final 25 meters of the drive were in AutoNav mode, and the drive terminated successfully when the time of day limit was reached.

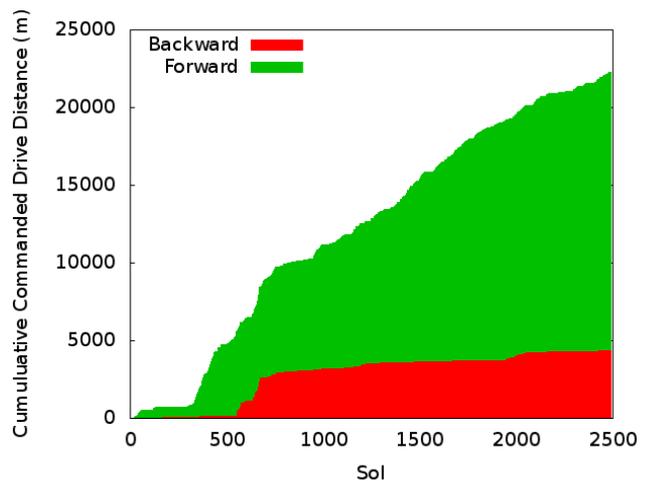
Figure 14. Curiosity cumulative commanded odometry by drive direction.

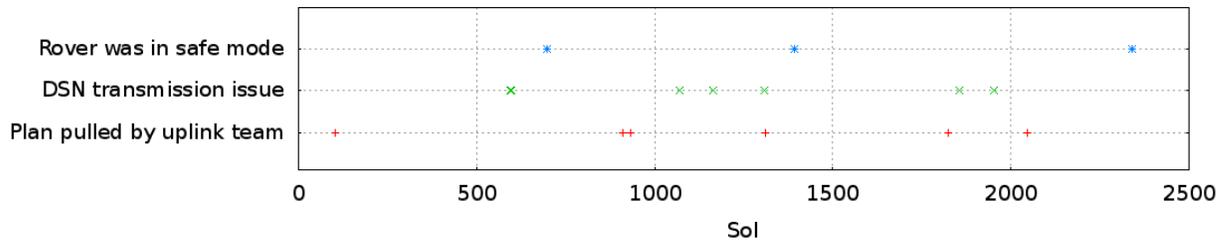
Figure 15. Sixteen drives were planned but not attempted by the rover.

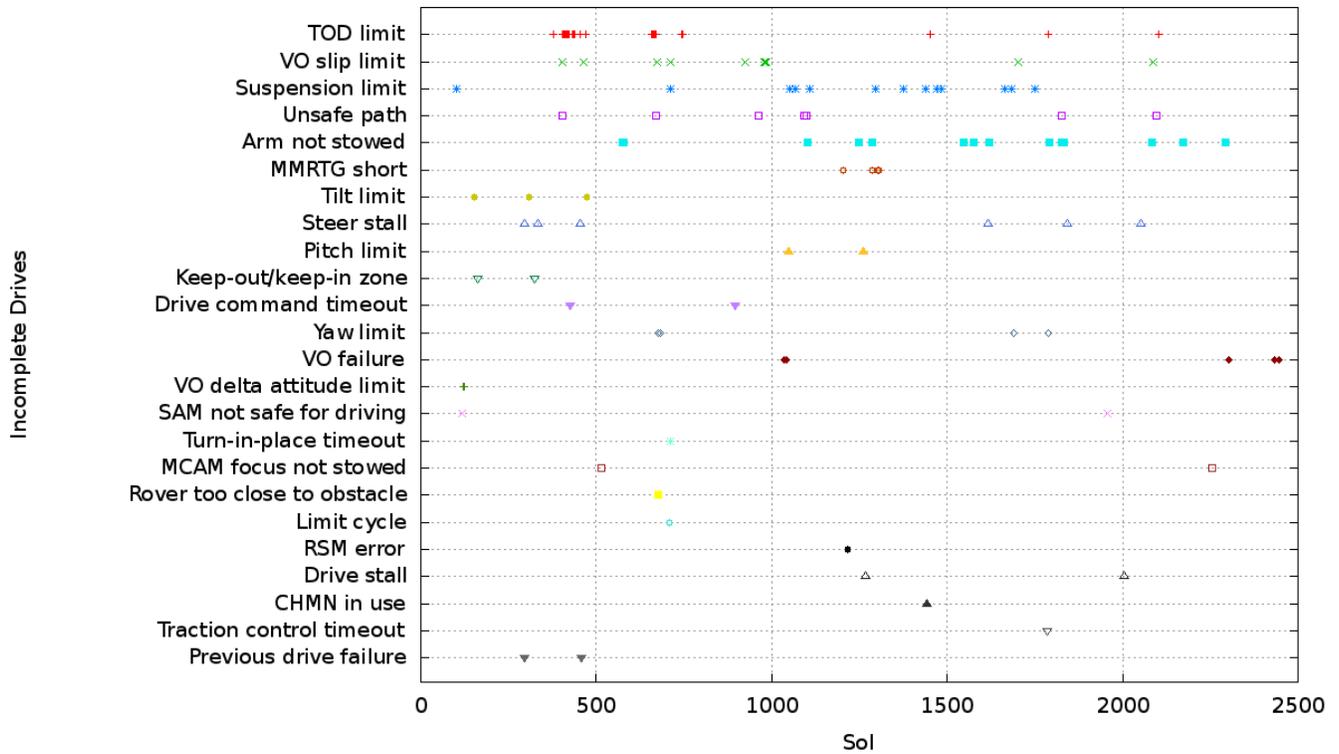
Figure 16. Twenty-four types of fault protection caused incomplete drives during the first seven years of the mission.

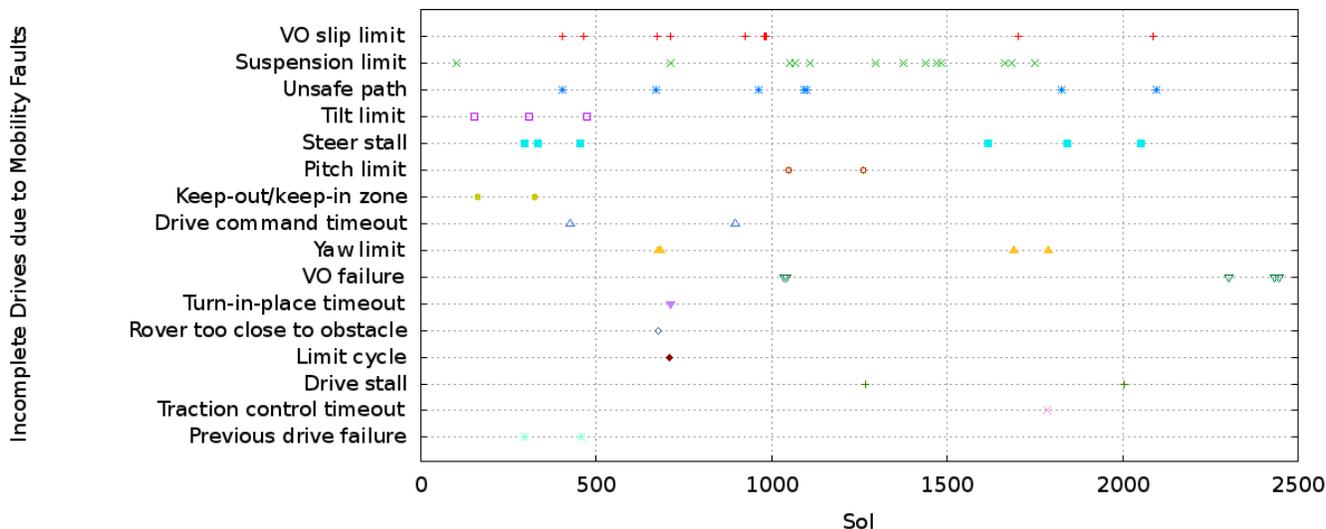
Figure 17. Sixteen types of mobility fault protection caused incomplete drives during the first seven years of the mission.

Real-time human intervention during drives on Mars is not possible due to the latency in uplinking commands and downlinking telemetry. Therefore, the flight software was designed to safeguard the rover during all activities, including driving. During a drive, mobility fault protection evaluates rover state at 8Hz. If any state relevant to driving is outside of set limits, a drive fault will occur, stopping the drive. Of the 116 drive faults that have occurred, 63 have been due to mobility fault protection. Table 6 lists the 16 reasons why the 63 drive failures occurred due to mobility fault protection, and Figure 17 illustrates their temporal distribution.

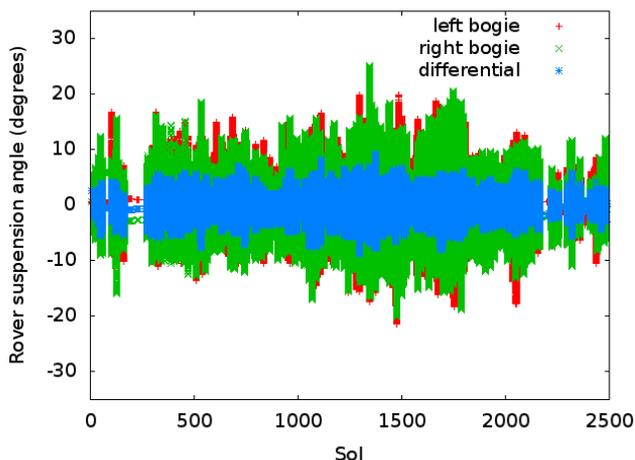
Figure 18. Curiosity suspension angles during the first seven years of the mission.

Curiosity suspension angles up through sol 2488 are shown in Figure 18. The max bogie and differential angles experienced by Curiosity are 25.2 and 9.4 degrees, respectively. The

nominal flight bogie and differential angle limits are 17 and 7 degrees, respectively. Exceeding a suspension limit has caused thirteen drive faults.

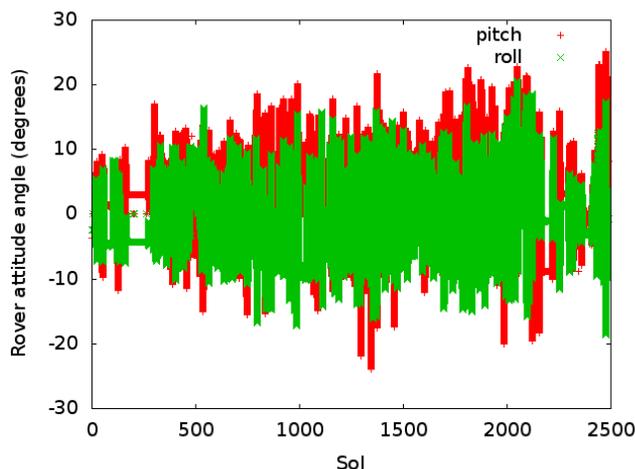
Figure 19. Curiosity pitch and roll angles during the first seven years of the mission.

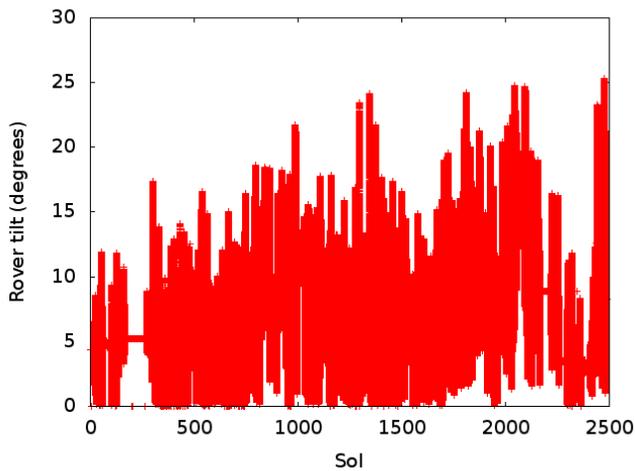
Figure 20. Curiosity tilt during the first seven years of the mission.

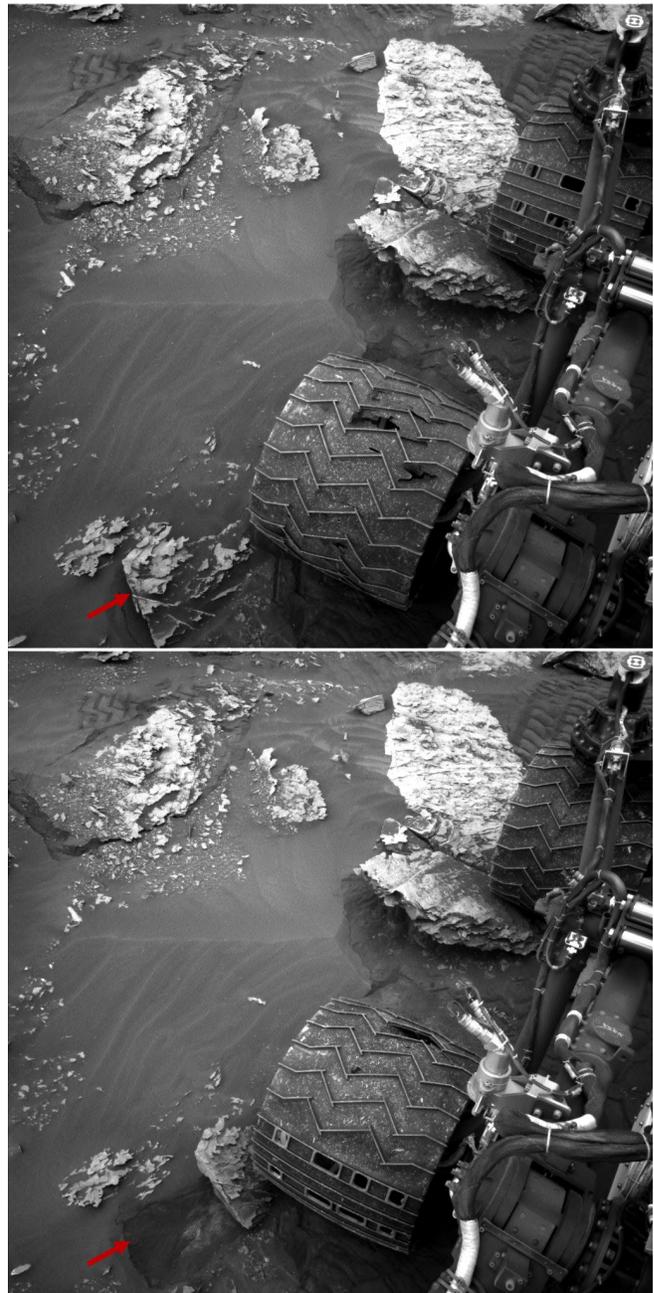
Figure 21. NavCam images of the RM and RR wheels on sols 2086 (top) and 2087 (bottom). The sol 2087 forward drive faulted when 98.7% wheel slip occurred, exceeding the 90% limit set for this drive. No forward progress was made. Note that a rock was dragged backward by the RM wheel.

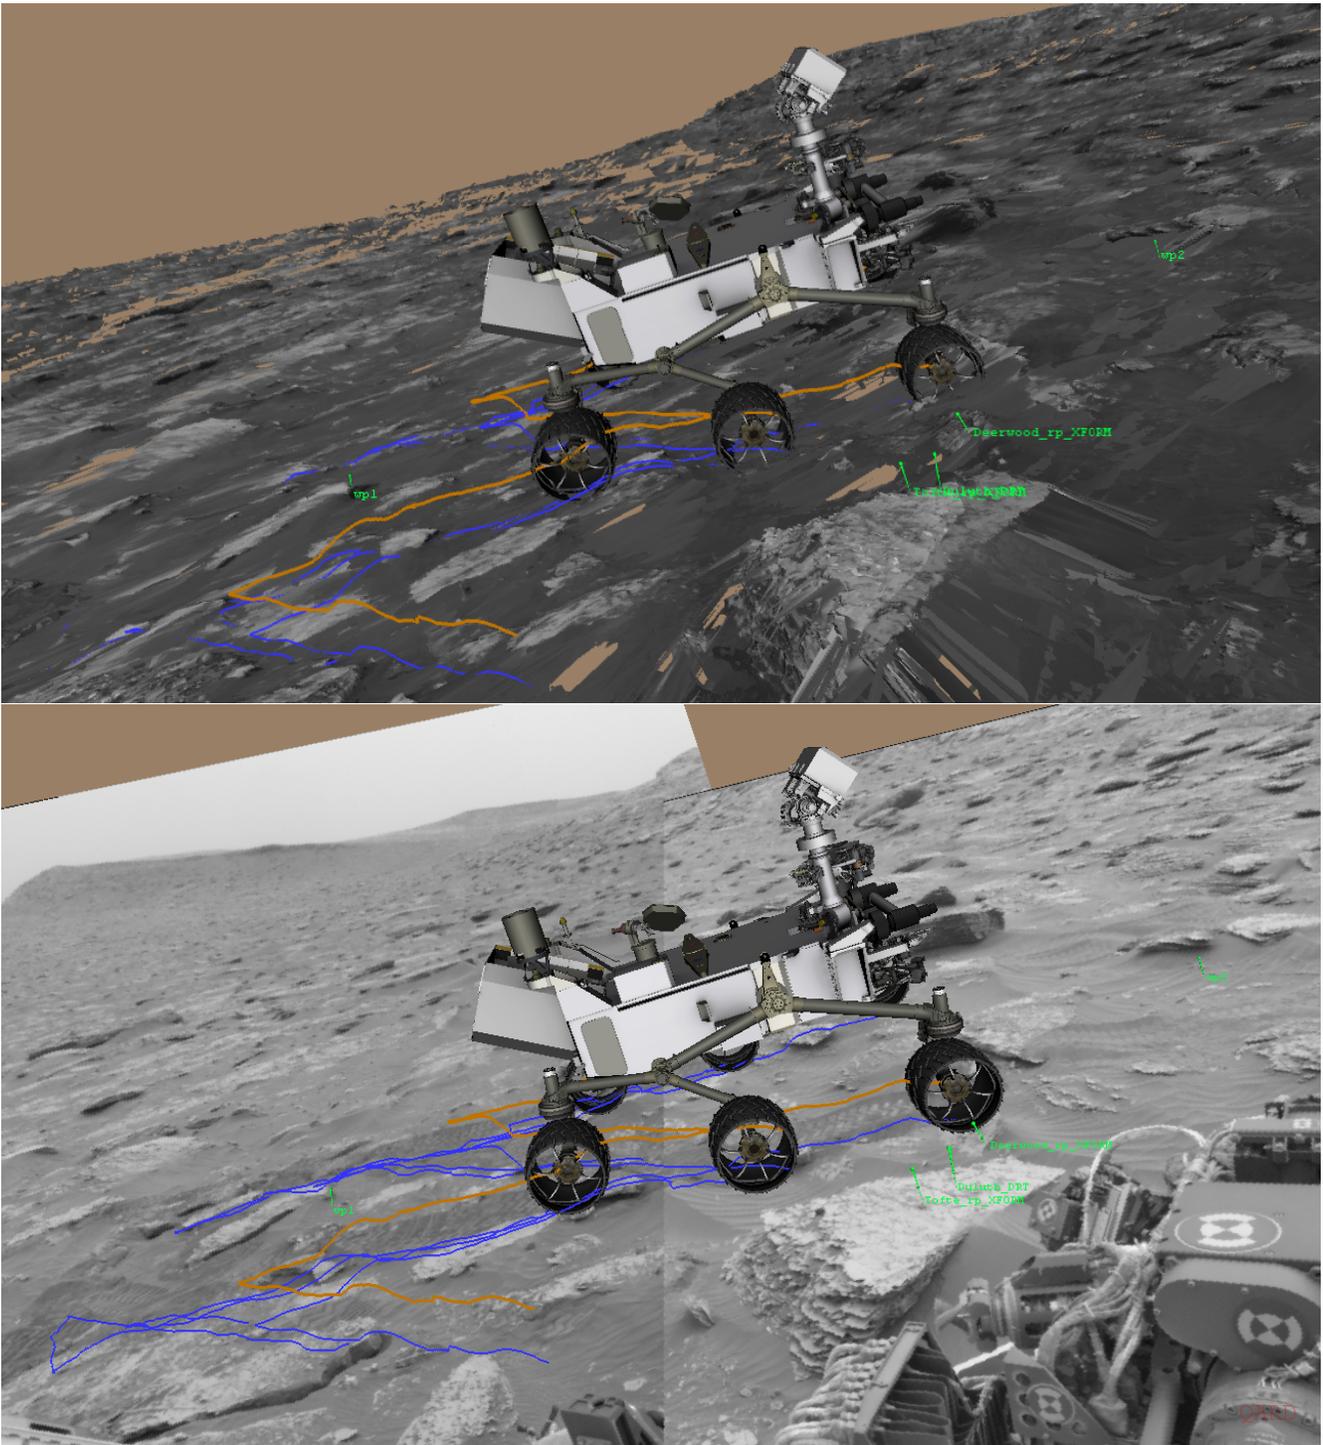
Figure 22. Visualizing the Sol 2086 drive, which failed due to high wheel slip. The upper image shows the actual rover path projected into the “planning mesh,” a visualization of the terrain used by Rover Planners to create drive command sequences. Orange lines track the wheel centers, blue lines track the lowest point on the wheel (i.e., ground contact). The lower image shows the same data projected into NavCam images taken on sol 2089, after the drive completed. Actual drive tracks are visible in the lower image. Images rendered by the rover planning tool RSVP.

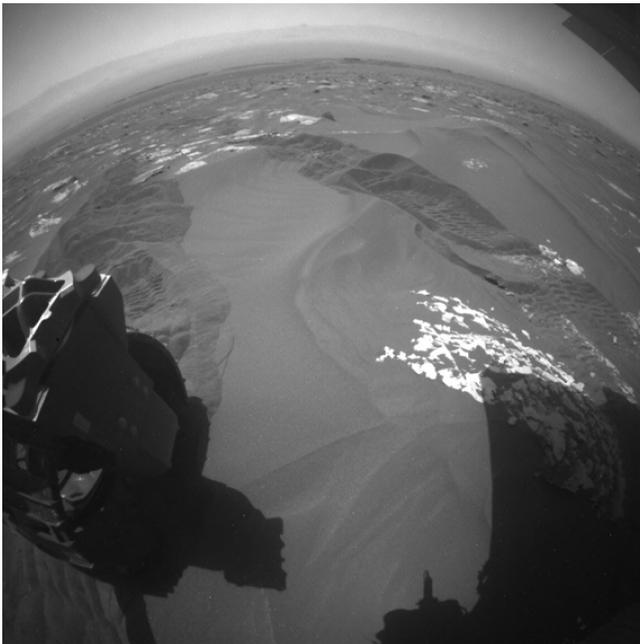
Figure 23. Rear HazCam image acquired after the sol 1789 drive. The RR wheel is visible in the image. High slip in sand caused Curiosity to exceed a 149.265 ± 30 degree yaw limit, faulting the drive.

quickly by the onboard attitude estimator, stopping the drive as soon as the limit is exceeded. Figure 23 illustrates terrain where wheel slip caused a 30 degree change from the desired rover heading. Exceeding the yaw limit has caused 4 drive faults.

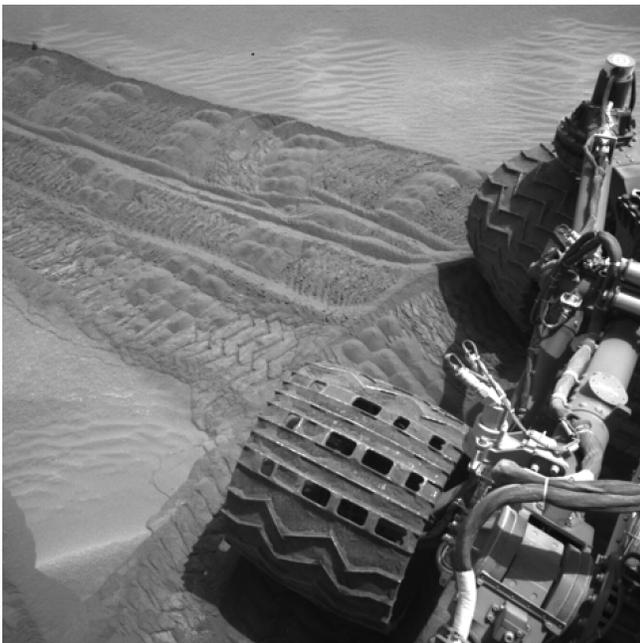
Figure 24. Sol 711 NavCam image of the RM and RR wheel after a turn-in-place command timed out. According to IMU data, the turn slip was 40.4%.

24, exceeding the duration limit for a turn-in-place command has caused 1 drive fault (sol 711). Other duration limits that have caused drive faults are exceeding the duration limit during execution of 1) an arc with TRCTL enabled (sol 1786), and 2) a go to waypoint motion (sols 426 and 896).

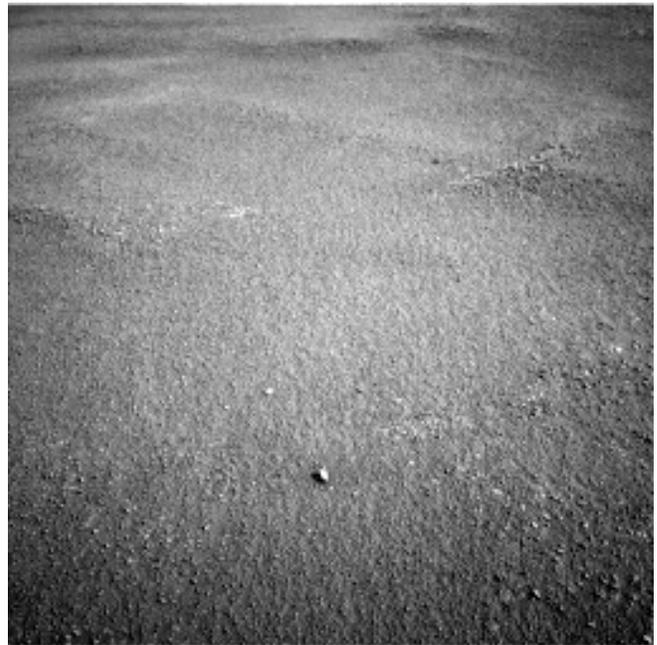
Figure 25. NavCam VO image from sol 2434 of terrain with a lack of autonomously detectable and trackable features. The max number of VO failures in a single drive (11) occurred here. The max wheel slip measured during the drive was 13.5%.

limiting the number of steps that can accumulate unknown and uncorrected slip). Although VO works very well in general, it depends on there being enough features detected in the nearby terrain to enable their motion to be tracked. If any of its internal sanity checks fails or the terrain lacks sufficient features, it can fail to converge, e.g., as in Figure 25. The largest number of failures that have occurred on a single sol is 11 (sol 2434). The 11th VO failure caused a goal error to

be declared and the drive to stop due to the VO failure limit of 10 having been exceeded. VO failures have caused 5 drive faults.

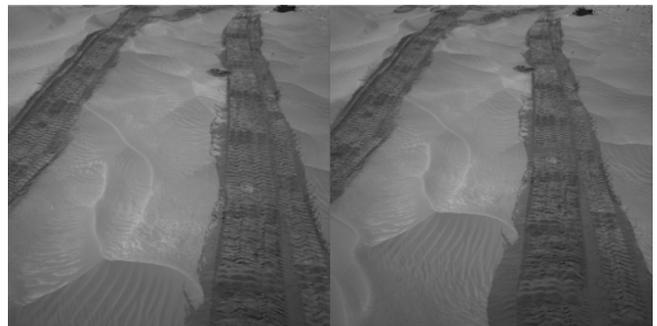
Figure 26. NavCam VO images of wheel tracks from sol 709. The commanded drive distance between the left and right image was 2 meters. Because Curiosity was not making enough progress towards the navigation goal, a limit-cycle drive fault was declared. During the final step of the drive, the wheel slip was 77.5%, below the 90% single occurrence limit set for this leg of the drive.

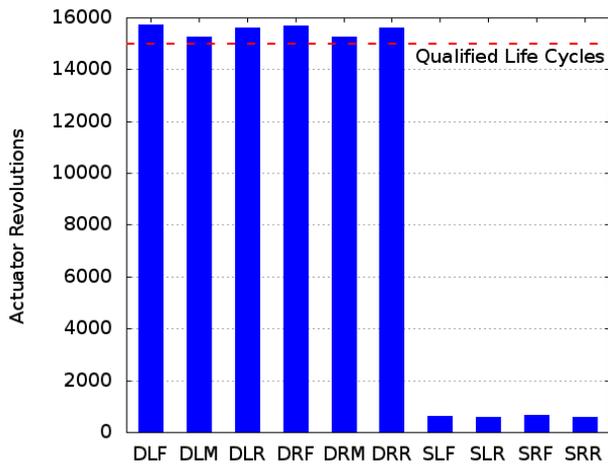
Figure 27. Drive and steer actuator revolutions as of sol 2488. DLF=drive left front, DLM=drive left middle, DLR=drive left rear, DRF=drive right front, DRM=drive right middle, DRR=drive right rear, SLF=steer left front, SLR=steer left rear, SRF=steer right front, SRR=steer right rear.

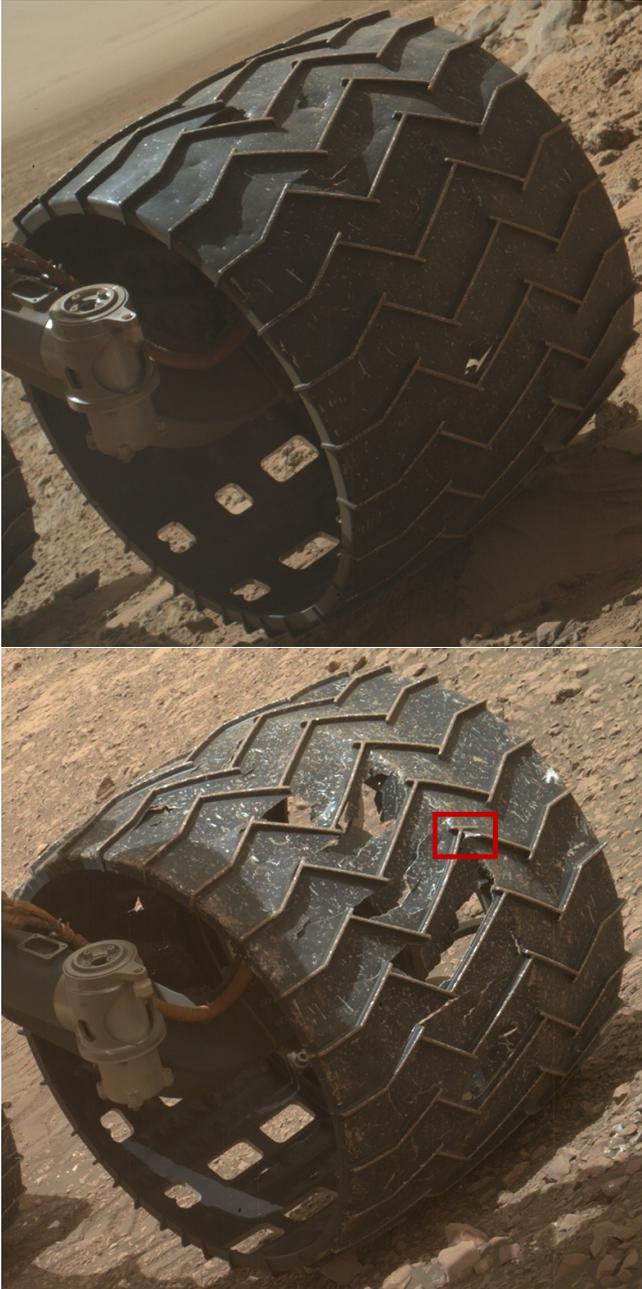
Figure 28. Images of the LM Wheel from sol 490 (top) and sol 2030 (bottom). A grouser is visibly broken in the image from sol 2030. Image Credit: NASA / JPL-Caltech / MSSS.

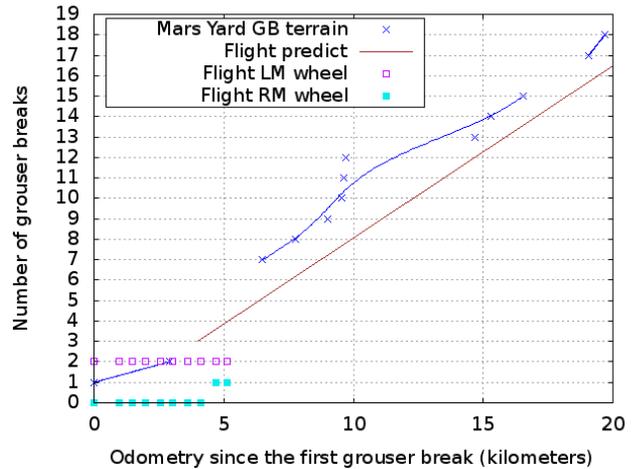
Figure 29. Number of grouser breaks on each wheel, measured since the first grouser break. Thus far, only the left middle and right middle wheels have grouser breaks. GB = good blue terrain, i.e., relatively benign terrain.
